Final Report No. 2342

by the Swiss Transportation Safety Investigation Board STSB

Concerning the serious incident involving
the SAAB 2000 aircraft, HB-IZW, operated
by Etihad Regional/Darwin Airline under
flight number AB 8054,

4.5 NM east of Billund Airport (EKBI),
Denmark

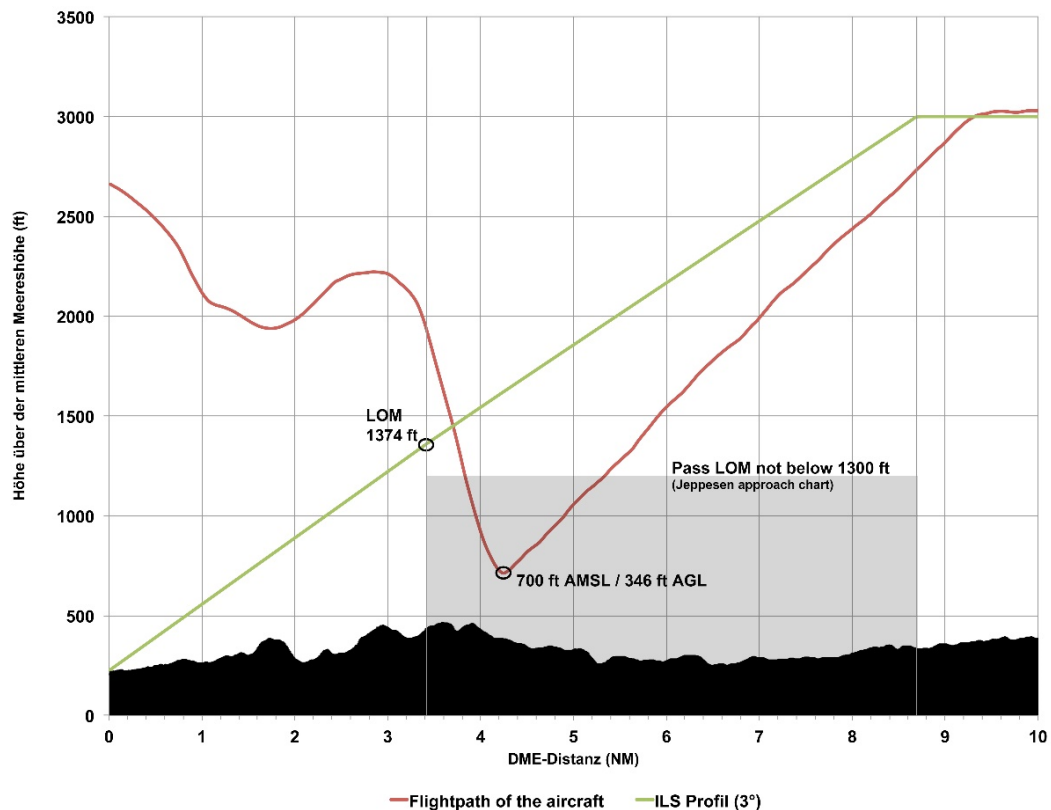
Illustration 1: The vertical profile of the localiser approach according to the DFDR data (red line) compared to a continuous descent final approach⁹ (green line). The grey area shows the lower approach limit, which an aircraft must not fly below until reaching the outer marker (LOM).

The average vertical approach speed was 771 ft/min. The indicated airspeed (IAS) was approximately 140 kt. The average ground speed was 103 kt. This resulted in an average vertical flight angle of -4.2 degrees.

In order to perform a continuous descent final approach as stipulated in OM A, the rate of descent should have been approximately 550 ft/min for an average ground speed of 103 kt. The chosen rate of descent of 800 ft/min was too high for the wind conditions prevailing at this time, which obviously was not noticed by the crew. As a result, the aircraft continued to deviate even further from the stipulated vertical profile. In the briefing, a ground speed of 140 kt had been anticipated. The current ground speed display on the ND, which is available at all times, was not considered during the final approach.

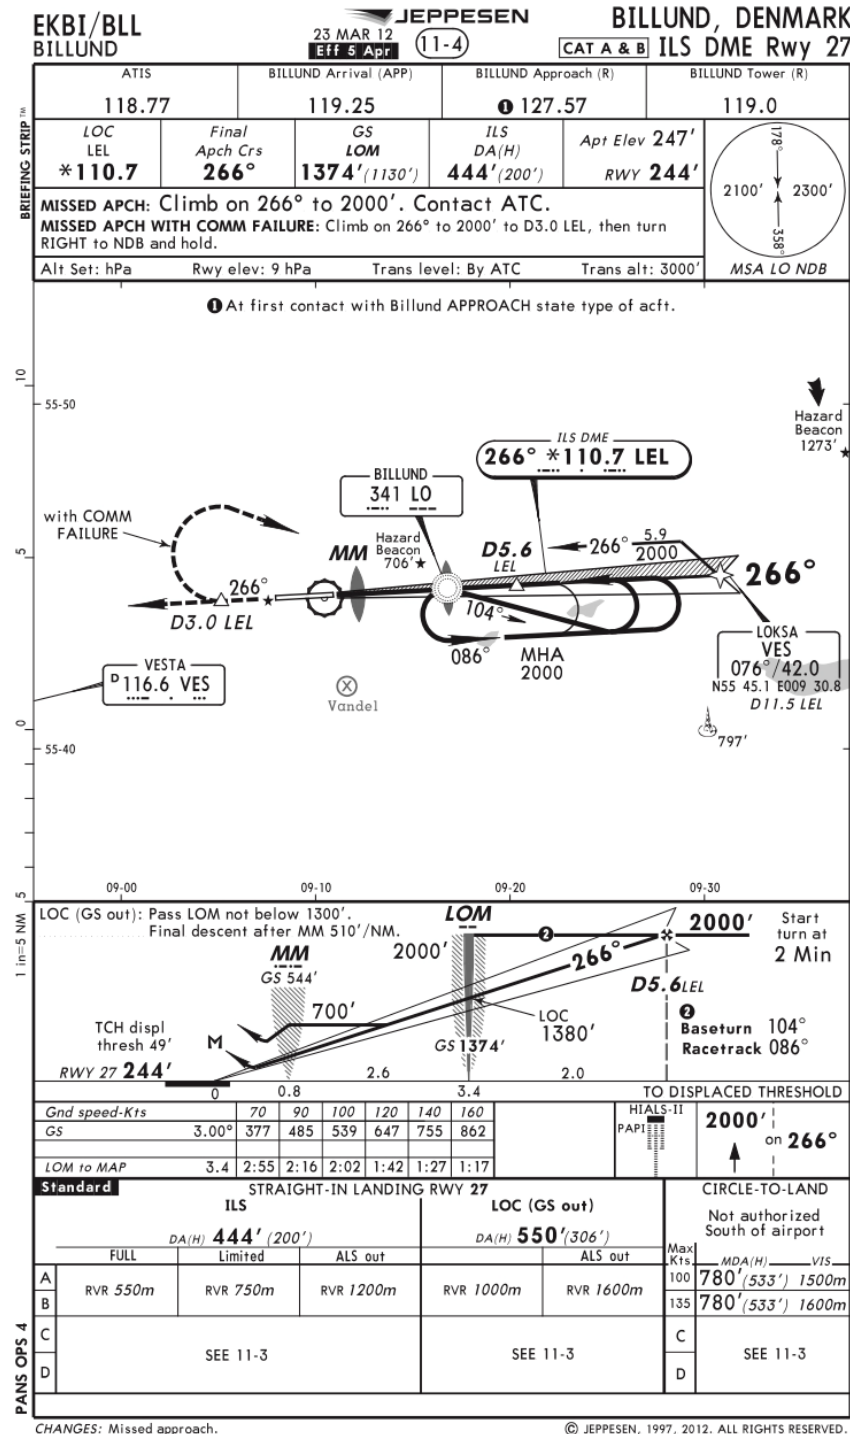
Illustration 6: ILS/LOC approach chart for runway 27 at Billund Airport (copy of the Jeppesen chart EKBI 11-4, 23 MAR 12, eff 5 Apr, valid at the time of the serious incident)

A recommended altitude descent table is not displayed in this chart.

The Jeppesen approach chart for an ILS/LOC approach to runway 27 at Billund Airport (version 23 MAR 12), which was valid at the time of the serious incident, did not have a recommended altitude descent table. This would have made it easier for the pilots to monitor the vertical profile.

The approach charts are now provided with recommended altitude descent tables.
