Final Report No. 2350

Concerning the serious incident (airprox)

between the business jet Falcon 2000EX, CS-DLB,
operated by NetJets under radio call sign NJE050N

and the glider Arcus, HB-3442,

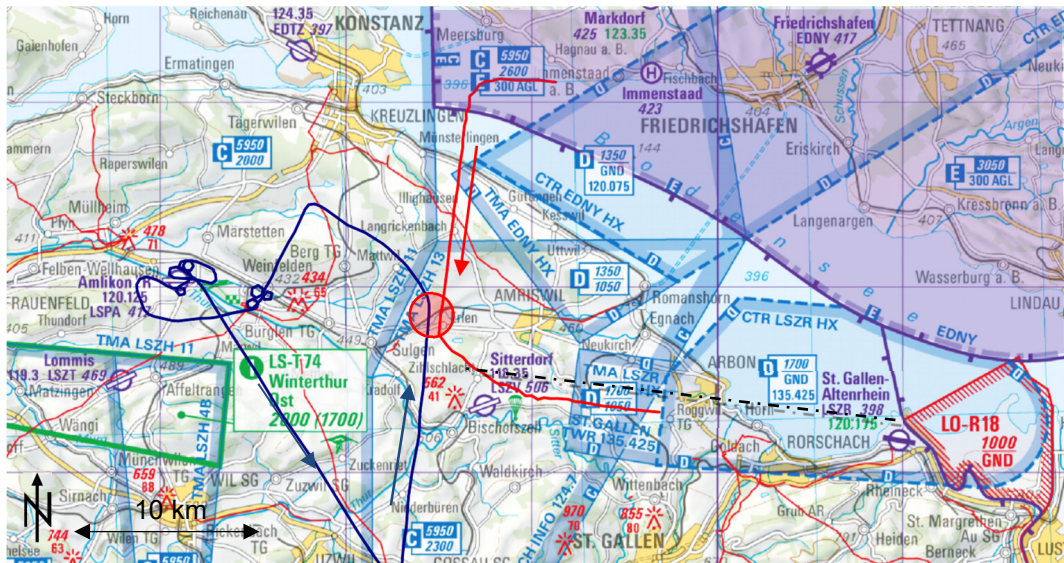
Illustration 1: Recordings of the flight paths of HB-3442 (blue) and CS-DLB (red), marked on the glider map of Switzerland. The final approach to ILS 10 St. Gallen-Altenrhein is marked as a dashed black line. The point of closest proximity is marked with a red circle. The Transponder Mandatory Zone (TMZ) around Friedrichshafen Airport is highlighted in purple. Source of base map: Swiss Federal Office of Topography.

Whilst gliding in a northerly direction, the glider pilot of HB-3442 noticed a business jet up ahead on the right-hand side of his aircraft at approximately 12:42 UTC and at a flying altitude of approximately 1570 m AMSL. This jet was CS-DLB, which was flying in the opposite direction at practically the same altitude. The glider pilot watched CS-DLB fly past to the right and estimated the distance to the other aircraft to be 100 metres or more. According to his statement, he was not alarmed since other aircraft frequently flew past at a similar distance in this airspace. He stated that it was extraordinary, however, that the aircraft was a larger business jet and that it was flying at practically the same altitude.

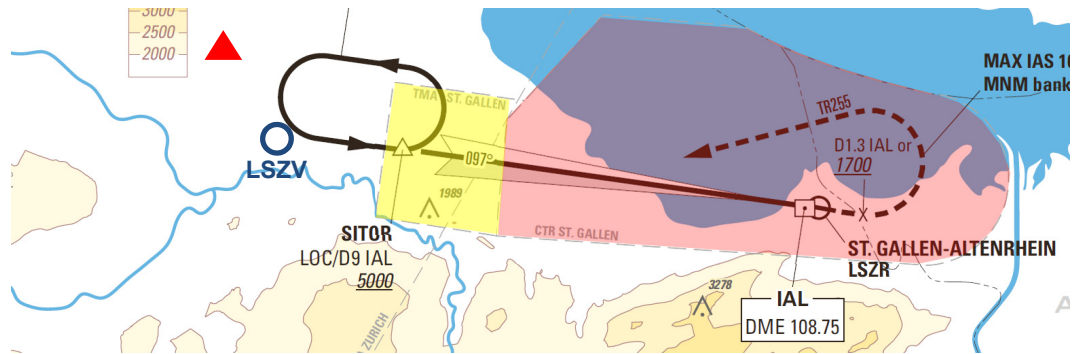
Illustration 2: Section from the Instrument Approach Chart (IAP) of ILS 10 at St. Gallen-Altenrhein, Swiss Aeronautical Information Publication (AIP). The location of the Sitterdorf Airfield (LSZV, dark-blue circle) was later added, as were the locations of the Control Zone (CTR, highlighted in red) and the Terminal Control Area (TMA, highlighted in yellow) at St. Gallen-Altenrhein. The point at which the airprox occurred is marked as a red triangle.

The approach axis of Instrument Landing System (ILS) 10 in St. Gallen-Altenrhein and, in particular, the altitude of approximately 1500 m AMSL at which IFR aircraft fly to the Final Approach Point (FAP), are not charted on the glider map. For this reason, the glider pilot was not aware that he was more likely to encounter an aircraft in this area that operated under IFR, such as CS-DLB. The extended TMA west of the St. Gallen-Altenrhein CTR, which ranges from 3500 ft to 5500 ft AMSL, was the only indication that instrument approaches might be executed in this area and at this altitude.

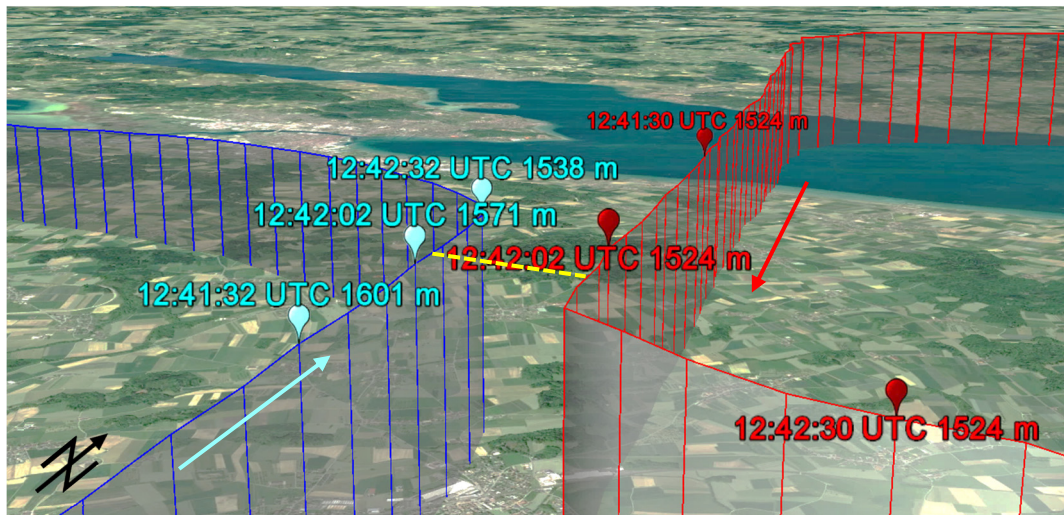
The flight path of CS-DLB was established based on radar data. The flight paths are shown in illustration 3. The closest proximity between the two aircraft was at 12:42:08 UTC with a horizontal distance of approximately 660 m (with an accuracy of approximately ± 100 m) and a vertical distance of approximately 40 m (± 25 m).

Illustration 3: Flight path of HB-3442 (blue) based on the Flarm data and of CS-DLB (red) based on the radar data, shown in Google Earth. The closest proximity occurred at 12:42:08 UTC (dashed yellow line).

- After both the flight crew of CS-DLB and the glider pilot had seen each other's aircraft, their flight paths crossed at 12:42:08 UTC flying in opposite directions at a horizontal distance of approximately 660 m and a vertical distance of approximately 40 m.
