Final Report No. 2354

Concerning the serious incident (AIRPROX)

involving the Airbus A320-214 airliner
operated by the Aer Lingus company,
call sign ATC EIN68N,

and the Cessna C525 aircraft,
in private operation,
registration N990FV

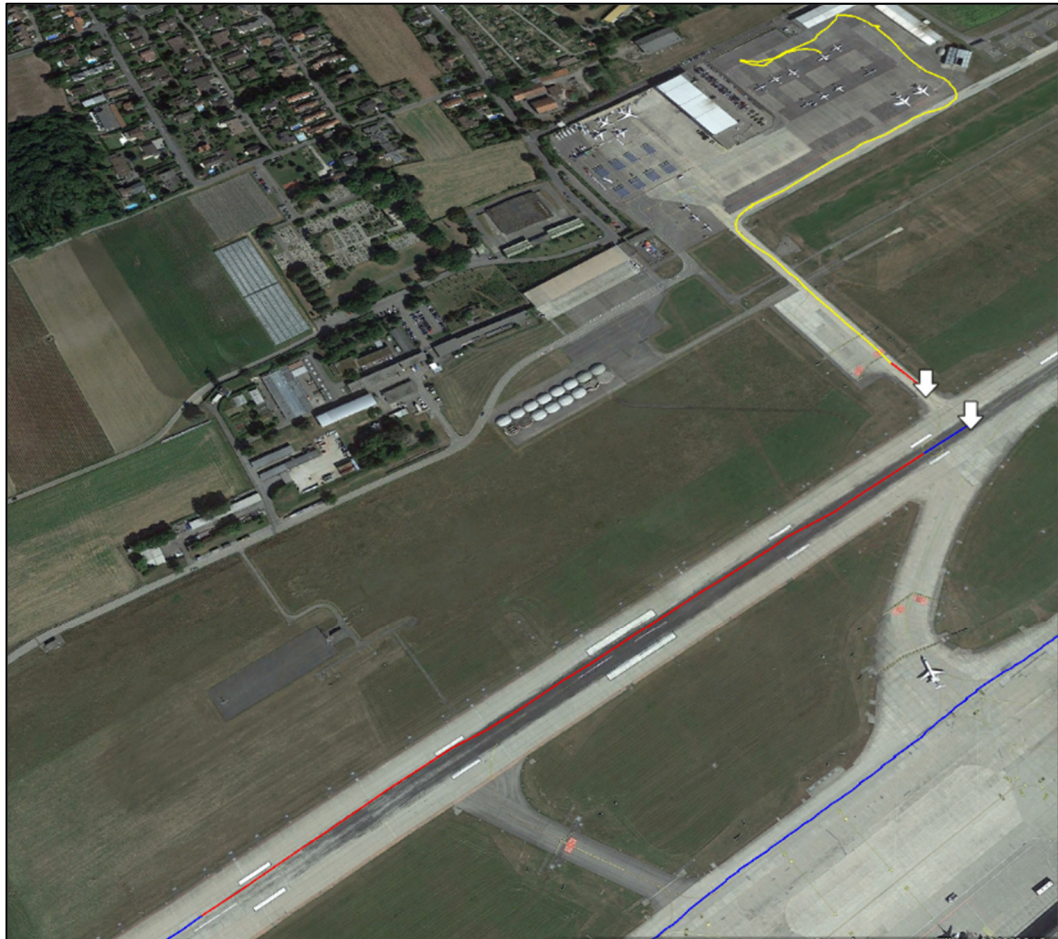
At 08:47:11 UTC the Airbus crossed taxiway Z and the tip of its left wing passed approximately 24 m from the nose of the Cessna C525.

Figure 1: Paths of N990FV (yellow) and EIN68N (blue). The parts shown in red indicate when the “RIMCAS” aural warning was generated.

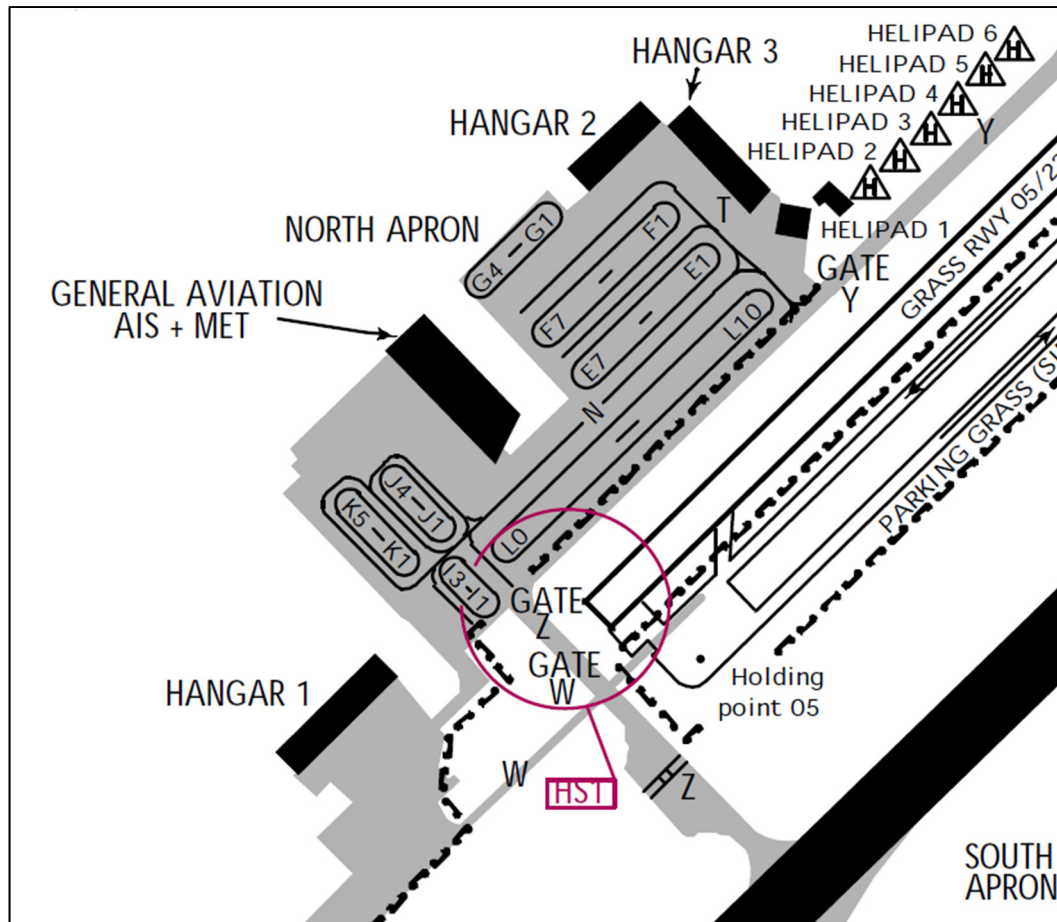
Each of the pilots of N990FV had JEPPESEN electronic aeronautical charts. The "JEPPESEN 10-9B" Geneva aerodrome chart is the one which provides the most details about taxiing on the north apron. Unlike the rather more detailed signalling of taxiway Y and its two holding bays Y1 and Y2, that of taxiway Z and its holding bay consists only of the letter "Z" alone, affixed to the representation of the latter. Two hot spots designated "*HOT SPOT HS1*" feature on it; their legend on chart "JEPPESEN 10-9" draws the attention of flight crews to the proximity of taxiways located under the final path or under the take-off centre lines of the grass runway.

Figure 2: North apron, hot spot HS1 on taxiway Z

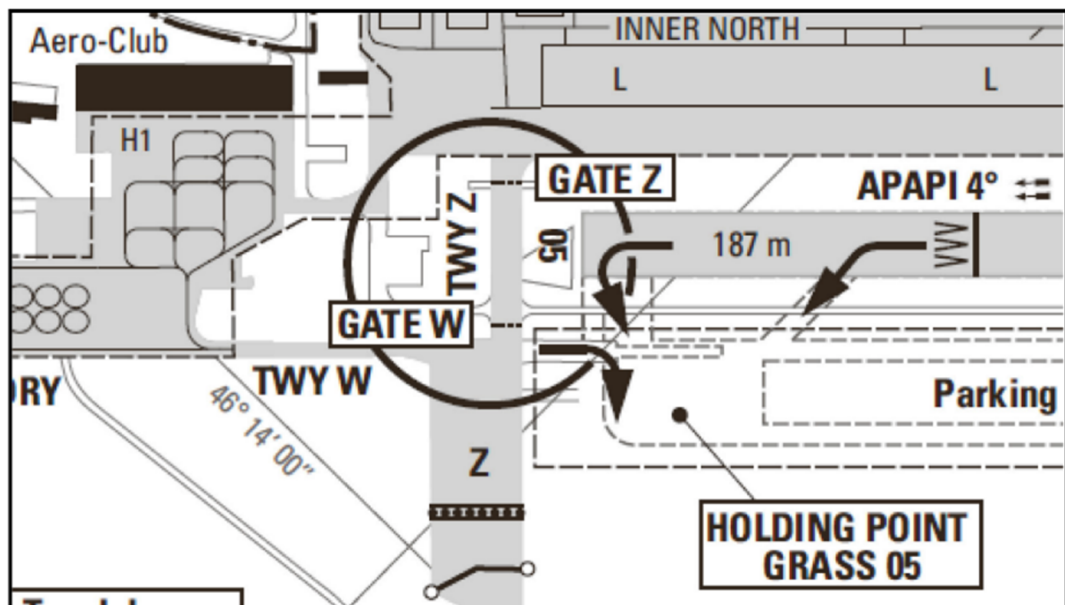
GND is assigned the task for the prevention of collisions between traffic on taxiway Z and grass runway operations (ARR 05 and DEP or option 23). In order to achieve this task, Gate W and Gate Z (see Picture below) may be used as taxi clearance limit if required.

Figure 3: Taxiway Z vs grass runway movements

As Gate W and Gate Z are not RWY holding positions, pilots will not automatically stop at these intermediate holding positions. Similarly, a clearance beyond these intermediate holding positions does not require a specific "crossing" clearance.

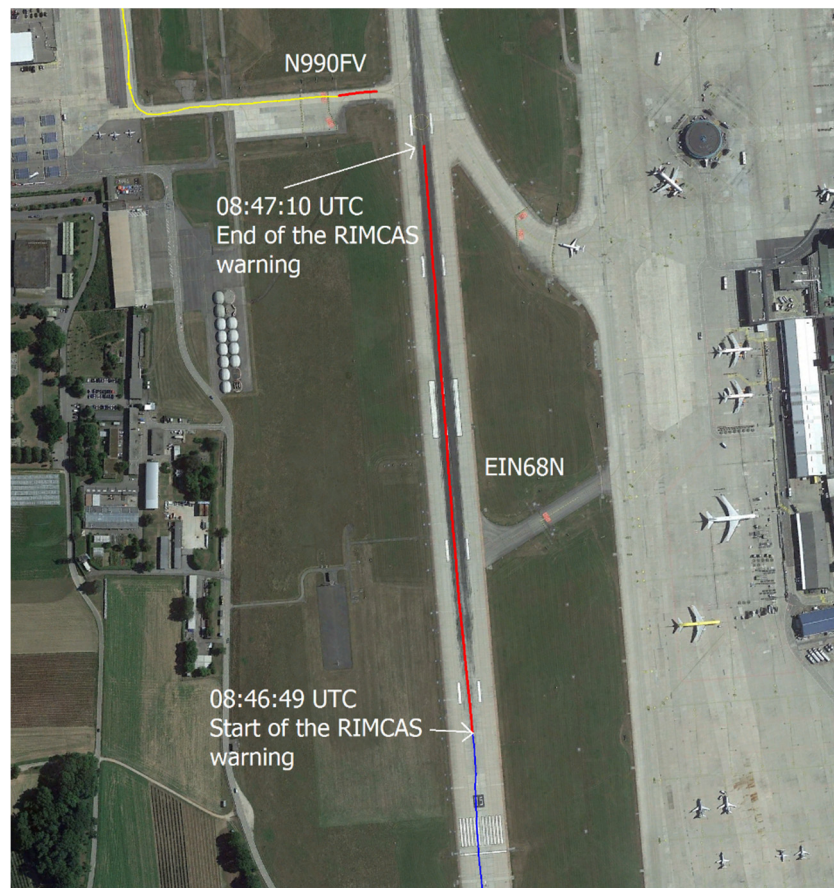
The warning commenced at 08:46:59 UTC when EIN68N was rolling for take-off at a ground speed of 77 kt and 675 m from the intersection of taxiway Z with concrete runway 05. At this time N990FV was approximately 12 m away from the CAT 1 Z runway holding position and was taxiing at 12 kt. The warning ended at 08:47:10 UTC; EIN68N was rolling at a ground speed of 126 kt and was at a distance of approximately 60 m from N990FV, which was taxiing at 5 kt in deceleration phase.

Figure 4: "RIMCAS" aural warnings

On taxiway Z, in the good visibility operating condition, the protected area of the runway is delimited by runway holding position CAT I. When crossing it causes a runway incursion, it would be appropriate for the RIMCAS warning to be issued at this moment. In the case of the serious incident, this would then have been 3 seconds earlier, when EIN68N's speed was 15 kt lower.

The Federal Office of Civil Aviation should ensure that the RIMCAS safety net is parameterised so that it generates an alarm which is perceptible in weather conditions other than those of reduced visibility.

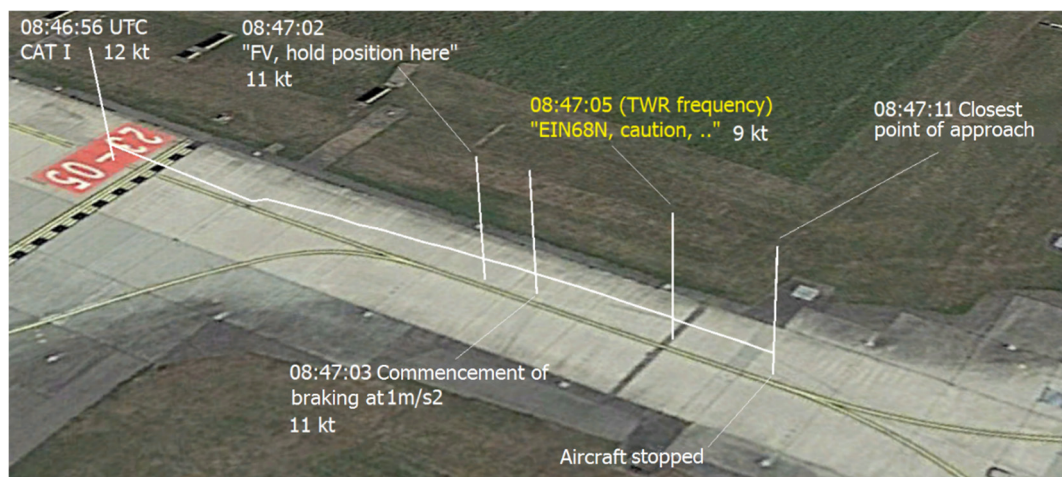
Figure 5: Speeds of N990FV

N990FV stopped approximately 15 m from the edge of concrete runway 05.

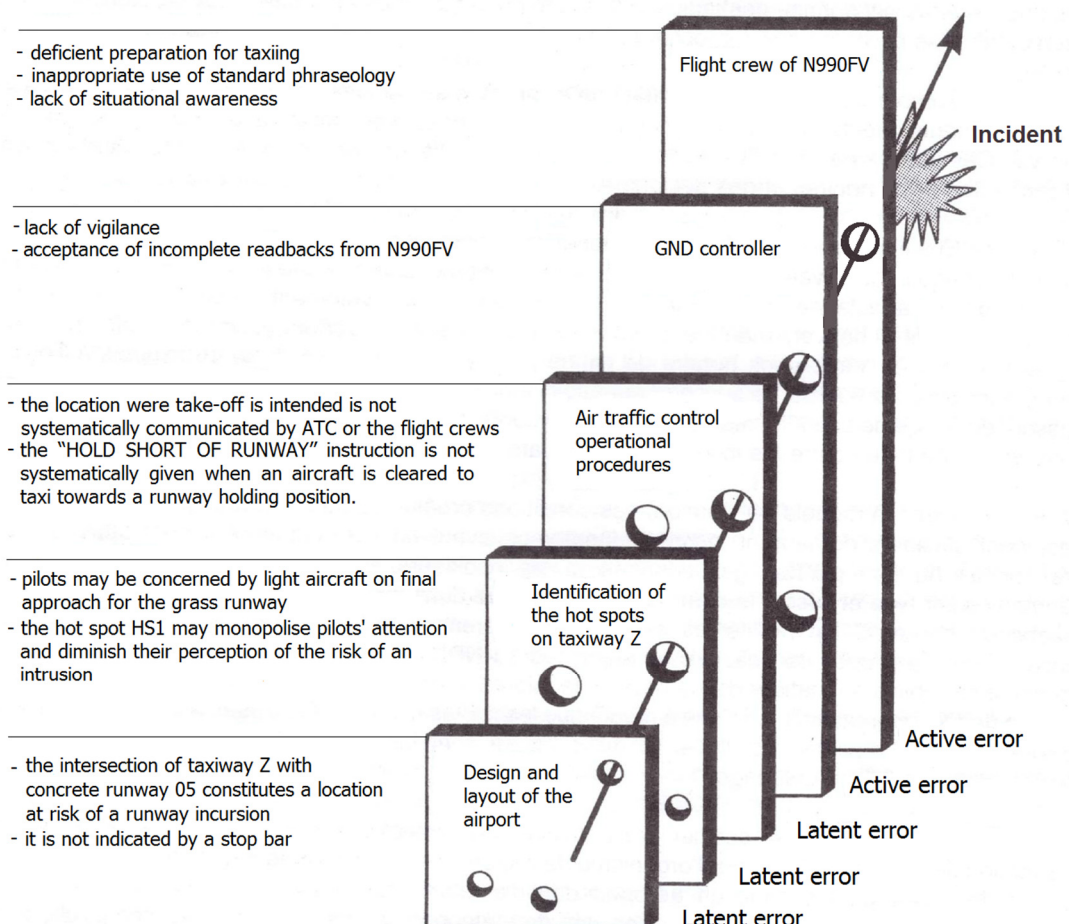
The lack of vigilance of the GND controller, in particular the failure to verify execution of the instruction "*N990FV here right...*" constitutes an active error.

In terms of flight management, the lack of situational awareness of the flight crew of N990FV, leading to the crossing without clearance of runway holding position CAT I Z, constitutes an active error.

Figure 6: Causal sequence leading to the serious incident
