Final Report No. 2359 by the Swiss Transportation Safety Investigation Board STSB

concerning the accident involving the
Bombardier Global 6000 aircraft 9H-AMZ

on 6th April 2016

at Geneva Airport (LSGG)

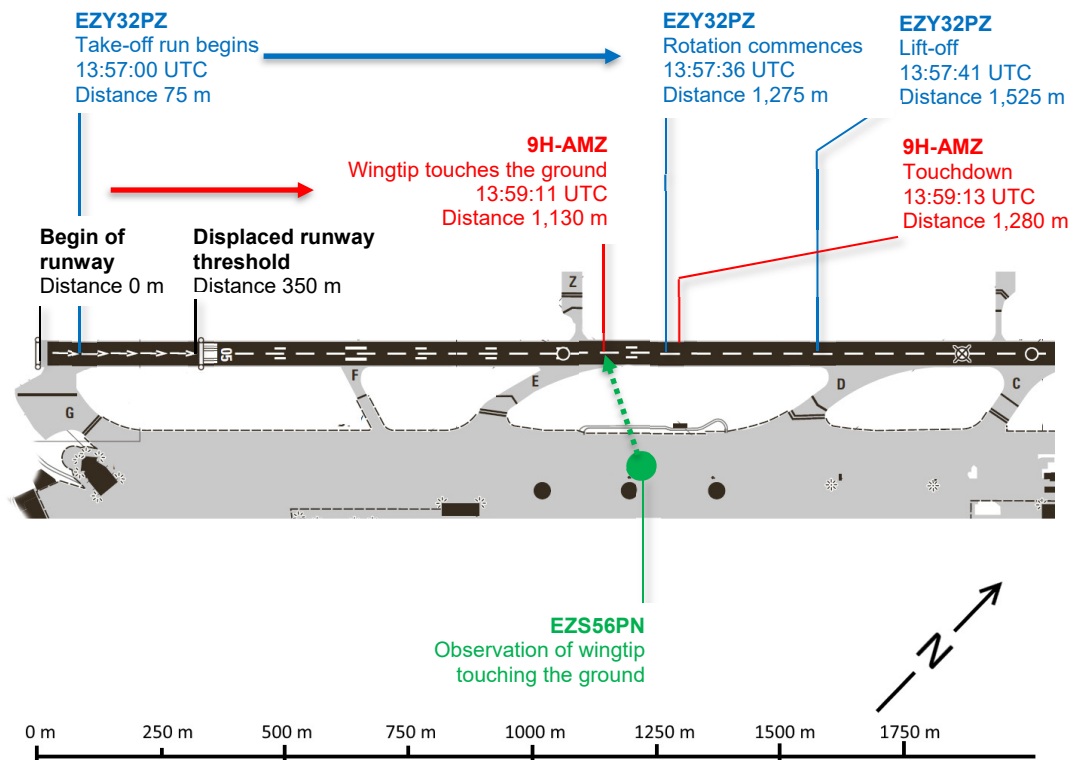
Illustration 1: View of the south-west section of runway 05. Positions of the departing Airbus A319 (EZY32PZ) and of the landing Global 6000 (9H-AMZ). On the south apron, the position of the aircraft (EZS56PN) is shown, from which the contact with the ground was observed.

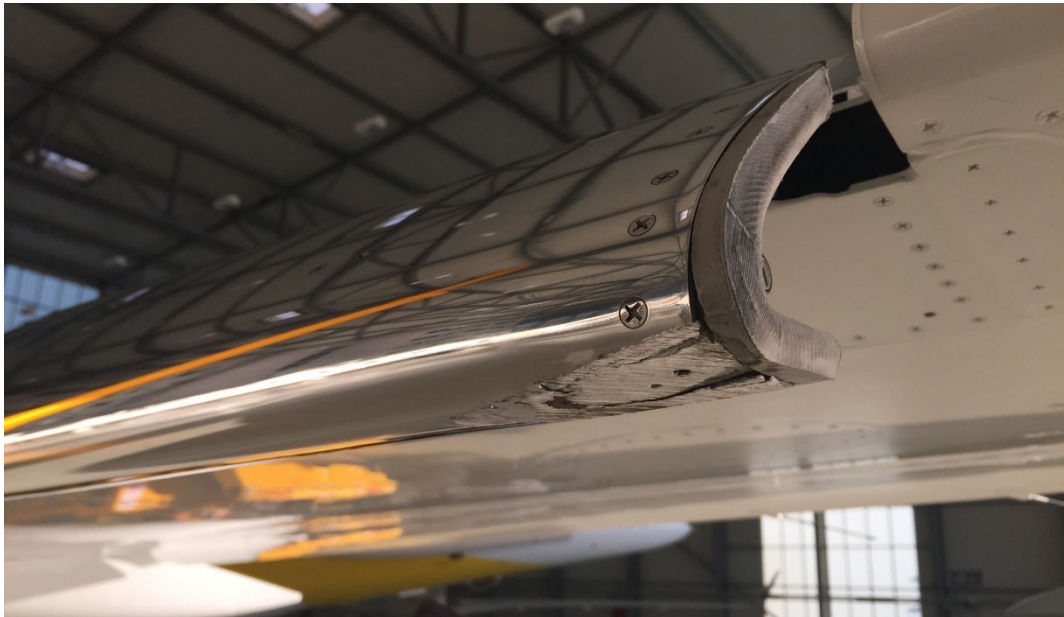
The occupants of 9H-AMZ were not injured. The aircraft was damaged on the left outer leading-edge slat.

The aircraft sustained damage to the left outer leading-edge slat in the form of scratch and rubbing marks due to the contact made with the ground (see illustration 2).

Illustration 2: Left outer leading-edge slat shown in its extended position with scratch and rubbing marks on the underside

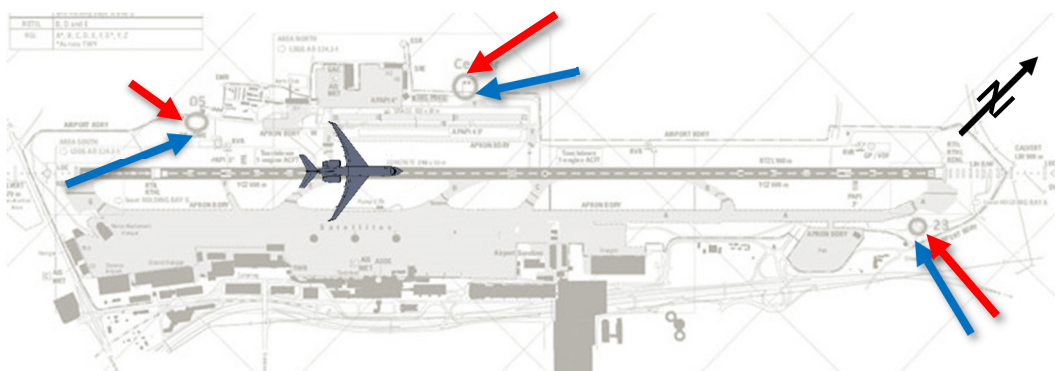
At the time when 9H-AMZ was landing, the following ground wind was measured at the three anemometers (see illustration 4):

Time	Runway threshold 05	Middle of the runway 'Centre'	Runway threshold 23
13:57:43 UTC	4 kt from 210°	4 kt from 040°	4 kt from 110°
13:59:11 UTC	2 kt from 250°	4 kt from 020°	4 kt from 100°

Illustration 4: Wind measurements in Geneva (LSGG) as recorded by ground radar along runway 05 at the time of the departing lead A319's take-off (in blue) and at the time of 9H-AMZ's wingtip strike (in red); the aircraft symbol shows the position at which the aircraft touched the ground with the tip of its left wing.

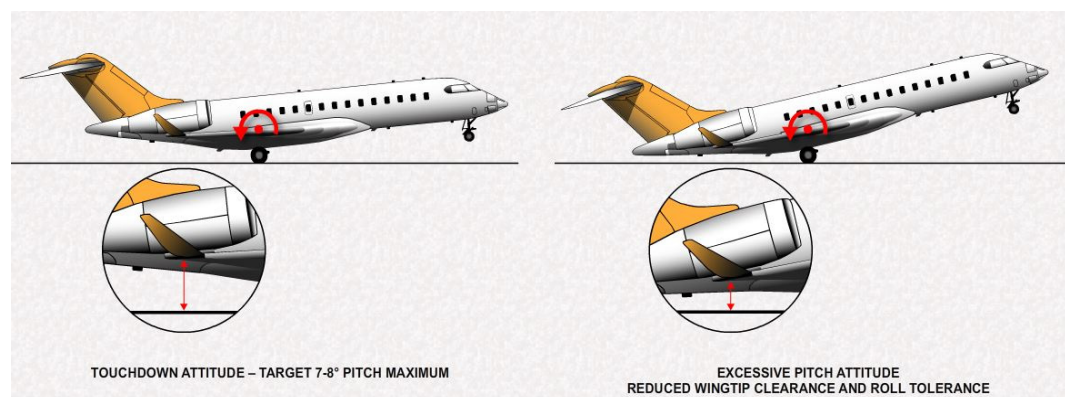
In addition, the FCOM states regarding crosswind landings: The tips of the wings can make contact with the runway when landing with an increased bank angle. To prevent this from happening, the bank angle should be limited to 3° or less and the aircraft should touch down immediately after coming into alignment with the runway. During a prolonged flare, the pilot continually increases the pitch attitude, meaning that the wingtips move closer to ground due to the pronounced sweep of the wing (see illustration 5).

Illustration 5: The image on the left shows the pitch attitude, which is a maximum of 7-8° during a normal landing, and the corresponding distance between the tip of the wing and the ground. Increasing the pitch attitude reduces this distance and the maximum acceptable bank angle as displayed in the image on the right (source: Bombardier e-learning module).

The bank angle at which a wingtip touches the ground decreases as the pitch attitude increases and is dependent on whether the landing gear is in the static or flight position (see illustration 6). As the lift on the wing rapidly decreases during landing and the landing gear is thereby compressed, the limiting static value is to be taken into consideration. In this accident, the pitch attitude at which the wingtip strike occurred was approximately 4.7°, which gives a bank angle of 9.0° (static) and 11.7° (flight) respectively.

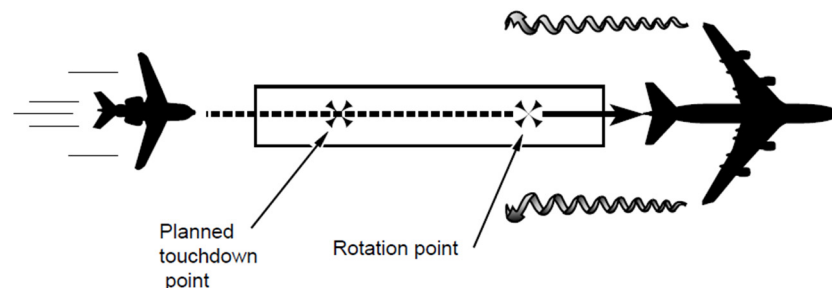
For situations with one departing and one landing aircraft behind it, there exist general recommendations. For example, The US Federal Aviation Authority (FAA) recommends a planned touchdown point on the runway that is before the rotation point of the departing lead aircraft (see illustration 7).

Illustration 7: Landing behind a departing larger aircraft (source: “*Pilot and Air Traffic Controller Guide to Wake Turbulence*”, FAA)
