Investigation Report No. 2369 by the Swiss Transportation Safety Investigation Board STSB

concerning the accident involving the
Pipistrel Alpha Electro 167 aircraft,
registration HB-SAA

on 3 January 2019

Corpataux-Magnedens, municipality of
Gibloux (FR)

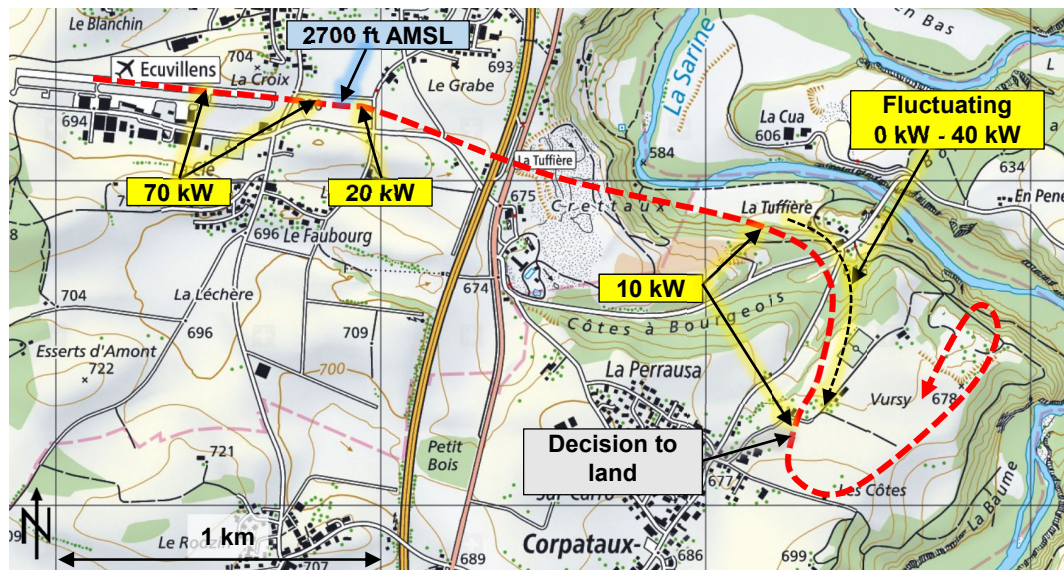
Because the remaining motor power did not allow level flight or a climb, the pilot decided to make an emergency landing on a field approximately 210 m long near the sports ground of the village of Corpataux-Magnedens (FR), located 2 km east of the runway 24 threshold at Ecuwillens aerodrome. He planned to land in a north-easterly direction because the wind was from the north-east. After flying the downwind leg and short base leg of the approach circuit he turned left onto the final approach when he realised that he was clearly too high to land. He therefore decided to land on the field in the reverse (south-westerly) direction and performed a 180° left turn at the end of the field at low height above ground level (see Figure 1).

Figure 1: Flight path and altitude of HB-SAA according to the pilot's statement and remaining motor power according to the analysis of the data recorder. Base map source: Federal Office of Topography.

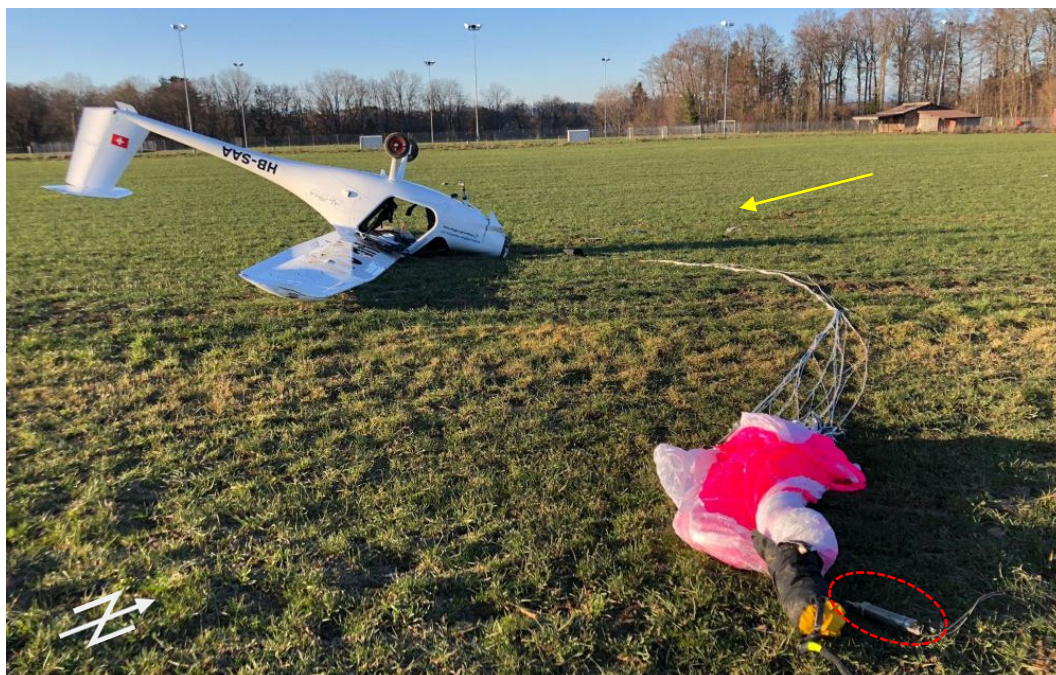
After a flying time of almost 3 minutes, the aircraft first touched down hard on the field on its nosewheel with a tail wind. The landing flaps were still set in the take-off position. The nose landing gear buckled on impact. According to the statement of the pilot, he deployed the Ballistic Parachute Recovery System (BPRS) immediately before or upon impact in order to shorten the landing distance. The BPRS activated as intended, but the canopy did not deploy completely. As a result, the aircraft flipped over its nose, remained lying upside down and was severely damaged (see Figure 2). The two battery compartments in the fuselage including the main batteries and their attachment to the airframe withstood the impact. The attachment of the left lap belt was torn from the airframe (see Section 1.4.2). Fire did not break out. There was little damage to the ground and no liquids escaped from the wreckage.

Figure 2: Final position of the aircraft (landing direction yellow arrow) with ejected, partially deployed rescue parachute and deployed rocket (red circle). The Corpataux-Magnedens (FR) sports ground is visible in the background.

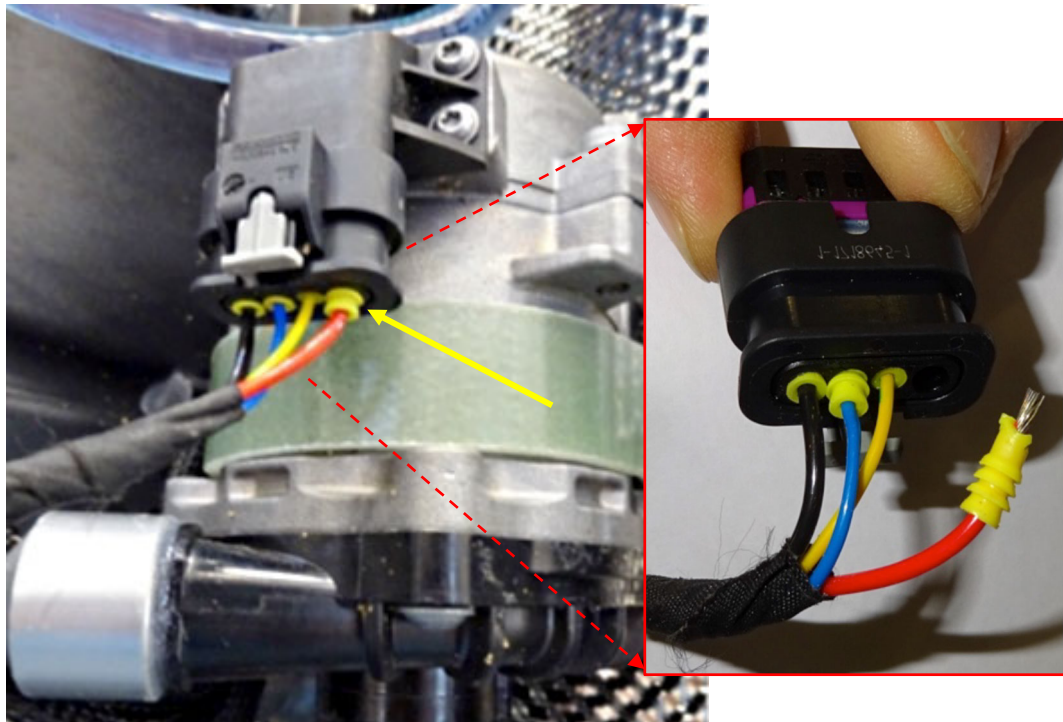
An investigation of the cooling system revealed that the electric circulating pump was functioning only intermittently despite the fact that the supply voltage of 12 V DC was being applied. A slight movement of the red supply cable in the four-pin connector was sufficient to stop or restart the pump. Directly at the plug this cable was offset at an angle and was under slight tension (no strain relief, see Figure 6).

Figure 6: Cable, plug connector and circulating pump on the motor bulkhead of HB-SAA (left) with the red power supply cable (yellow arrow) incorrectly attached. The detail on the right shows the plug after applying light tension to all four cables: the blue cable was also pulled out of the pin.

Disassembling the connector showed that the power supply cable was incorrectly crimped in the pin contact. The cable's copper wires were not mechanically clamped in the pin and were only held by the yellow rubber grommet in the pin contact. The ends of some copper wires showed traces of burning due to electric arcs (see Figure 7), which indicates that the current flow must have been interrupted several times at these points.

The blue wire on the connector (see Figure 6) was also insufficiently crimped in the pin contact. Some copper wires were not contained within the pin socket. The cable could be pulled out of the pin with little force.

Subsequent investigations of the cooling system revealed that insufficient crimping on contact pins in the circulating pump connector had caused precisely such a loose contact and that this had led to an interruption to the power supply and consequently to the failure of the pump. It was revealed that the connector had been mounted incorrectly.

The EASA should ensure that the aircraft manufacturer adapts the propulsion unit's cooling system in such a way that the failure of a single system component, such as the circulating pump, does not significantly affect cooling and consequently motor power.

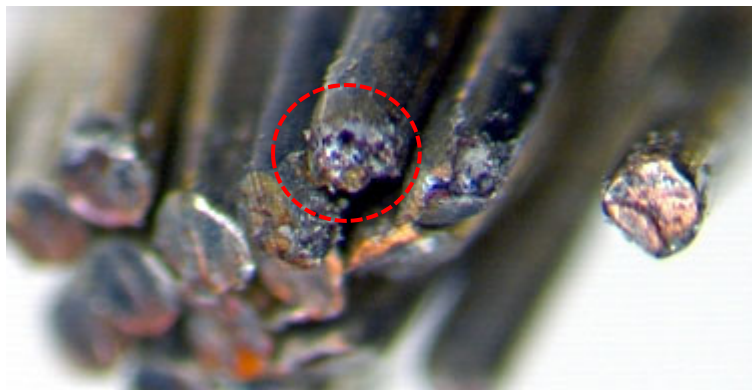
Figure 7: Close-up of the end of the red power supply cable. Traces of burning (electric arcs) can be seen on several copper wires (red circle).

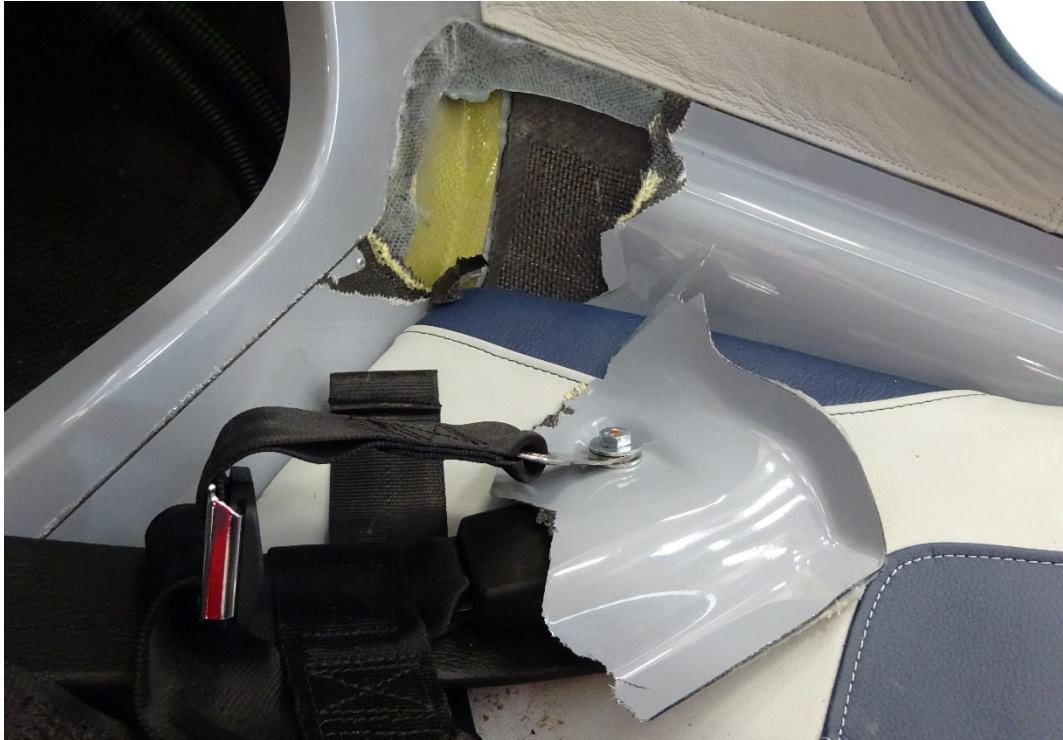
The two seats were equipped with four-point belts. The pilot had fastened both lap and shoulder straps during the flight involved in the accident. The left attachment point of the lap belt tore out of the airframe on impact (see Figure 8).

Figure 8: Torn off attachment point of the pilot's left lap belt.

The investigation on the aircraft wreckage revealed that the attachment point of the left lap belt to the airframe did not withstand the forces during the impact, even though the impact could not have been excessively violent, as the pilot sustained only minor injuries. The STSB identified a serious safety risk and issued a corresponding safety recommendation (see Section 4.1.1.2).

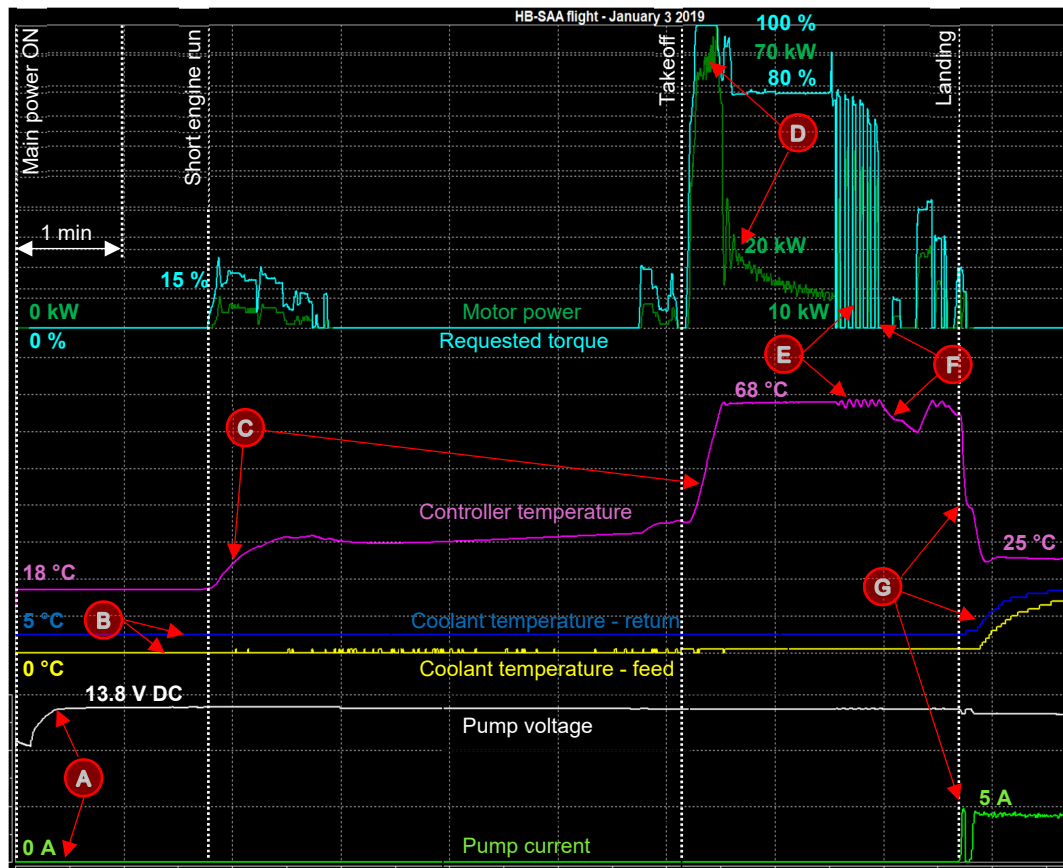
Figure 9: Analysis of the data from the data recorder of the flight involved in the accident.

Due to the failure of the cooling system, the temperature of the power controller increased at a continuous and rapid rate. During take-off and climb at maximum motor power, the temperature limits of the power controller were exceeded after less than 20 seconds. First, at a temperature of 65 °C, the warning "DRIVE OVER-TEMP" appeared on the Engine Parameters and Systems Indications (EPSI). Immediately afterward, when a temperature of 67 °C was exceeded, the motor power was automatically reduced (power derating) despite the fact that the power lever remained in the position for maximum motor power. The motor power fell to below 10 kW, i.e. less than 15 % of the take-off power (see Section 1.3.8).

At the time of the emergency landing, the current to the circulating pump increased sharply from 0 A to 5 A. Immediately afterwards, the temperature of the coolant rose and the temperature of the power controller dropped very rapidly. This leads to the conclusion that the circulating pump started to operate at this point in time. This could be explained by a temporary re-closing of a loose contact in the circulating pump circuit caused by the hard impact.
