Interim report of the Swiss Accident Investigation Board

concerning the accident of the airplane
Bombardier DHC-8-402 registered as
9A-CQC

on 27 September 2013

on runway 14 at Zurich Airport

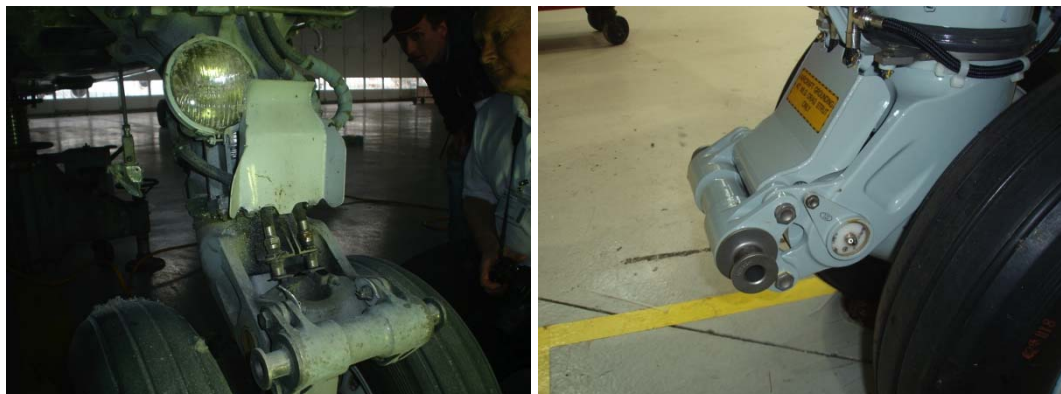
It was discovered that the cover plate protecting the two weight on wheel (WOW) sensors located on the front of the nose landing gear strut (subsequently referred to as *WOW cover plate*) had fractured at the lower left and right lug attachment points. The WOW cover plate had pivoted upwards around the cover's two upper mounting points (cf. Figure 1). Pictures of the nose landing gear bay taken just after the accident showed the WOW cover plate squeezed in the nose landing gear mechanism (cf. Figure 2).

Figure 1: Left side: WOW cover plate found after lowering the nose landing gear.
Right side: Normal WOW cover plate installation.

- *"Both fracture faces are in a very poor condition (secondary, mechanical damage). Over 90% of the fracture surface is destroyed.*
- *In the small areas where the fracture surface is still intact, a mixture of dimple fractures (due to static overload) and welding porosity was found.*
- *The analyzable areas of both fractures revealed a significant amount of freely solidified area.*
- *Freely solidified area within a weld-seam is a clear indication for welding defects such as hot-cracking and/or porosity.*
- *The area with local shear dimples is too small and isolated to draw any conclusions out of this finding at the current state of the investigation."*

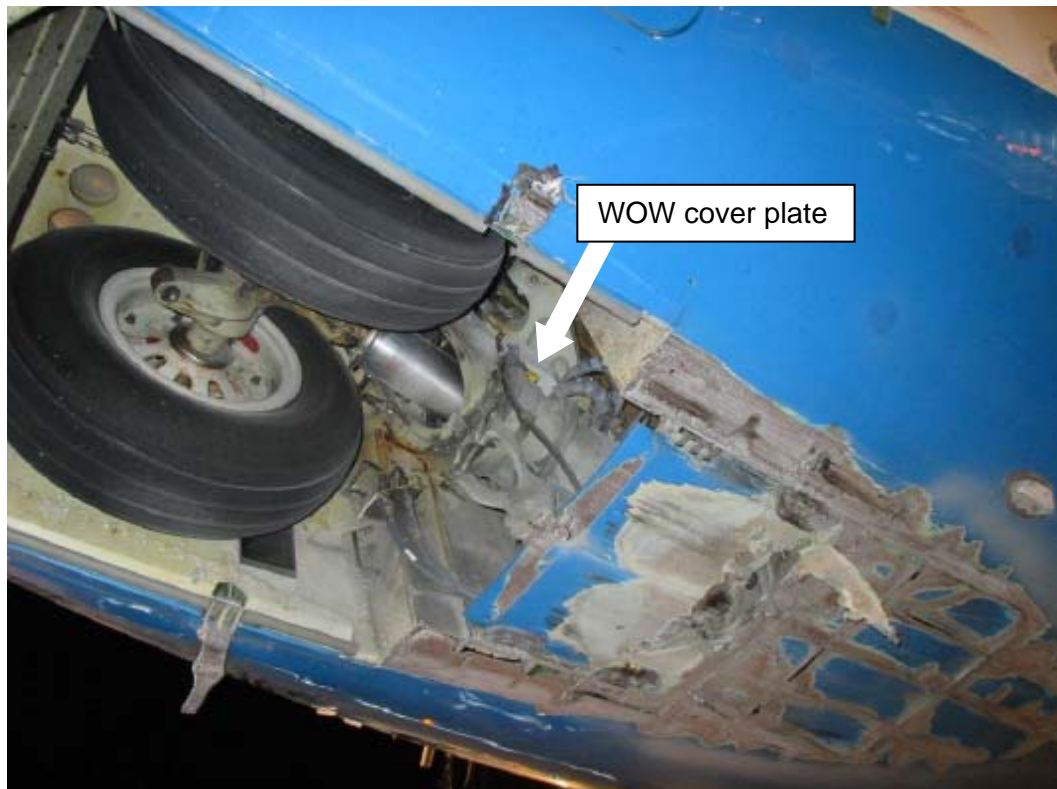
Figure 2: The nose gear WOW cover plate squeezed between the lower and the upper drag strut of the nose landing gear. The picture was taken on the accident site.

This interim report does not contain a detailed analysis. However, based on the factual information available at the present stage of the investigation, it can be concluded that the fractured and pivoted WOW cover plate of the DHC-8-402 airplane did impede the nose landing gear extension.

- The nose gear weight on wheel (WOW) cover plate was found squeezed between the lower and the upper drag strut of the nose landing gear.
- The WOW cover plate had fractured at the lower left and right lug and had pivoted upwards.

Transport Canada and the European Aviation Safety Agency, together with the aircraft and the landing gear manufacturers, should take appropriate measures in order to facilitate early detection of damaged weight on wheel cover plates on nose landing gears in levered suspension configuration.

Transport Canada and the European Aviation Safety Agency, together with the aircraft and the landing gear manufacturers, should assess the risks involved with the installation of weight on wheel cover plates on nose landing gears in levered suspension configuration and take appropriate preventive measures.
