Summary Report

Aircraft type	Bombardier BD700 1A10 GLEX		9H-CIO	
Operator	Comlux Malta Limited, Villa Margherita, Ta Xbiex Malta			
Owner	Valion Investment Ltd, c/o Trident Trust Company BVI LTD, Tortola, British Virgin Islands			
Commander	French citizen, born 1974			
Licence	EASA (European Aviation Safety Agency) Airline Transport Pilot Licence Aeroplane (ATPL (A)), issued by the Federal Office of Civil Aviation (FOCA)			
Flight hours	Total	3900 h	During the last 90 days	63 h
	On the incident type	2900 h	During the last 90 days	63 h
Co-Pilot	Kazakh citizen, born 1986			
Licence	EASA ATPL(A), issued by the Maltese Civil Aviation Directorate			
Flight hours	Total	6400 h	During the last 90 days	130 h
	On the incident type	1200 h	During the last 90 days	130 h
Location	Above the city of Bern			
Coordinates	-		Altitude	4000 ft
Date and time	2 June 2018, 13:38 (LT = UTC + 2 h)			
	All of the times mentioned in this report are given in local time

Type of operation	Commercial			
Flight rules	Instrument Flight Rules (IFR)			
Point of departure	Bern-Belp Airport (LSZB)			
Destination	Antalya Airport (LTAI)			
Flight phase	Take-off and climb			
Type of serious incident	Airprox involving a

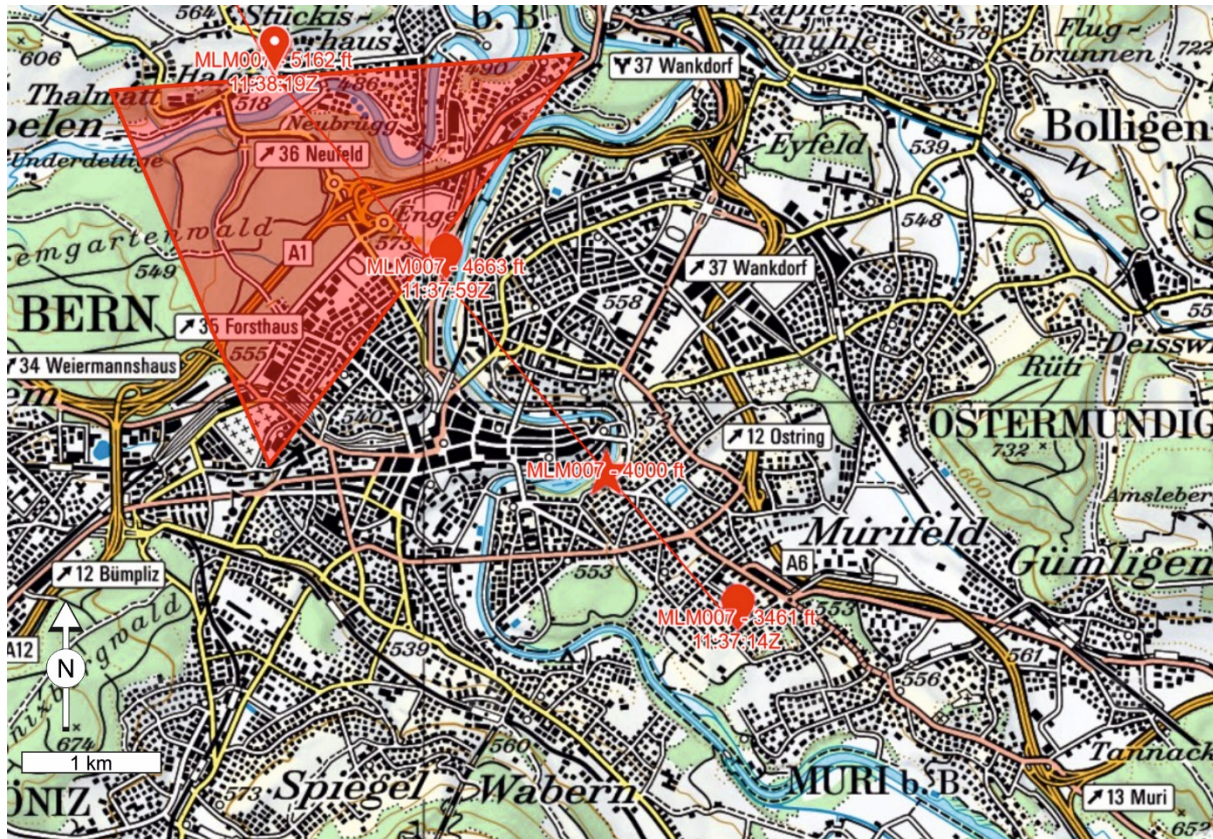
On 2 June 2018, the Notice to Airmen (NOTAM) number W1119/18 applied to an area in the north of Bern's university hospital. This NOTAM informed the aviation community about flight activities involving RPASes. These activities took place in airspace between three coordinates

to the north of Bern's university hospital. The upper limit of this airspace was 500 ft (150 m) above ground.

Illustration 2: Map showing the airspace marked in NOTAM W1119/18 (red triangle) and the flight path of 9H-CIO under flight number MLM007 (red line). The three red markers show the first data points from 9H-CIO's radar recordings. The red star shows where the aircraft reached 4000 ft. Source of map: Swiss Federal Office of Topography.

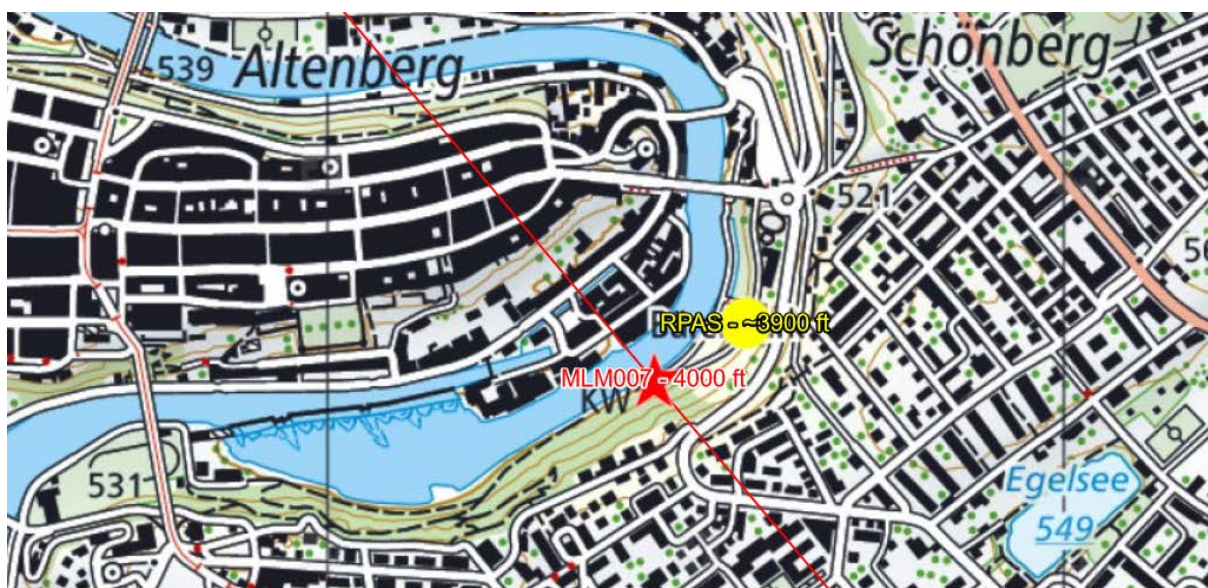
The analysis of 9H-CIO's flight data showed that the aircraft was at 4000 ft shortly before reaching the knee of the Aare river. The crew estimated the sighted RPAS approximately 150 metres to the right of the aircraft's flight path, marked with the yellow dot in illustration 3.

Illustration 3: Enlarged section of the map from illustration 2. The red line shows the flight path of 9H-CIO. The red star indicates where the aircraft reached 4000 ft. The yellow dot shows the area in which the crew could have seen the RPAS. Source of map: Swiss Federal Office of Topography.

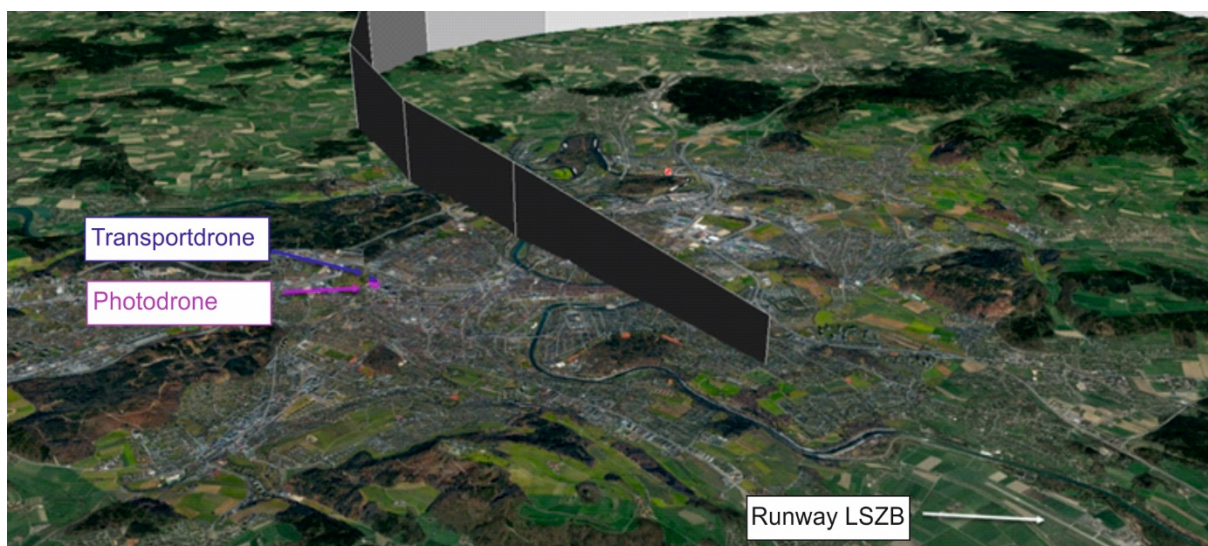
At the time of the serious incident, the two drones involved in the test flights were in the vicinity of Bern's university hospital, approximately 2 kilometres north-west of 9H-CIO's position over ground. Therefore, any potential involvement of these two drones in the airprox with the business jet can be excluded.

Therefore, it seems most likely that the crew of 9H-CIO had sighted another unidentified RPAS.

Illustration 4: A 3D image showing the flight path of 9H-CIO compared to the positions of the two drones involved in the test flights (purple and pink arrows). Source of map: Google.
