# **Final report no. 2393 of the Swiss Transportation Safety Investigation Board STSB**

on the airprox between the aircraft

Bombardier CL-600-2B19, 9H-ILB, and  
Diamond DA-40, HB-SDV

on 18 December 2020

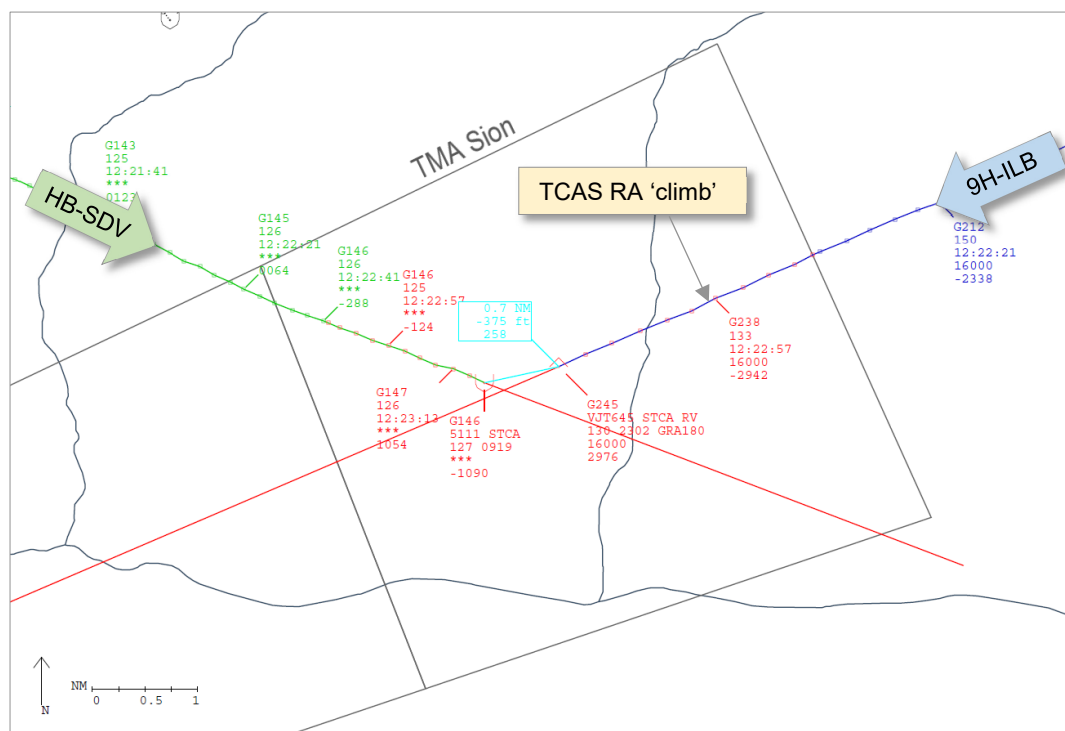
The Diamond DA-40 single-engine airplane, registered as HB-SDV, took off at around noon on 18 December 2020 from Lausanne (LSGL) airfield. The pilot intended to fly southbound over the Rhone Valley through the area of the Sion Terminal Control Area (TMA)<sup>4</sup>, which is located east-northeast of Sion airport (LSGS) in the zone of the instrument approach to runway 25, and made radio contact with the flight information service in Geneva at 12.05.25 UTC. Prior to the airprox, the single-engine airplane was flying in a straight line and ascending slightly in a south-easterly direction (cf. Figure 1).

**Figure 1:** Radar plot of the flight paths of HB-SDV (green) and 9H-ILB (blue) at 12.23.21 UTC when the two aircraft came into close proximity of each other at a distance of 0.7 NM horizontally and 375 ft vertically (light blue).

The two aircraft – both climbing – now moved into greater proximity with one another. At 12.23.15 UTC, the pilot of HB-SDV indicated that he would now have to descend because 9H-ILB was also climbing (*“we have to descend because he is climbing”*). The distance between the aircraft was still 100 ft vertically and 1.1 NM horizontally. The vertical distance then increased again, reaching 375 ft at 0.7 NM and 900 ft at 0.1 NM.

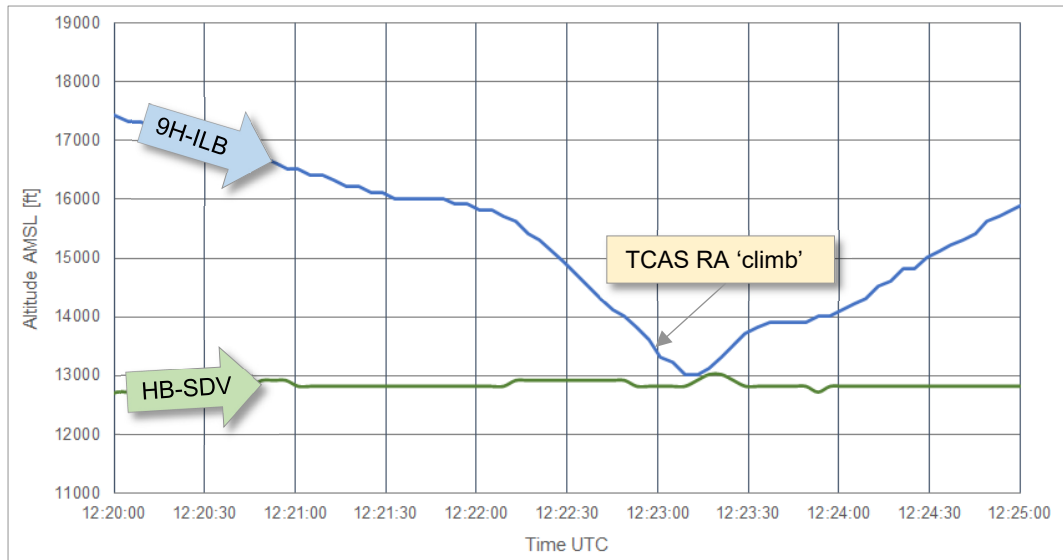
Shortly afterwards at 12.22.58 UTC, the TCAS collision warning system of 9H-ILB issued a resolution advisory (RA) *“climb”*. The crew of 9H-ILB followed this RA and initiated a climb (cf. Figure 2). At the same time, the pilot of HB-SDV transmitted via voice radio that the 9H-ILB was in sight and that he would therefore enter a climb (*“in sight, we climb a little bit”*).

**Figure 2:** Flight altitudes of HB-SDV (green) and 9H-ILB (blue) in feet above mean sea level, plotted over time. The steps in the curves are due to the altitude recording being rounded to 100 ft.

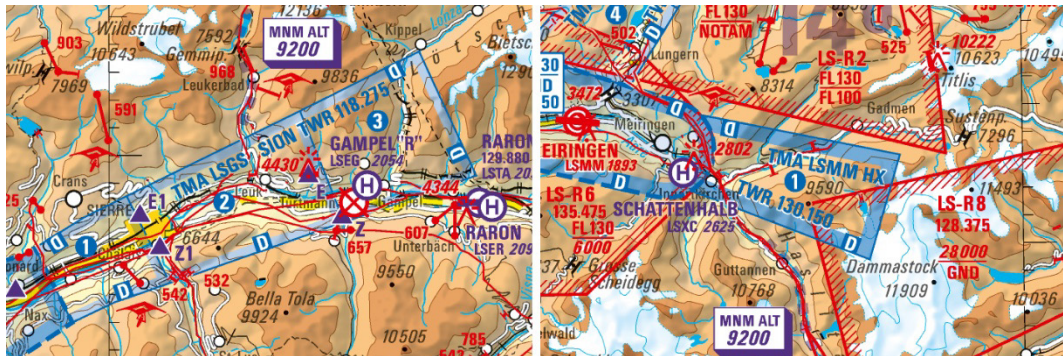
Some civil and military airports in Switzerland have temporary TMAs. They are generally designated on the aeronautical chart with the abbreviation HX (cf. Figure 3, image on right) and as 'TMA HX' in the VFR manual.<sup>5</sup> This kind of TMA can be activated at short notice via voice radio if required and must be activated during IFR approaches and departures.

In contrast, the Sion TMA is marked on the aeronautical chart by a border which deviates from this rule (cf. Figure 3, image on left) and is designated as 'TMA TEMPO' in the VFR manual. Along with Alpnach TMA, Sion TMA is the only one of this kind in Switzerland. It is not activated at short notice via voice radio, but instead only after prior publication via NOTAM<sup>6</sup> and DABS<sup>7</sup>.

**Figure 3:** Image of temporarily activated TMAs on the aeronautical chart of Switzerland: on the left is Sion TMA (activation after prior publication, labelled with a thin light frame), and on the right, for the purpose of comparison, Meiringen TMA (activation via voice radio, labelled with a normal frame and the abbreviation 'HX'). Source of the maps: Federal Office of Topography.

The Federal Office of Civil Aviation (FOCA) should promptly take suitable measures to reduce the risk of airprox incidents in the Sion TMA area arising from IFR traffic passing through class E airspace, for example by permanently activating the current TMA via NOTAM ("TMA TEMPO") or by introducing a TMA that can be activated at short notice via voice radio if necessary ("TMA HX").
