Summary Report

Aircraft	Boeing B777-300ER	A7-BAO
Operator	Qatar Airways Q.C.S.C., Doha, State of Qatar	
Owner	Qatar Airways Tower, Airport Road or P.O. Box 22550, Doha, State of Qatar

Location	16 NM north-north-west of Basel		
Coordinates	---	Altitude	Flight level (FL) 350
Date and time	19 November 2016, 09:10 UTC		
Type of operation	Scheduled flight		
Flight rules	Instrument flight rules (IFR)		
Flight phase	Cruise flight		
Incident type	Electrical smell in the cockpit, use of oxygen masks		
Point of departure	Miami (KMIA)		
Destination	Doha (OTHH)

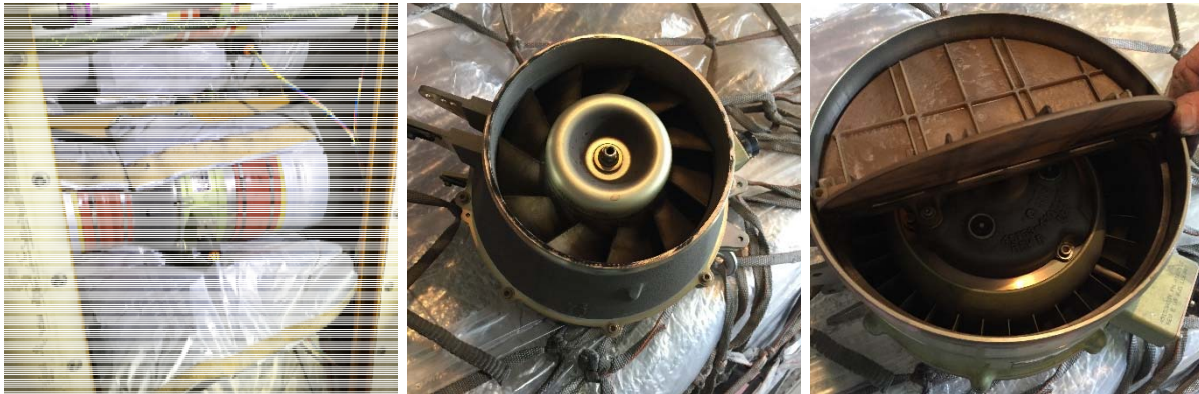
The flight crew stated that the status message EQUIP COOLING FAN R was displayed at the same time that the electrical smell occurred. The specialists at the maintenance company therefore removed this cooling fan, which is located on the left sidewall of the forward cargo compartment (see figure 3). It became apparent that the rotor of the fan was jammed and a slight electrical odour could still be detected.

Figure 3: Image on the left: cooling fan on the left sidewall of the forward cargo compartment. Image in the middle and on the right: removed cooling fan with jammed rotor (photos taken on 19 November 2016 at 12:29 UTC).

It can be assumed that the electrical coils in the right cooling fan were burnt and that the resulting electrical smell, accompanied by a slight development of smoke, found its way into the E&E compartment and from there entered the cockpit, where it was detected by the flight crew.
