Final Report No. 2438

concerning the serious incident involving
the commercial aircraft Dornier D328,
D-CSUE,

on 20 April 2024

Pfannenstiel, Municipality of Meilen (ZH)

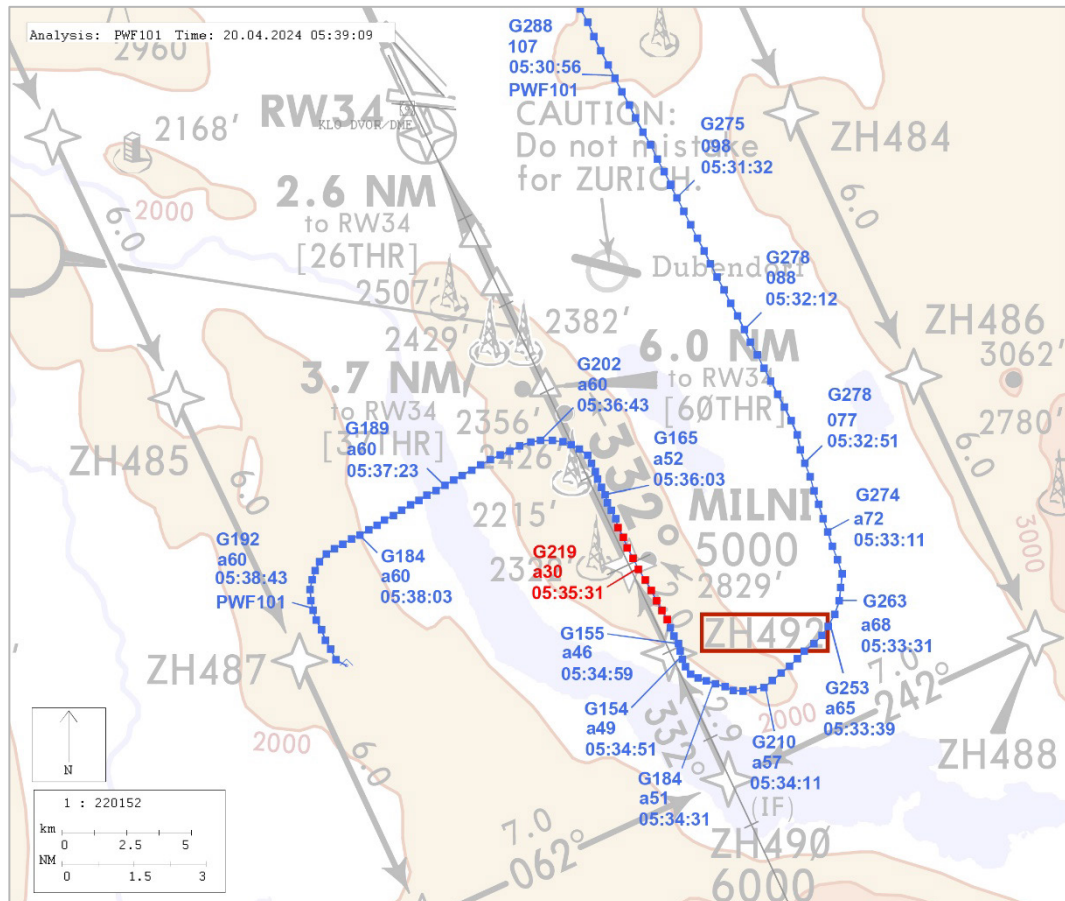
At 05:35:11 UTC (see red section of the radar track in figure 1), the ground-based Minimum Safe Altitude Warning System (MSAW)⁴ of the air traffic control system triggered an alarm. The flight crew was immediately notified of the warning and instructed to check their altitude and climb to 5000 ft immediately, with the words '*Private Wings One Zero One, Low Altitude Warning, check your altitude immediately, QNH One Zero One Six, climb to five thousand feet.*' The instruction to climb immediately was repeated at 05:35:26 UTC, together with the cancellation of the

Figure 1: Flight path of D-CSUE (blue) according to radar records with positions every four seconds, indicating ground speed (G) in knots, flight level or barometric altitude (a) in hundreds of feet and time in UTC. The red dots represent the period during which a warning was issued by the Minimum Safe Altitude Warning System (MSAW). The lowest height above the terrain was recorded at 05:35:44 UTC and was 300 ft. Source of the base map: Federal Office of Topography Swisstopo.

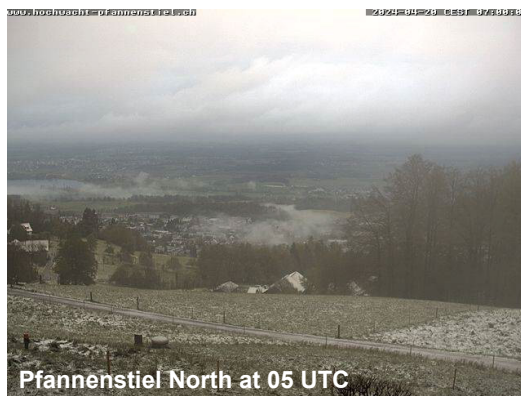
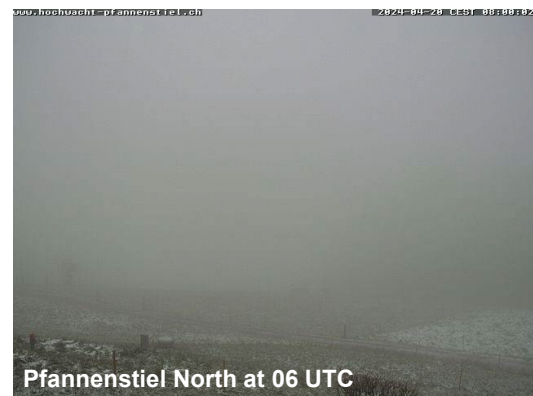
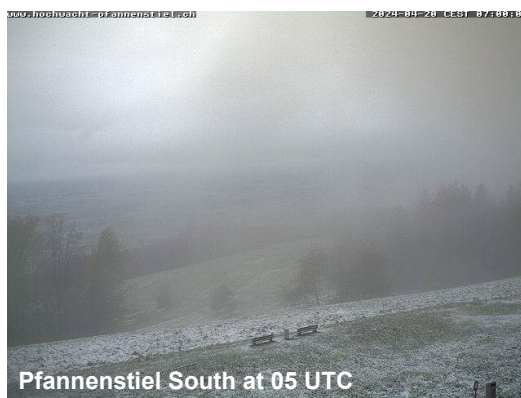
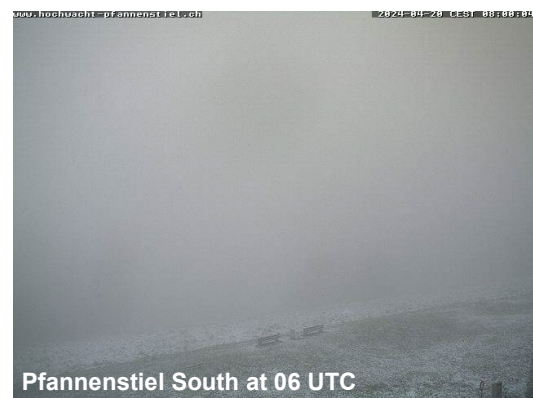
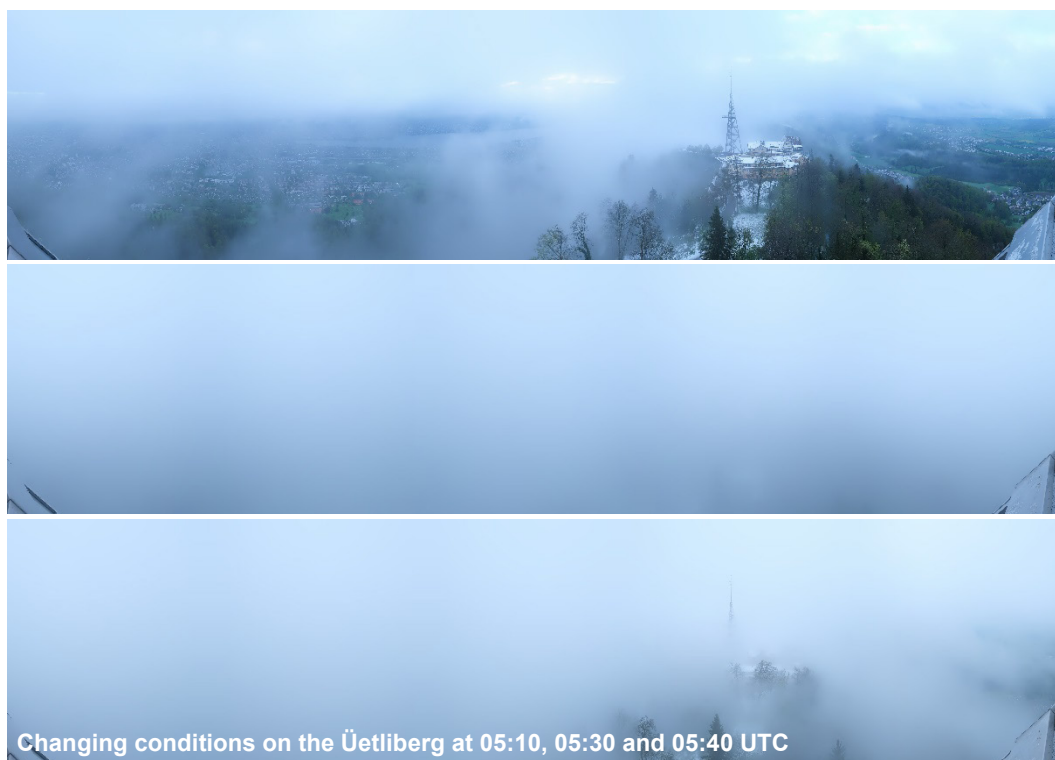
Figure 2: A selection of various webcam recordings around the time of the serious incident

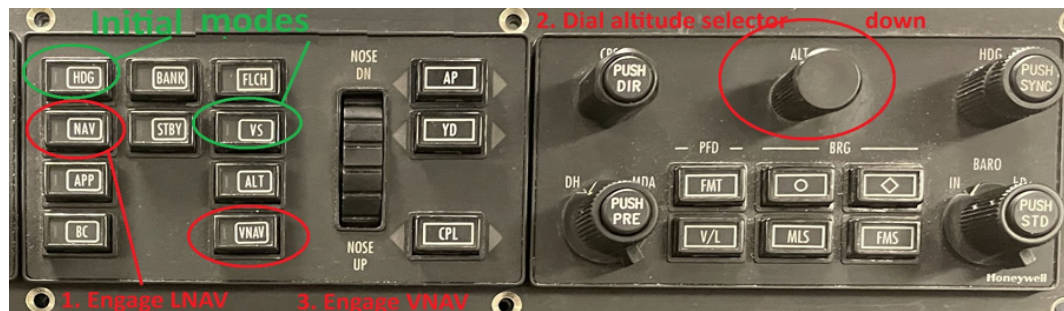
The scenarios flown in the simulator tests (see chapter 1.16) allow no other conclusion than that, during this brief ASEL CAP phase, the preselected altitude was set by the flight crew to the LNAV Decision Altitude of 1990 ft in accordance with operational specifications using LNAV/VNAV mode (see chapter 1.6.2.2). This led to a reversion to Vertical Speed (V/S) mode at 05:34:48 UTC. The flight crew must then have switched to VNAV mode at 05:34:56 UTC to transfer the aircraft to vertical flight guidance along the profile (VPATH) after the Final Approach Fix MILNI (see figure 3).

Figure 3: Flight guidance panel of the autopilot showing the most probable sequence of mode changes selected by the flight crew when approaching the Final Approach Fix MILNI in the initial modes with heading (HDG) and vertical speed (VS). Then 'NAV' (①) was selected, the lower altitude value was set on the preselected flight altitude knob "ALT" (②), followed by switching on the 'VNAV' mode (③).

Due to the fact that the aircraft's altitude at this point was already less than approximately 50 ft below 5000 ft AMSL (see chapter 1.11.1 or annex 2), the FMS logic ignored the 5000 ft altitude constraint and its altitude target was changed to the preselected altitude of 1990 ft. That in combination with the FMS request VNAV ALT HOLD²⁵ led the internal logic of the Flight Control System to issue a command that resulted in a rapid descent rate with a calculated value of slightly over 4000 ft/min.

The European Union Aviation Safety Agency (EASA) should ensure that the anomaly caused by software version NZ4.8 can no longer occur in DO-328 aircraft, for example by installing the Honeywell IC-810 avionics computer with updated FMS software version NZ6.2, as enabled by Major Change Approval 10065397.
