Interim report by the Swiss Transportation Safety Investigation Board STSB

concerning the accident involving the
motorglider SF 25C “Falke”, D-KDEU,

on 17 October 2021

Airfield Dierdorf (EDRW),
Germany

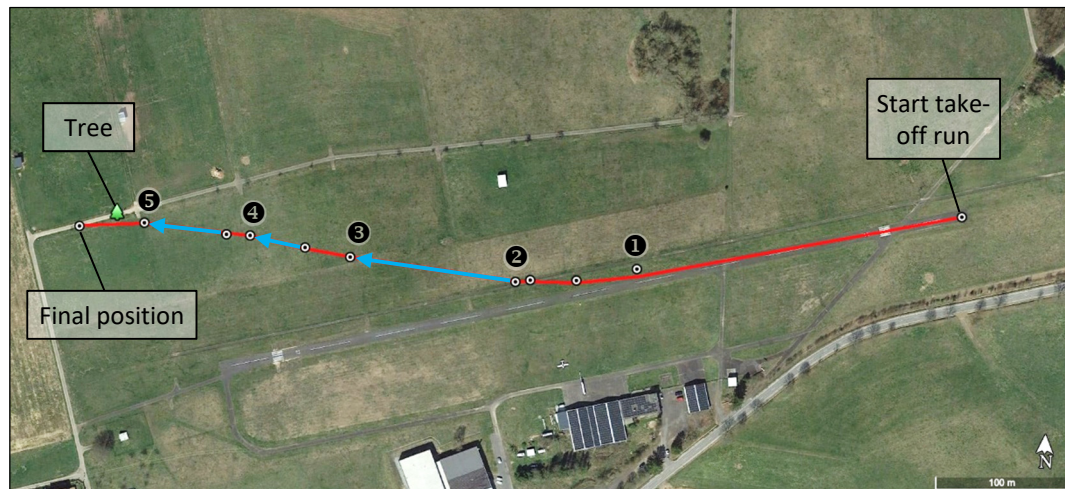
According to the flight instructor, the take-off run took place in calm conditions and was normal up to the height of the airfield buildings. After approximately 245 m, the motorglider veered to the right onto the grass strip adjacent to the hard-surface runway (see Figure 1, position ❶). At this moment, the airplane did not react immediately to the control inputs. The instructor suspected that the student pilot was locking the control stick or the rudder pedals, so he told her to release them. The student pilot stated that she was not holding any of the controls and heard the instructor yell "*aileron, aileron*" at that moment. The motorglider subsequently took off after a take-off run of approximately 335 m (position ❷) and picked up speed flying close to the ground, which the instructor perceived as normal and controlled by him. The airplane flew in a direction that deviated about 30° to the right from the runway axis and in which the terrain was slightly sloping.

Figure 1: Takeoff of D-KDEU (red line), determined based on the traces of the takeoff run in the grassland (small white circles), shown in google earth. The blue arrows indicate the phases in which the motor glider was in the air.

About 125 m after lift-off (position ③), the motor glider touched down with its undercarriage in the grassland for the first time and unexpectedly for the flight crew, and took off again shortly afterwards. Until that moment, the instructor was convinced that the motor glider would fly normally and only needed to pick up some speed. The terrain in the direction of flight was sloping and therefore enabled a problem-free continuation of the flight. An aborted take-off, on the other hand, would have inevitably led to a collision with the trees ahead. For this reason, he immediately dismissed the idea of aborting the take-off.

After the motor glider was airborne again, the nose of the aircraft dropped anew and the landing gear of the motor glider touched the grassland a second time (position ④). At the same time, the aircraft headed for a tree next to a dirt road ahead (see Figure 1). At this stage, the instructor realised that something was wrong and that he had lost control of the motor glider. He had tried to avoid the tree in front with full control deflections.

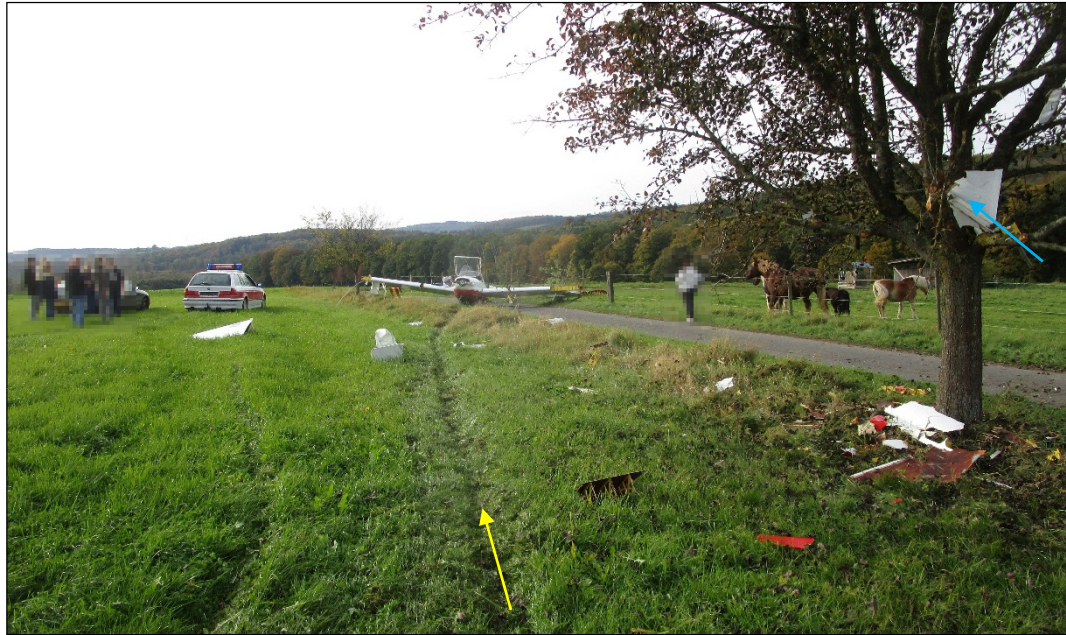
As a result, the motor glider hit the grassland again (position ⑤), this time very violently. The propeller tips touched the ground and broke off. The right wing subsequently collided with the tree, separating the right outer wing. The motor glider then turned 180° around its vertical axis to the right and, skidding on the main landing gear, came to rest on the dirt road (see Figure 2). During this manoeuvre, the left outer wing was separated and the aircraft suffered severe damage to the tail unit and fuselage.

Figure 2: Final position of the D-KDEU seen in the direction of flight. On the right the tree, with which the right wing collided (blue arrow), and in the center the track of the main wheel in the meadowland (yellow arrow).

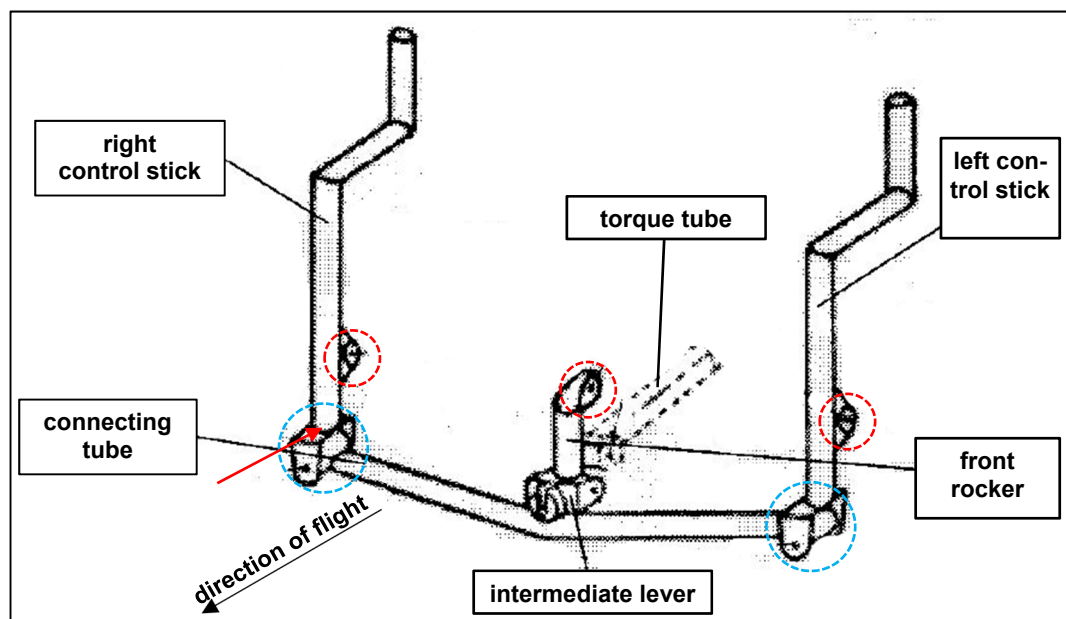
Figure 3: Schematic of the control parts for aileron and elevator control with the fixed bearings (red dashed circles) and the transfer joints (blue dashed circles). The red arrow indicates the position where the right control stick of D-KDEU was broken. Source of graphic: Aircraft manufacturer, processed by SUST.

The right control stick of the motorglider D-KDEU was broken directly above the weld seam of the transfer joint (see Figure 3) and was therefore only attached to the fixed bearing. This meant that the flight instructor, who was sitting in the right-hand seat, could still move the control stick but could no longer make any control inputs for aileron and elevator. The aileron could still be moved with the left control stick, which the student pilot was feeling for during the take-off run. However, due to the construction of the control linkage, the elevator could no longer be controlled with this stick.

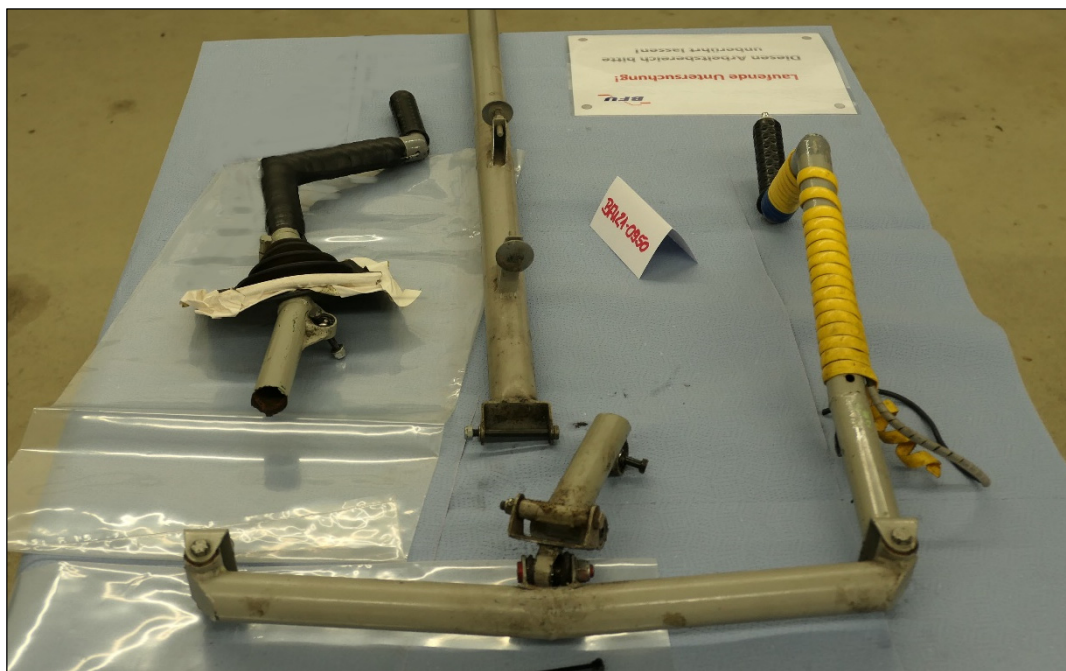
- The right control stick was broken above the weld seam at the transfer joint.
- The fracture was visibly corroded on both sides.
- Inside the broken steel tube (inner surface of the tube) of the control stick there was heavy corrosion.

Figure 4: Overview of the controls for aileron and elevator with the broken right control stick (left side on the picture, see also red arrow in Figure 3).

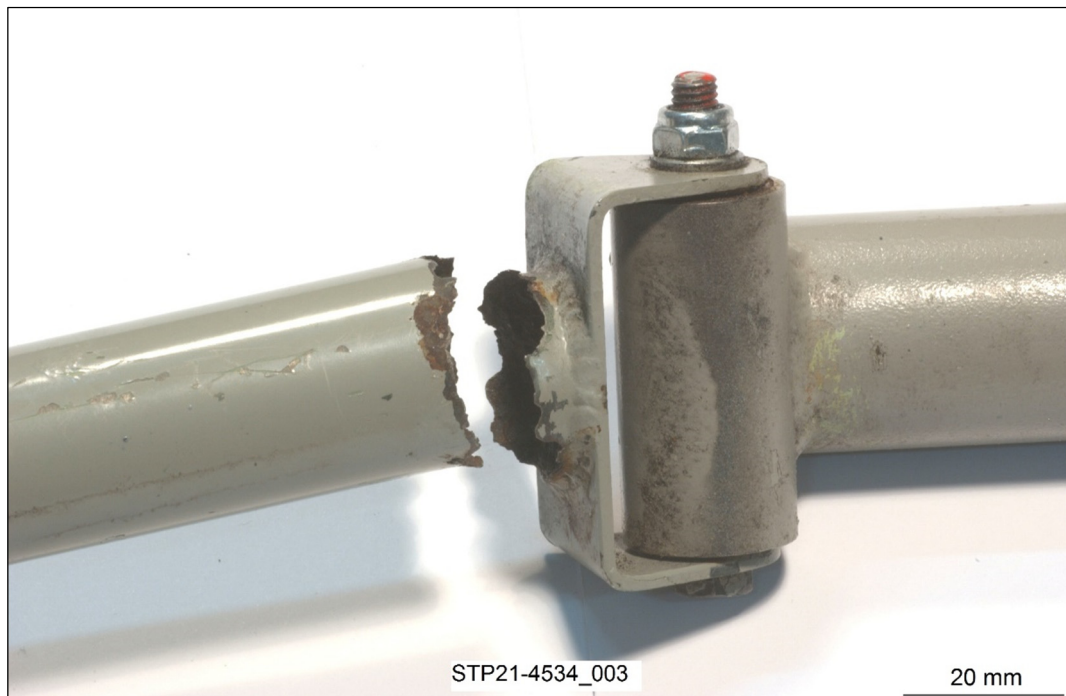
Figure 5: Fracture of the steel tube of the right control stick above the weld seam at the transfer joint.

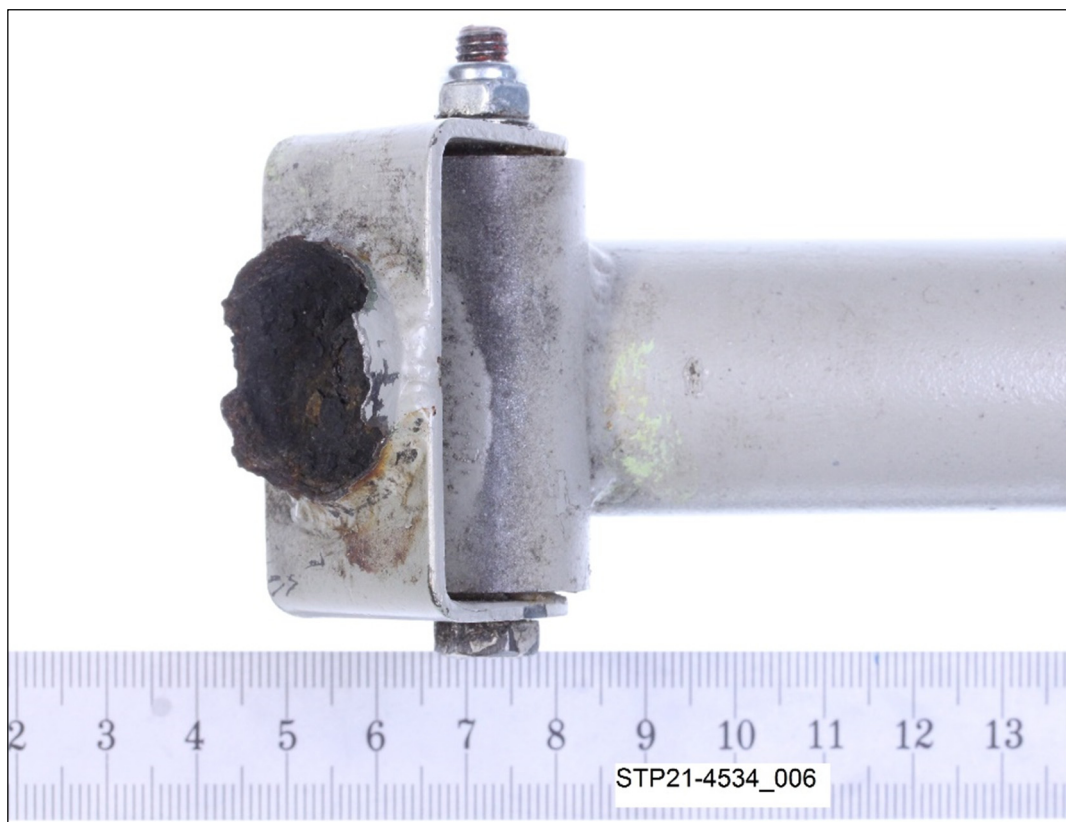
Figure 6: Fracture point at the transfer joint, near the weld seam / heat-affected zone.

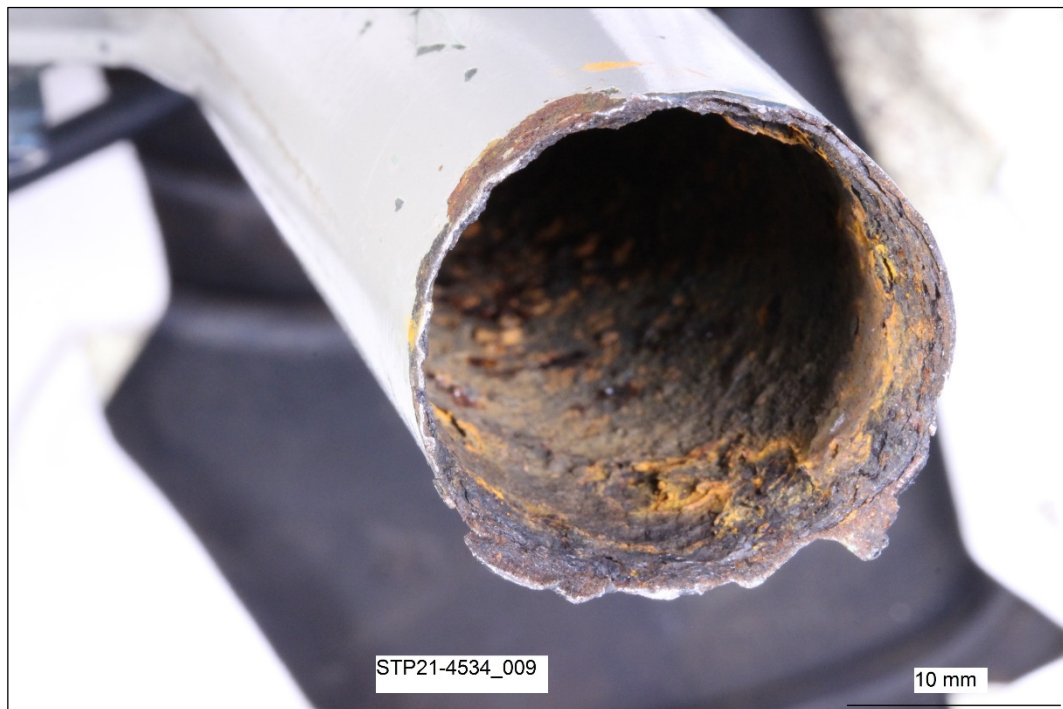
Figure 7: Fracture of the steel tube of the right control stick with heavily corroded inner surface of the tube.

The steel tube of the right control stick was heavily corroded on the inside, which apparently led to a weakening of the tube. The rupture of the tube occurred in this heavily corroded area. The affected controls and control linkage will be further investigated metallographically. The corresponding details will be included in the final report.

The European Union Aviation Safety Agency (EASA), in cooperation with the aircraft manufacturer Scheibe Aircraft GmbH, should take measures to ensure that motorgliders of the type SF 25 are only operated if no such corrosion phenomena exist on their controls and control linkages.
