Summary Report

Aircraft	Schempp-Hirth Flugzeugbau, Arcus M			D-KEJB
Operator	Private			
Owner	Private			
Pilot	British citizen, born 1948			
Licence	Sailplane Pilot Licence (SPL) according to European Union Aviation Safety Agency (EASA), issued by United Kingdom Civil Aviation Authority			
Flying experience	total	4850 h	during the last 90 days	14 h
	on type	51 h	during the last 90 days	4:45 h
Location	Bellechasse airfield (LSTB)			
Coordinates	--	altitude	--	
Date and time	19 June 2019, 13:15 hrs (LT ¹ = UTC ² + 2 h)			
Type of operation	Private			
Flight rules	Visual Flight Rules (VFR)			
Point of departure	Bellechasse airfield (LSTB)			
Destination	Bellechasse airfield (LSTB)			
Flight phase	Take-off and climb			
Type of serious incident	Runway excursion			
Injuries to persons	Crew	Passengers	Third persons	
Minor	0	0	0	
None	1	1	not applicable	
Damage to aircraft	Slightly damaged			
Other damage	Slight damage to the field

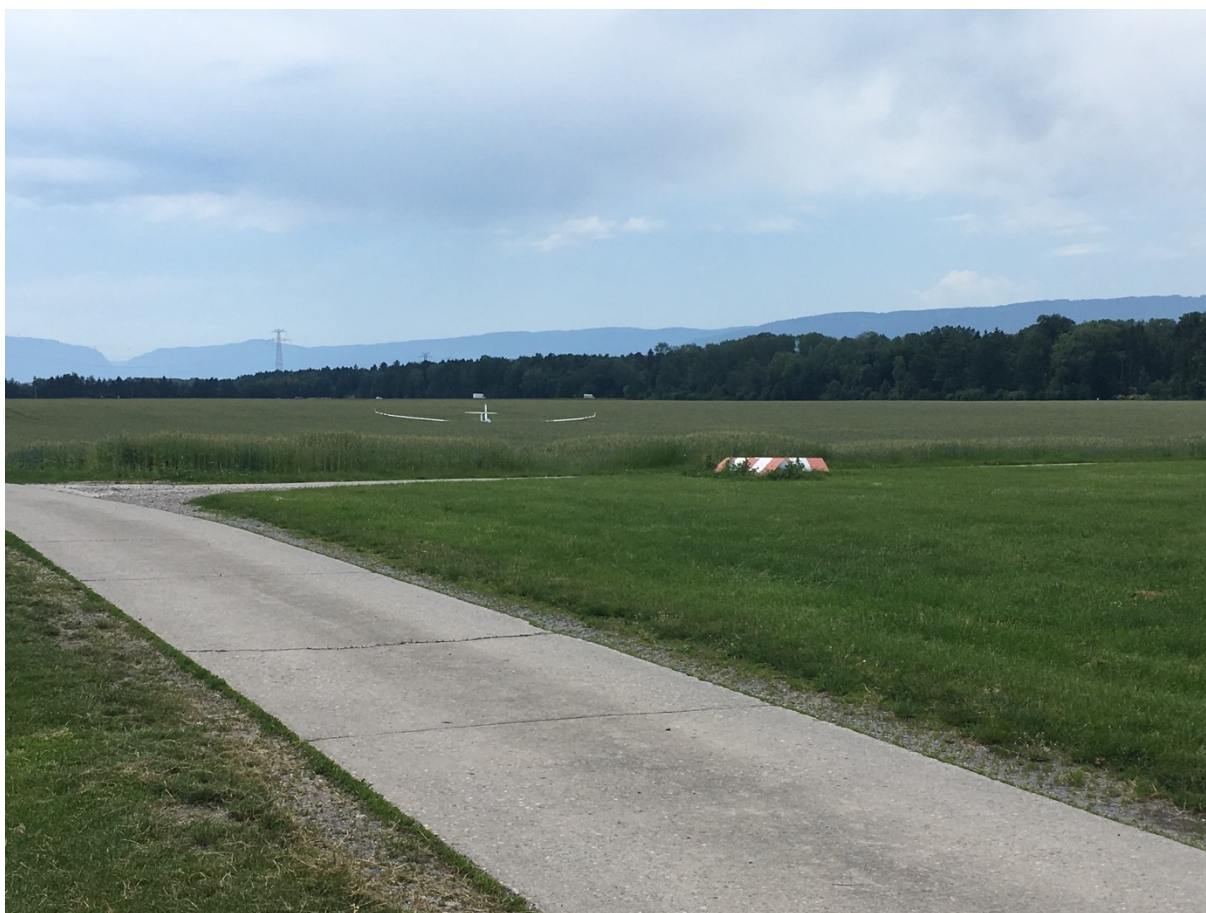
Figure 1: End position of the D-KEJB in the cornfield, photographed in a westerly direction from the field path running parallel to the runway. The red and white marking indicates the end of runway 26.

The two pilots were able to leave the glider uninjured. There was minor damage to one winglet³.

The tracks in the cornfield between the end of runway 26 and the glider's final position showed that the D-KEJB did not roll along the entire distance of approximately 100 m but had also been flying over some sections of the field. No tracks in the crops could be found in the terrain depression at the end of runway 26.
