Final report no. 2418

by the Swiss Transportation Safety Investigation Board STSB

concerning the accident involving the
Ultralight glider
Alisport Silent 2 Electro, D-MANS,

on July 22, 2021

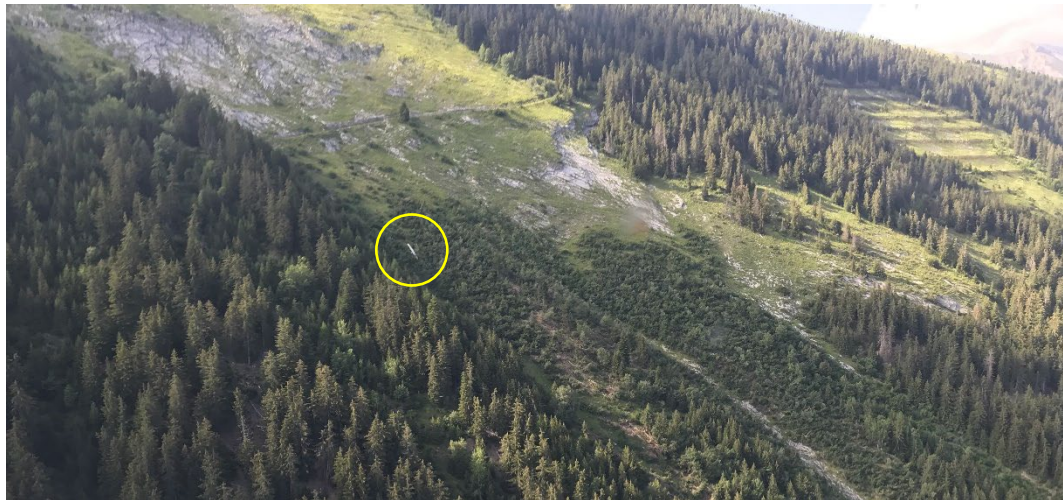
Shortly thereafter, an eyewitness observed that the nose of the glider moved upwards, followed by the initiation of a turn. After a rotation of about 90°, the glider then crashed in an almost vertical position. At 15:40, the impact occurred on a steep slope at 1630 m AMSL (cf. Figure 1). The pilot was fatally injured and the glider was destroyed.

Figure 1: Aerial view of the accident site looking northeast, taken on the day of the accident.

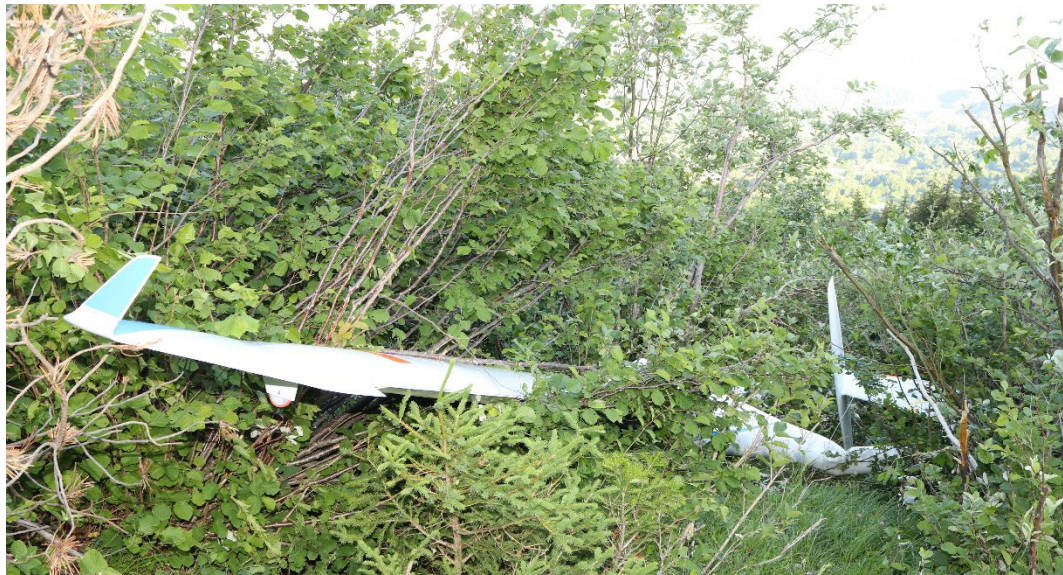
In the present case, the existence or non-existence of the above-mentioned hazards was hardly, if at all, discernible for the arriving emergency services (cf. Figure 2). Information on aircraft equipment and appropriate self-protection measures were not available promptly at the accident site (cf. chapter 1.6). This could have led either to excessive risk to emergency services or to a delay in immediate life-saving measures, if such had been required.

Figure 2: Wreckage of the D-MANS as it appeared to the rescue forces arriving at the accident site. It cannot be identified that there was a risk of electric shock and that no ballistic parachute system was installed (photo by the Valais Cantonal Police).

The International Civil Aviation Organization (ICAO), in cooperation with its member states, should provide a database for emergency services so that they can be aware of the hazards posed by all aircraft involved in accidents without delay.

The Federal Office of Civil Aviation (FOCA) should, until the implementation of Safety Recommendation No. 596, provide a database for emergency services so that they can obtain information about the hazards posed by all aircraft involved in accidents in Switzerland without delay, irrespective of their country of registration.

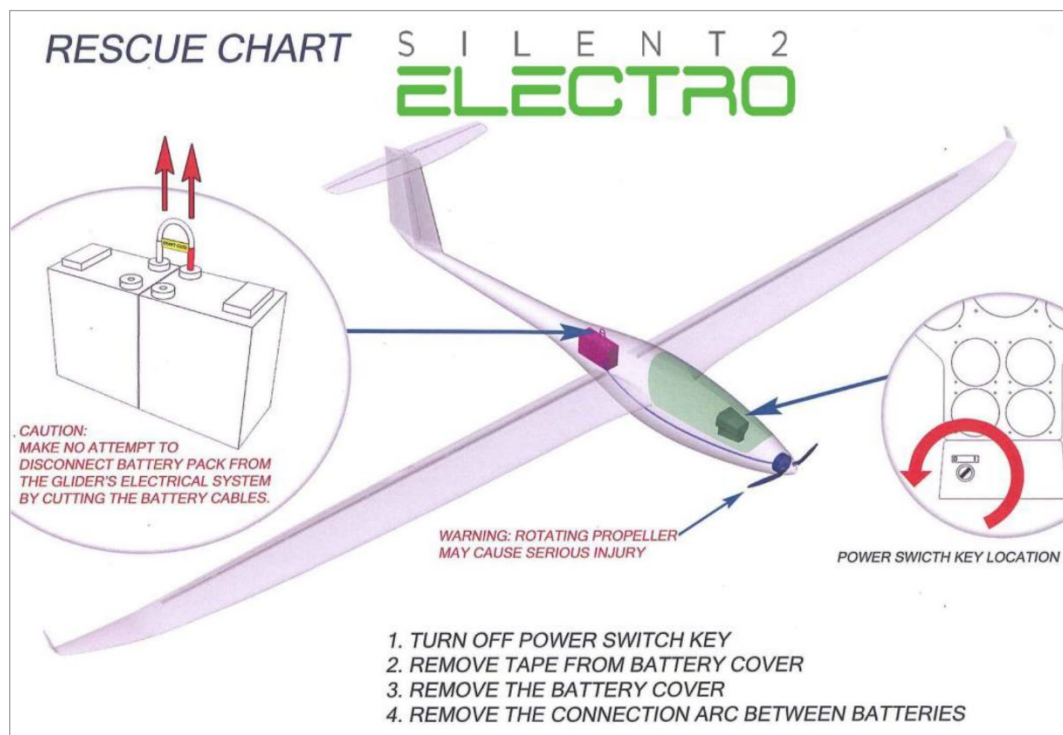
In the present case, such a rescue card did exist, but only as an illustration in the flight manual of the Silent 2 Electro (cf. Figure 3). It was therefore not available to the emergency services in a timely manner and also did not contain any information on the presence or absence of a ballistic parachute system.

Figure 3: Illustration of the rescue card in the flight manual of the Silent 2 Electro.
