# **Final Report No. 2362 of the Swiss Transportation Safety Investigation Board STSB**

concerning the serious incident  
involving the Pilatus PC-6/B2-H4 aircraft,  
registration EC-IBY

on 21 December 2016

Buochs aerodrome (LSZC)

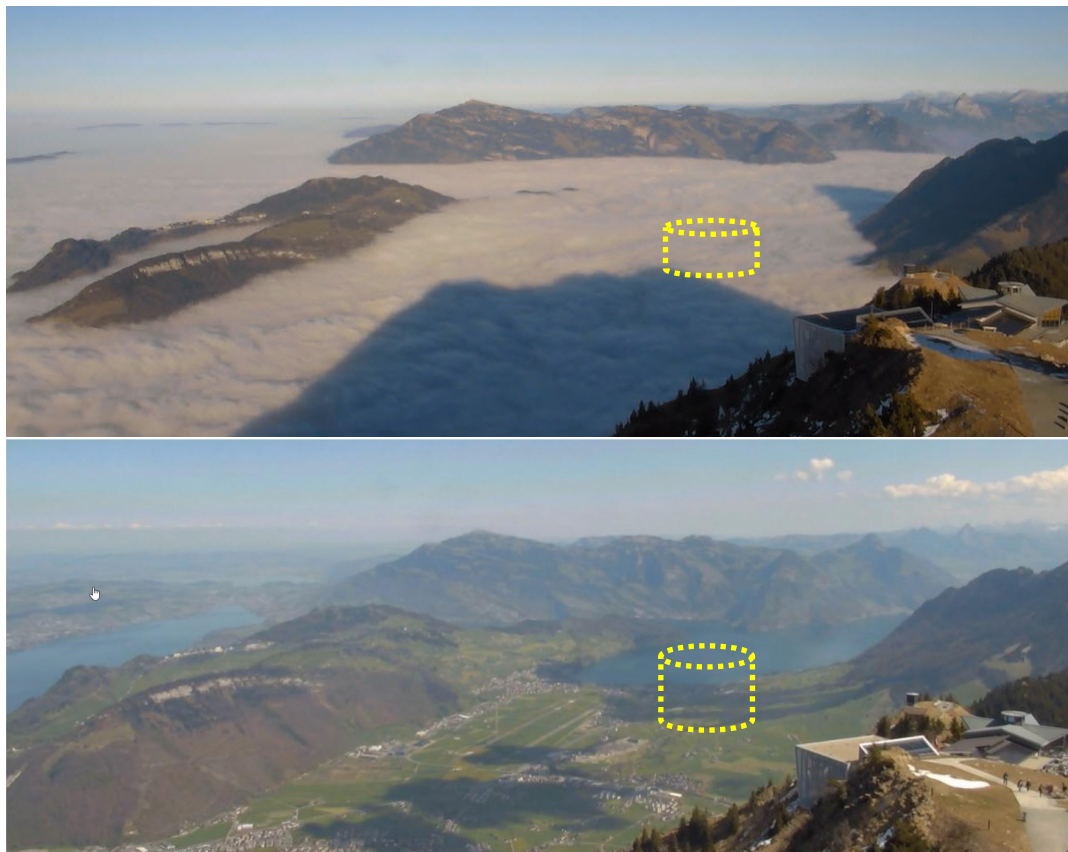
**Figure 1:** Webcam images taken at Stanserhorn Station looking north-east towards the aerodrome area at the time of the serious incident (top) and for comparison an image from 10 April 2017. The yellow dashed cylinders indicate the area above the cloud cover (top) and over the terrain within which the descent was performed.

To illustrate the area below the stratus clouds, an image from the Stanserhorn webcam database was searched, from which the rising terrain to the south of the aerodrome is evident (on the right of the lower, yellow dashed cylinder).

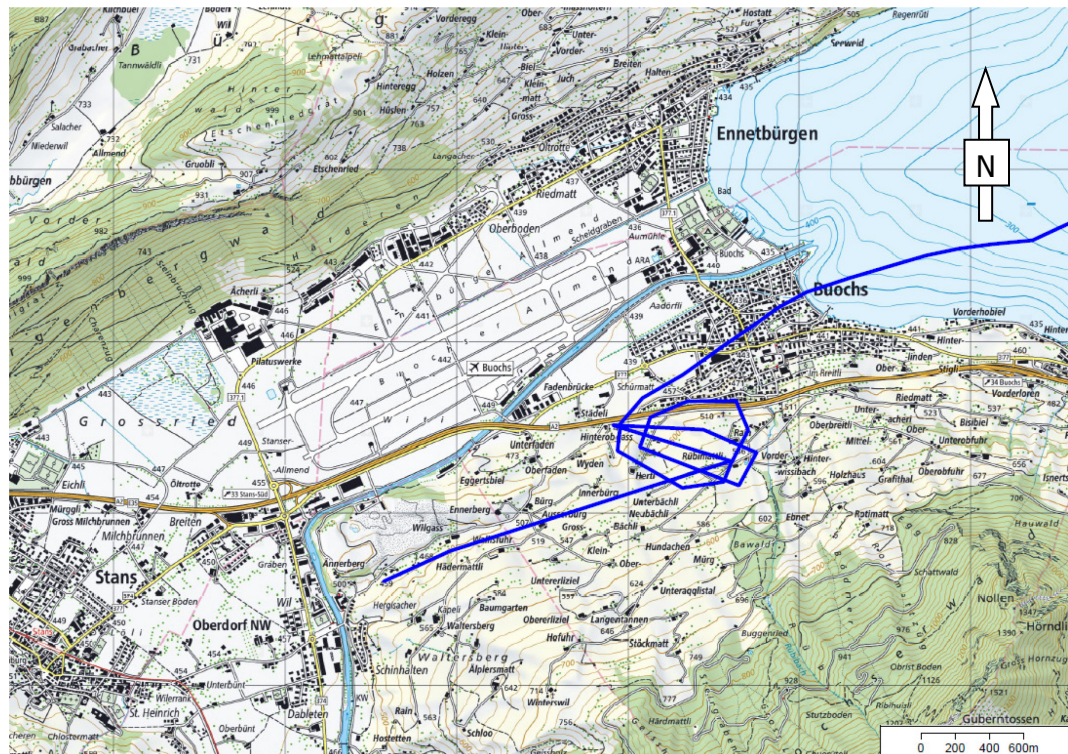
**Figure 3:** Plan view of the flight path of EC-IBY in the final phase of the flight. Source of the basic map: Federal Office of Topography.

As these recordings show, the descent through the clouds was made south of the village of Buochs over a surface area which is less than 1 km<sup>2</sup>.

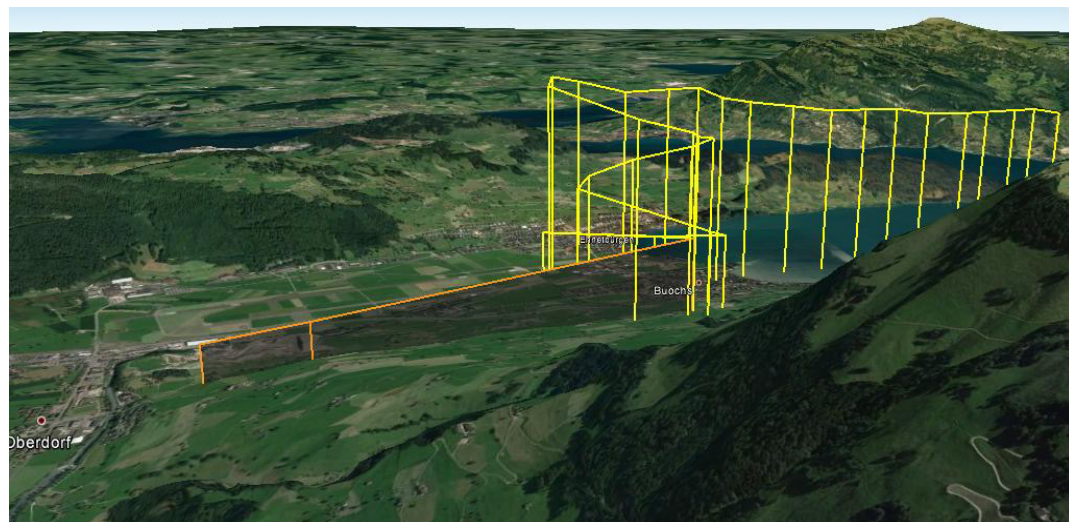
**Figure 4:** 3D side view of the flight path shown in figure 3. Source of the base map: Google Earth.

The yellow line illustrates how the altitude decreased from approximately 5000 ft to just over 2800 ft between 15:03:17 LT and 15:04:37 LT before the aircraft joined the downwind leg (orange line) for runway 06. The altitude then continuously decreased further in the final phase of the recording to temporarily 100 to 150 m above the ground, before the turn onto the base leg.
