## Summary Report

<b>Aircraft type</b>	Cessna 525A	EC-KES	
<b>Operator</b>	Taespejo Portugal, Lda, Rua de Grivão, 12B, 7350-076 Elvas, Portugal		
<b>Owner</b>	Banco Santander, S.A., Rua de Grivão, 12B, 7350-076 Elvas, Portugal		
<b>Pilot</b>	Portuguese citizen, born 1967		
<b>Licence</b>	EASA (European Aviation Safety Agency) Commercial Pilot Licence Aeroplane (CPL(A)), issued by the Portuguese Civil Aviation Authority ( <i>Autoridade Nacional da Aviação Civil – ANAC</i> )		
<b>Flight hours</b>	<b>Total</b>	6,878 h	
	<b>During the last 90 days</b>	89:22 h	
	<b>On the aircraft type</b>	3,540 h	
	<b>During the last 90 days</b>	89:22 h	
<b>Co-pilot</b>	Spanish citizen, born 1985		
<b>Licence</b>	EASA CPL(A) issued by the Spanish Aviation Safety Agency ( <i>Agencia Estatal de Seguridad Aérea – AESA</i> )		
<b>Flight hours</b>	<b>Total</b>	1,001:25 h	
	<b>During the last 90 days</b>	78:48 h	
	<b>On the aircraft type</b>	274:27 h

<b>During the last 90 days</b>	78:48 h	
<b>Location</b>	Bern Airport (LSZB)		
<b>Coordinates</b>	---	<b>Altitude ---</b>	
<b>Date and time</b>	2 <sup>nd</sup> March 2018, 21:17 (LT = UTC + 1 h)		
<b>Type of operation</b>	Commercial		
<b>Flight rules</b>	Instru

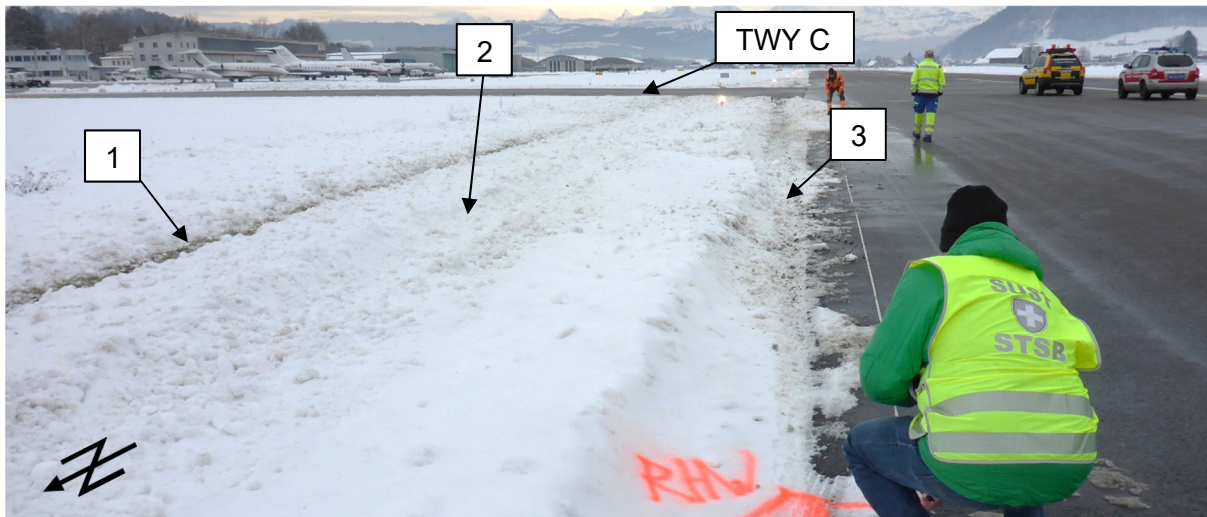
The wheel tracks in the snow were measured on the same night and a second time the following day. The first wheel track, which due to the course of the track (see image 2 and image 3) could be attributed to the left-hand-side main landing gear, started with a slight imprint in the snow around 0.5 m to the left of the runway boundary and around 65 m before TWY B, and ended approx. 2 m to the left of the runway boundary and approx. 27 m before TWY B. Immediately after TWY B, the track made by the left-hand-side main landing gear started again, this time with an imprint down to the frozen ground under the snow. Approx. 42 m after TWY B and approx. 1 m to the left of the runway boundary, the wheel track in the snow made by the nose landing gear started, which only left a slight imprint in the snow as it continued. Approx. 60 m before TWY C, the wheel track made by the right-hand-side main landing gear also ran into the snow to the left of the runway boundary (see image 1). After TWY C, the wheel tracks clearly bent to the right, back onto the runway, where they ended approx. 75 m after TWY C.

**Image 1:** South-easterly view along the left-hand boundary of the runway, approx. 60 m before TWY C: the wheel track made by the left-hand-side main landing gear is visible on the left (1), to its right is the slight imprint of the wheel track made by the nose landing gear (2), and the wheel track made by the right-hand-side main landing gear can be seen on the right (3, orange arrowhead containing the letters 'RHW').

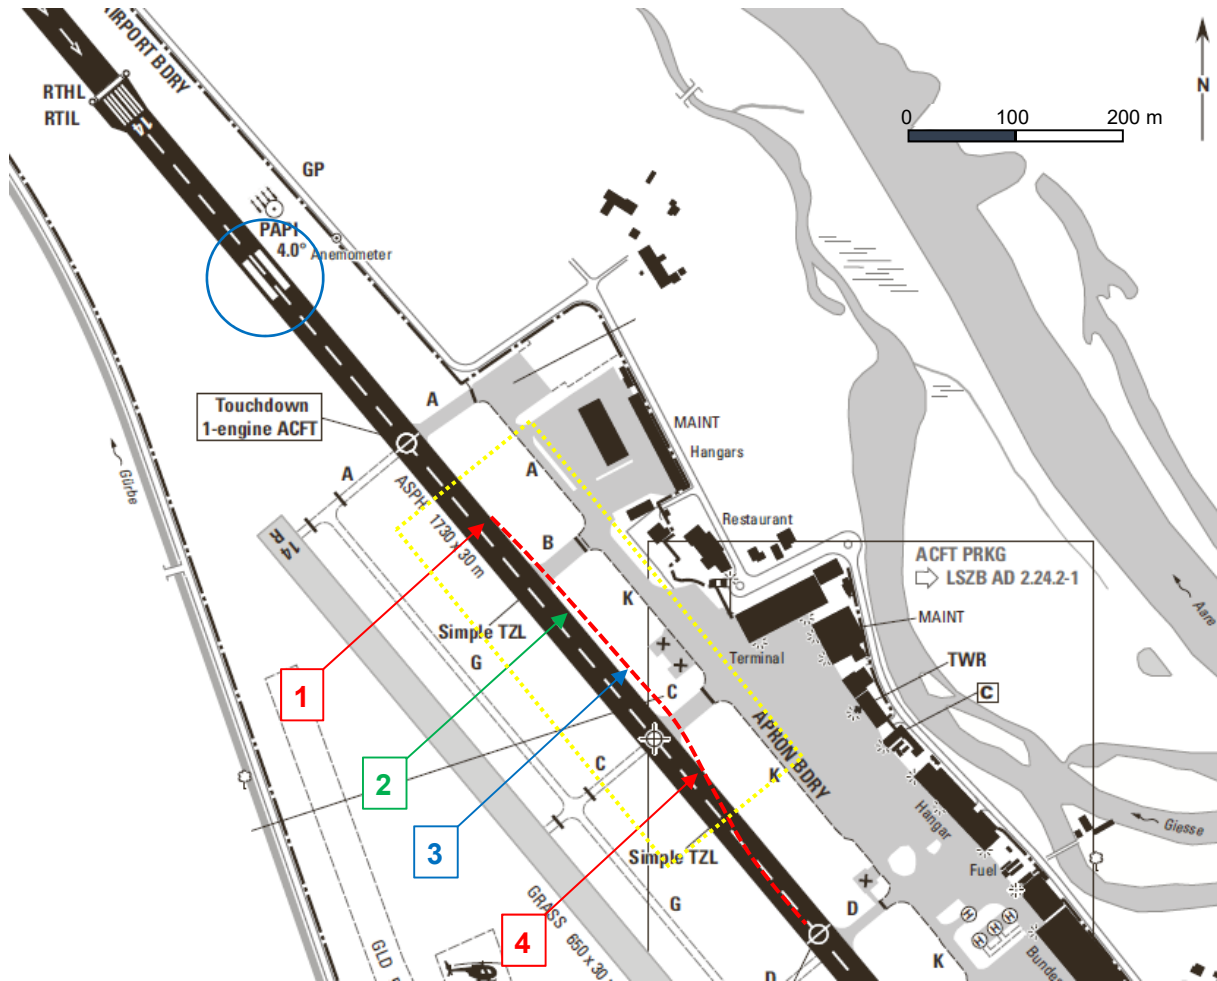
**Image 2:** Section of the aerodrome chart from Bern Airport (LSZB) showing the path on which EC-KES rolled after landing (red dotted line). The red arrow (1) shows where the left-hand-side main landing gear first touched down in the snow to the left of the left-hand boundary of the runway. The green arrow (2) shows where the nose landing gear touched down. The blue arrow (3) shows where the right-hand-side main landing gear also rolled into the snow to the left of the runway. The second red arrow (4) shows where the aircraft returned to the runway. The blue circle indicates runway 14’s aiming point marking, the yellow-dotted rectangle marks the section shown in image 3.

of TWY B. The distance from the aiming point marking to the start of the wheel track in the snow was approx. 300 m. According to their statements, the crew did not realise that the aircraft had landed on the left-hand boundary of the runway and rolled for approx. another 300 m along this runway boundary in snow-covered meadowland. The following possible conclusions can be drawn from this:

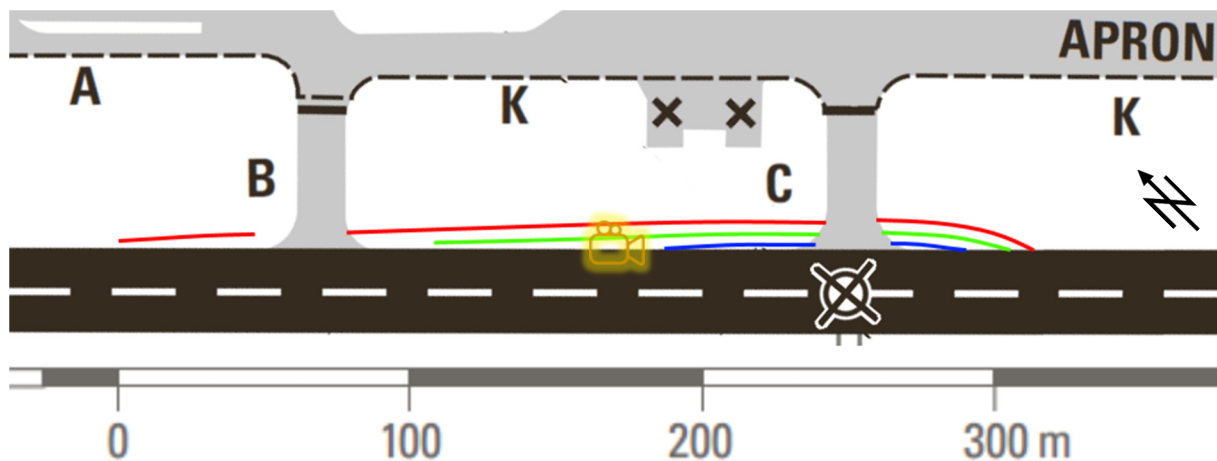
**Image 3:** Enlarged section of the runway showing taxiways A, B and C with the tracks made by the three landing gears of EC-KES (red = left-hand-side main landing gear, green = nose landing gear, blue = right-hand-side main landing gear). The camera symbol marks the position from which image 1 was taken.

The distance between the two outer wheel tracks in the snow was around 4.9 m, which corresponds to the distance between the wheels of the main landing gear of a Cessna 525A. In the area between TWY B and the end of the wheel tracks in the snow after TWY C, six runway edge and taxiway lights were damaged or in places completely torn off.
