Final Report No. 2383

concerning the accident involving the
aircraft PA-28RT-201, G-BVDH,

on 25 August 2019

Simplon Pass, within the municipality of
Simplon (in the canton of Valais), Switzer-
land

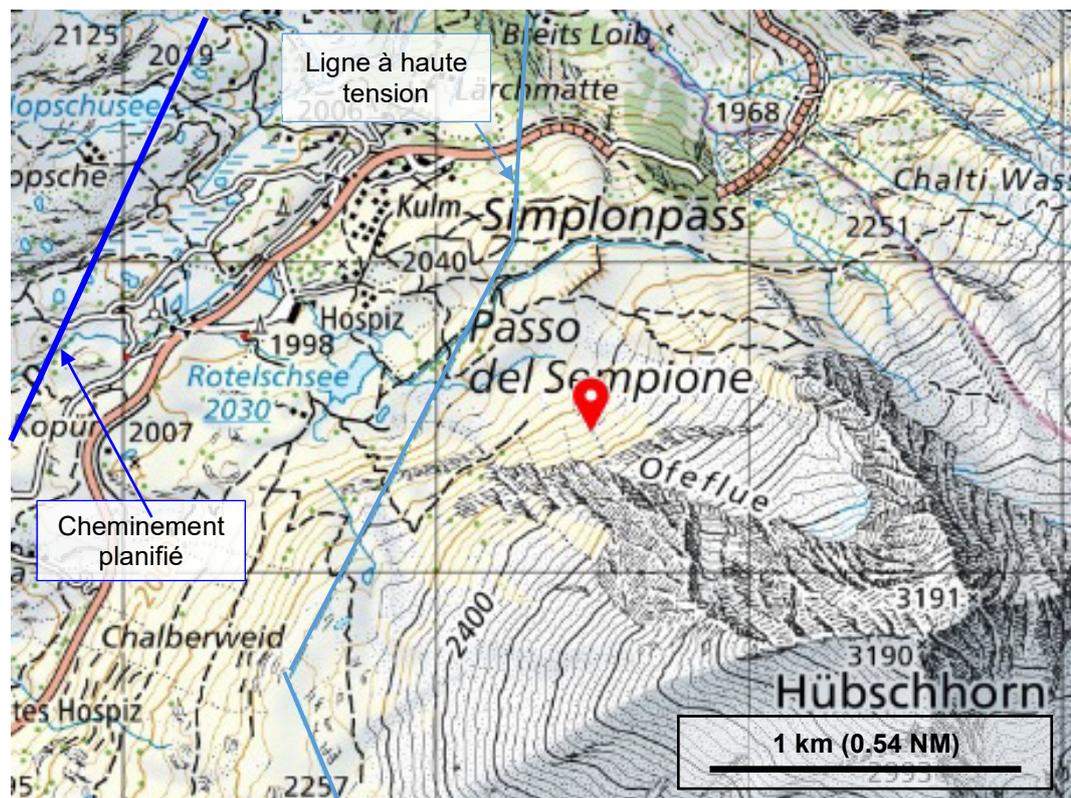
The accident site was located in a scree, approximately 1.5 km south-east of the Simplon Pass (2006 m or 6578 ft AMSL) on the steep north-west facing slope of the Hübschhorn (peak at 3190 m/M or 10 459 ft AMSL).

Figure 5: Location of the accident site at 2246 m (7364 ft AMSL) on the north-west facing slope of the Hübschhorn with terrain altitude indication in metres. Base map source: Federal Office of Topography Swisstopo.

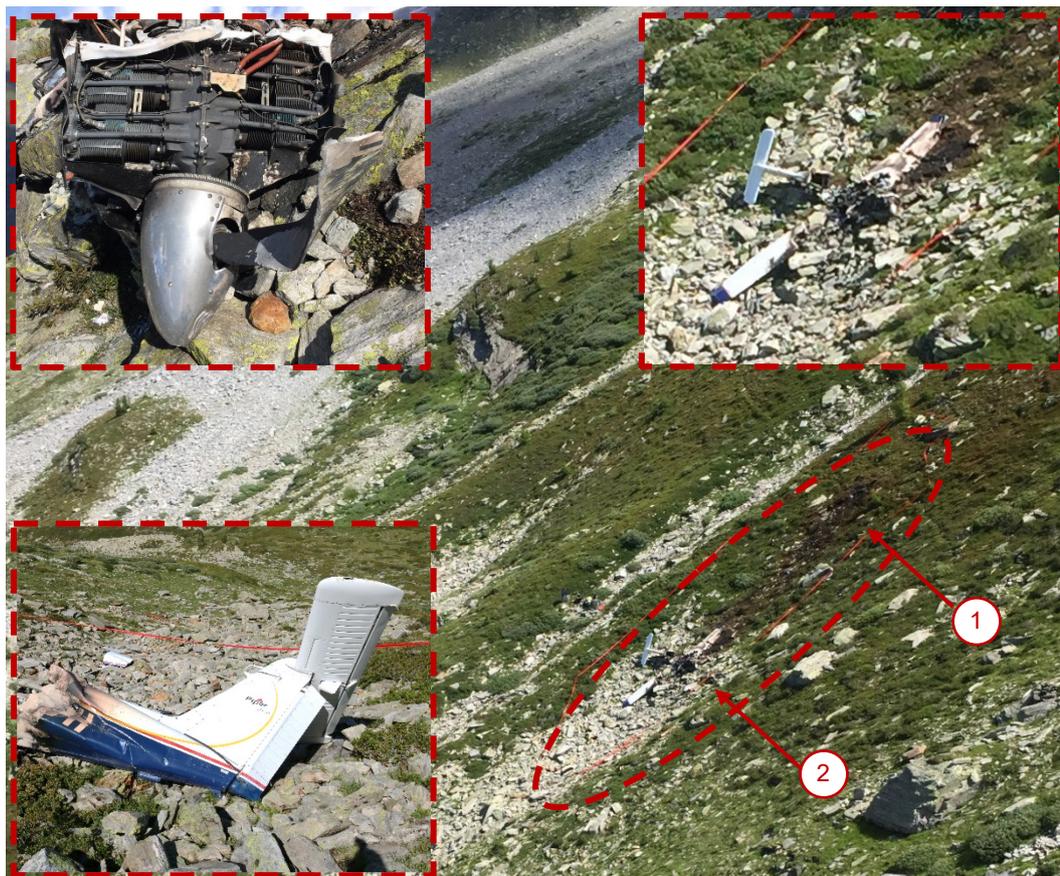
The single engine aircraft impacted with the terrain in an almost flat attitude, proceeding to slide downwards approximately 10 metres before reaching its final position. A post-impact fire occurred.

- The aircraft was laying flat on the ground.
- The post-impact fire destroyed the cabin and cockpit area; the engine compartment was severely damaged.
- The position of the elevator trim or a failure of the flight controls could not be identified.
- The T-tail assembly was still complete but uncoupled from the fuselage.
- Less damage was found on the right-wing tip in comparison with the left wing.
- The aircraft undercarriage was retracted.
- The flaps selector was in the retracted position.
- All documents on board including the aircraft logbook and AFM were destroyed by the post-impact fire.
- The propeller deformation induced by the impact demonstrate that the engine was delivering power.
- No Emergency Locator Transmitter was installed.
- The fire brigade had to decontaminate the ground for a light fuel spill.

Figure 6: View of the location of the impact with the ground (1) and the final position (2) of the aircraft G-BVDH, laying in a scree on the north-west face of the Hübsschhorn.

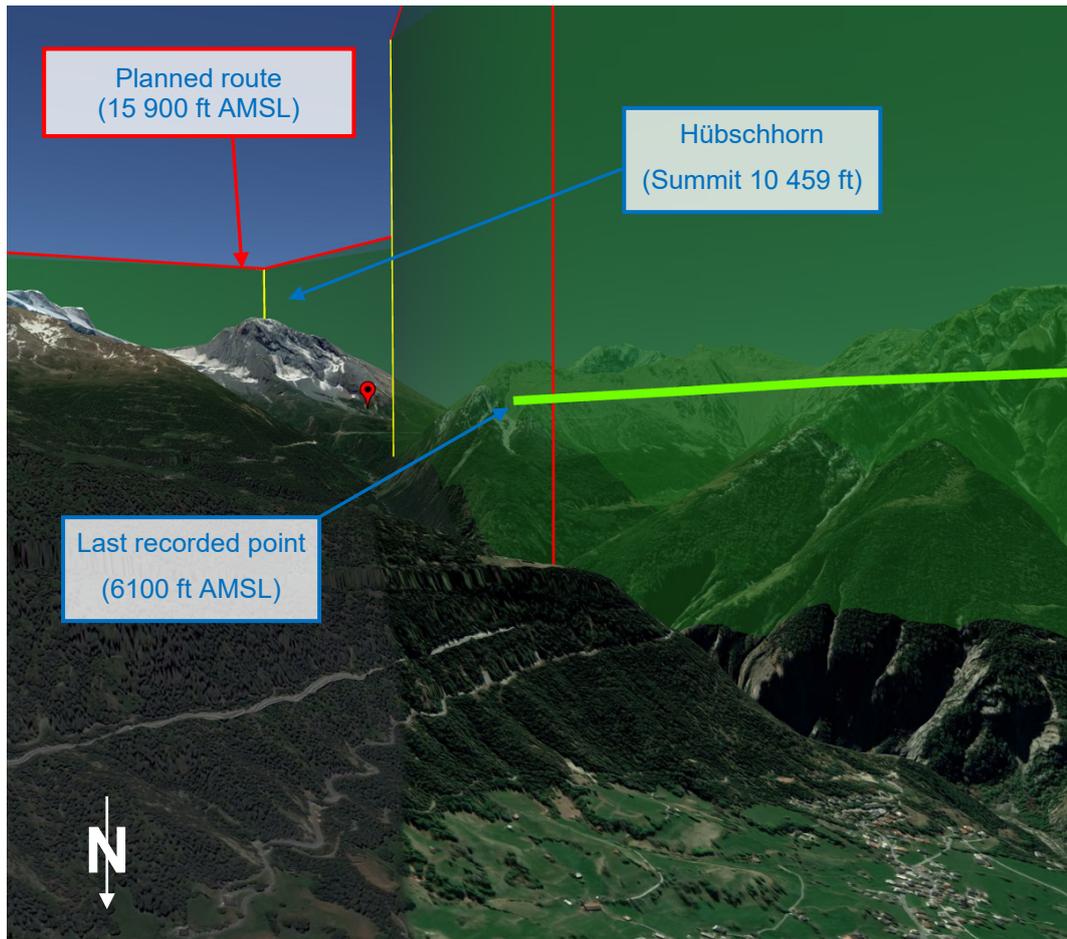
As shown below and in Figure 1, the pilot last amended his route 2 hours prior to departure from Lausanne - La Blécherette by adding waypoints in the vicinity of the Simplon Pass. Both routes in SkyDemon were planned by the pilot at an altitude of 15 900 ft. The altitude at which the aircraft was recorded by Flightradar24, as well as the planned altitudes, are depicted in the Google Earth picture below. The last recorded altitude of the aircraft in the vicinity of Brig was approximately 6100 ft AMSL. An average ground speed of 120 kt and a rate of climb of about 100 ft/min were recorded during the shallow climb from Montreux to Brig.

Figure 9: Google Earth view from the vicinity of Brig of the recorded flight path (green) and the planned routes (yellow, first planned route; red, last amended route 2 hours prior to departure). Both routes have been planned at an altitude of 15 900 ft AMSL. The recorded flight path indicates a last altitude of approximately 6100 ft at 10:23 when entering the Simplon valley. Due to geographical constraints the flight path has not been recorded further towards the Simplon Pass. The location of the impact at an altitude of 7364 ft is shown with a red marker below the Hübschhorn.

From Montreux (waypoint N°1 in Figure 2) to Brig (waypoint N°6) the lateral trajectory of the G-BVDH aircraft indicates that the pilot followed precisely his pre-programmed path on his electronic tablet. His ground speed remained stable at about 120 kt and the rate of climb was only about 100 ft/min as shown in Figure 3. These flight parameters brought him after 20 minutes of flight from Martigny to an altitude of 6100 ft AMSL at the entrance of the Simplon Valley, about 2200 ft below the minimum safe altitude recommended on the ICAO chart.

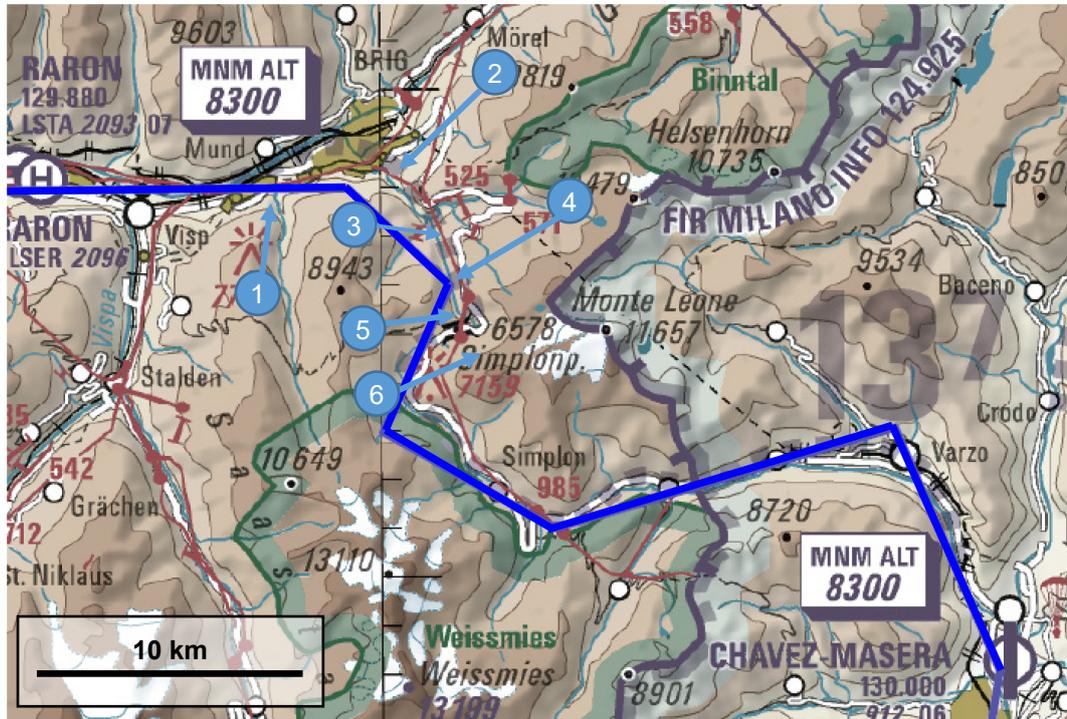
Figure 10: Last segments of reconstructed flight from Brig (Valais) to the impact location near the Simplon Pass with markers indicating the position from where the pictures were taken. The blue line represents the planned route according the filed OACI flight plan. The minimum recommended safe altitude for the route segment 44 is 8300 ft AMSL, as depicted in the violet box. Base map source: Federal Office of Topography Swisstopo.

This lack of anticipation on the management of the flight altitude, generated a climb with a pronounced nose-up attitude in the Simplon valley during the last 5 NM which corresponds to a flight duration of approximately 2 min 30 sec. With the configuration of the dashboard of a PA28, this nose-up attitude consequently also increased the difficulty to see the ground on its trajectory. This lack of visibility led him to fly low over the Simplon Valley power line and prevented him from anticipating a possible turn around to adapt his flight tactics.

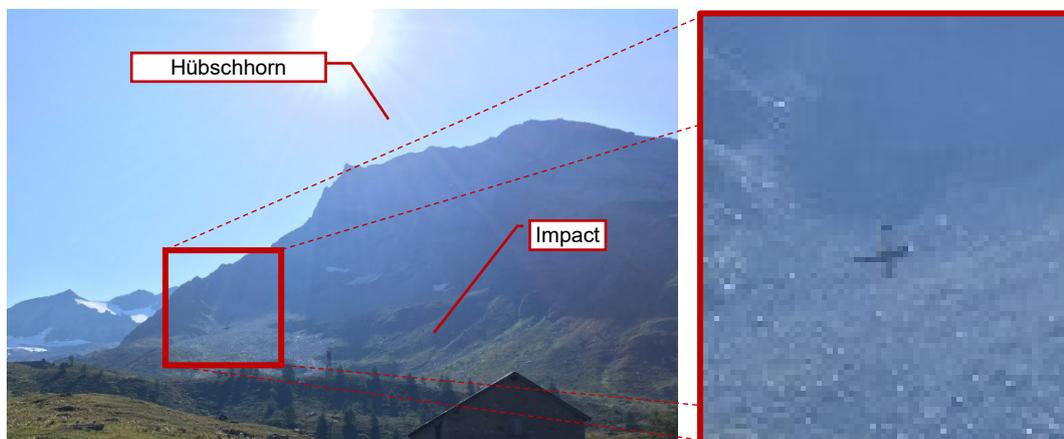
Figure 12: View from group 1 of G-BVDH a few seconds before the impact.

The photo taken by this hiker shows the aircraft in a nose-up position. From the paint scheme of the aircraft, with the lower fuselage in blue (see Figure 3), it can be determined that the aircraft is banking heavily to the left.

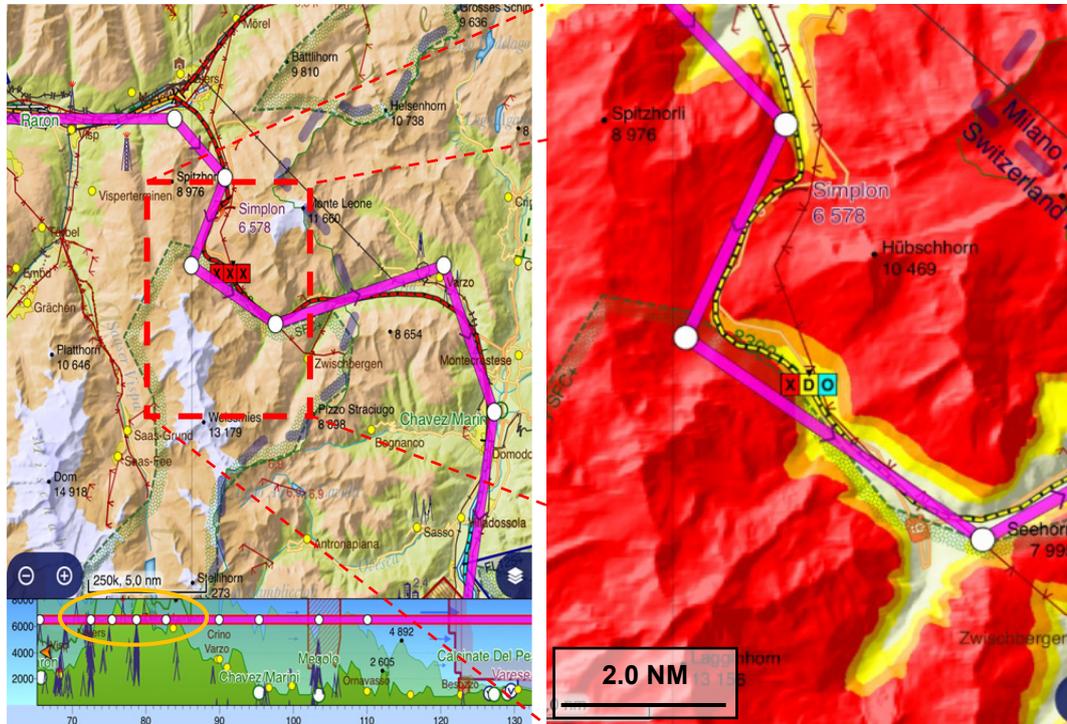
When a cruising altitude is set during flight planning, Skydemon displays at the bottom of the main map the planned vertical profile according to the waypoints. For example, at a selected flight altitude of 15,900 ft, the vertical profile meets no obstacles on the established path on 13 August 2019. However, if an altitude of 6500 ft is selected, similar to the one last recorded at the beginning of the Simplon Valley, the vertical profile intersects the terrain around the Simplon Pass (see Figure 14).

Figure 14: View of the planned flight path (magenta) on 13 August 2019 in the Skydemon application. The lower part of the image on the left shows the vertical profile of the planned flight (magenta) at 6500 ft and the terrain flown over (green). The vertical profile intersects the terrain around the Simplon Pass (orange circle). On the right, visualisation of the Simplon Pass surroundings with the "Colour high terrain" feature activated at an altitude of 6500 ft.

However, for some undetermined reason the pilot never planned a flight altitude, as it remained unchanged at an altitude of 15,900 ft throughout the flight. The introduction of a cruise altitude appropriate for the flight also allows visualisation of a potential collision with terrain using the Skydemon application (see Figure 14) during flight planning. The picture in Figure 3, taken in flight by the backseat passenger, shows that the "Colour high terrain" functionality was not activated, and therefore the visualisation of a risk of collision was not available in flight either.
