## Summary Report

<b>Aircraft</b>	Airbus A319-131	G-EUPJ		
<b>Operator</b>	British Airways PLC, Harmondsworth, United Kingdom			
<b>Owner</b>	British Airways PLC, Harmondsworth, United Kingdom			
<b>Pilot</b>	British citizen, born 1964			
<b>Licence</b>	European Aviation Safety Agency (EASA) airline transport pilot licence aeroplane (ATPL(A)), issued by the UK Civil Aviation Authority			
<b>Flying hours</b>	<b>Total</b>	> 10 000 h	<b>During the last 90 days</b>	239 h
	<b>On the aircraft type</b>	> 6 000 h	<b>During the last 90 days</b>	239 h
<b>Co-pilot</b>	British citizen, born 1970			
<b>Licence</b>	EASA airline transport pilot licence aeroplane (ATPL(A)), issued by the UK Civil Aviation Authority			
<b>Flying hours</b>	<b>Total</b>	> 8 000 h	<b>During the last 90 days</b>	156 h
	<b>On the aircraft type</b>	> 4 000 h	<b>During the last 90 days</b>	156 h
<b>Location</b>	In a holding pattern above the BLM VHF omnidirectional radio beacon (VOR) in the German/French/Swiss border area north of Basel	<b>Altitude</b>	FL 180

<b>Date and time</b>	24 <sup>th</sup> July 2015, 20:05 UTC (LT = UTC + 2 h) All of the information in this report is given in coordinated universal time (UTC)			
<

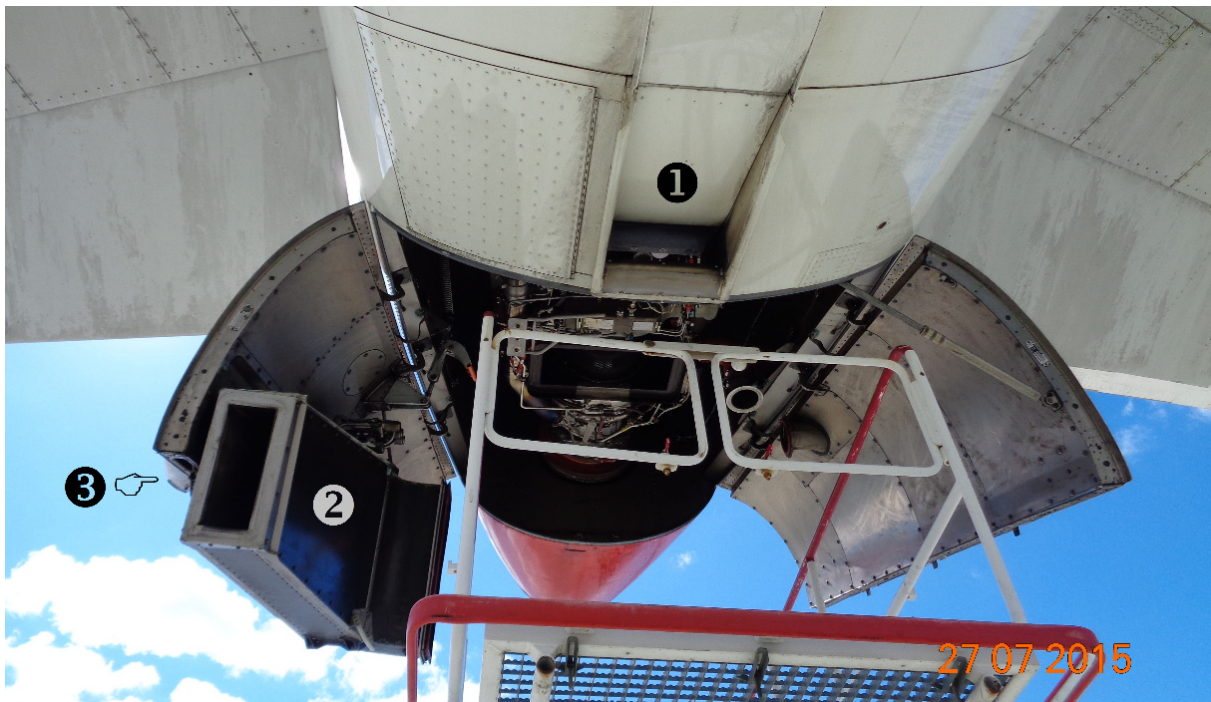
Indications of an oil leak were found in the APU bay in the aircraft's tail cone, even though the APU bay had been cleaned and inspected on the previous day, prior to the APU being switched on. The leak consisted of engine oil from the APU which was dripping from the APU generator drain plug onto the APU air inlet duct in small quantities (see illustration 1).

**Illustration 1:** View of the open APU bay in the aircraft's tail cone. The air required for the operation of the APU is sucked in through the air inlet (1) and reaches the APU via the air inlet duct (2) attached to the hatch. When the APU bay is closed, the top of the air inlet duct acts as a drip tray, which is emptied to the outside via the drain mast (3); the drain mast is located directly behind the air inlet.

The serious incident can most probably be attributed to the air conditioning packs being contaminated with engine oil from the APU, which was dripping from the APU generator drain plug onto the APU air inlet duct in small quantities. From the air inlet duct, the oil was drained to the outside via a drain mast, which is located directly behind the APU air inlet. It is therefore probable that the leaked oil reached the APU air inlet when the APU was in operation on the ground, potentially assisted by the effect of tailwind.

Following the reinstallation of a flight data recorder and a cockpit voice recorder as well as other finishing work, G-EUPJ was approved for operation with a decommissioned APU. The aircraft could then be flown to London without passengers.

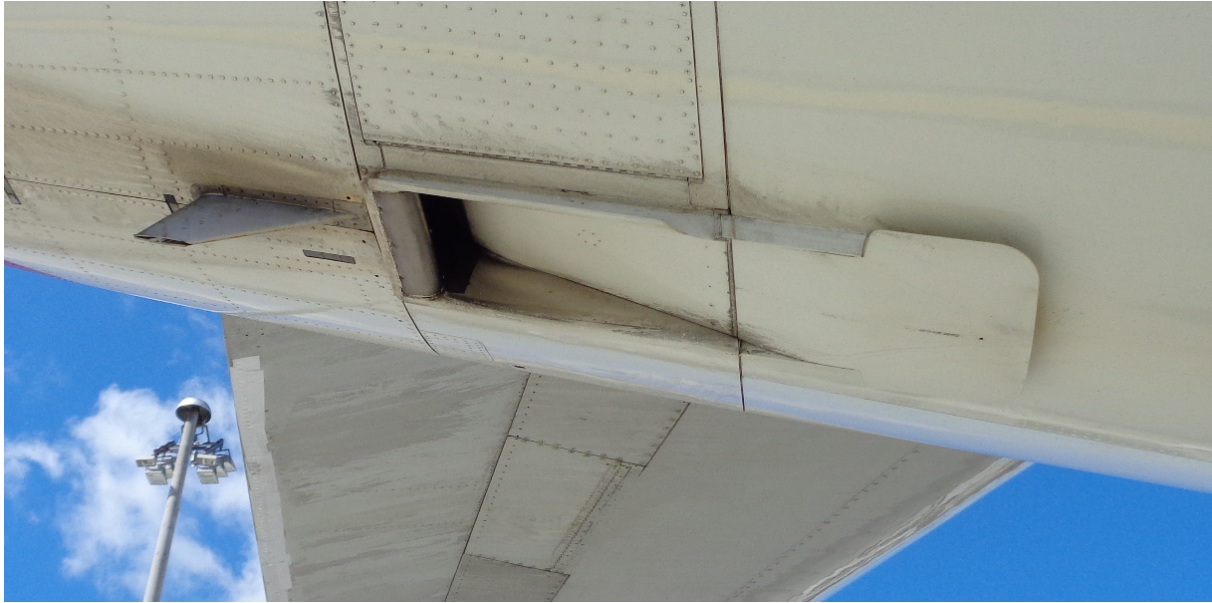
**Illustration 2:** View of the open APU inlet duct on the underside of the aircraft's tail cone. The drain mast can be seen to the left of it.
