Summary Report

Aircraft	Raytheon 400 A Nextant 400XT		G-FXAR	
Operator	FairJet Limited, Birmingham International Airport B28 3QN			
Owner	FlexJet LTD, Birmingham International Airport B28 3QN			
Pilot	British citizen, 1966			
Licence	Air Transport Pilot Licence Aeroplane – ATPL(A) in accordance with and subjected to the provisions issued by the United Kingdom Civil Aviation Authority – UK CAA			
Flight hours	total	8400 h	during the last 90 days	3 h
	on the type of incident	3 h	during the last 90 days	3 h
First Officer	British citizen, 1959			
Licence	ATPL(A) in accordance with and subjected to the provisions issued by the UK CAA			
Flight hours	total	11'625 h	during the last 90 days	72 h
	on the type of incident	195 h	during the last 90 days	65 h
Location	approx. 10 NM south-east SOSAL			
Coordinates	---	Altitude	FL380	
Date and time	2 nd May 2018, 12:35 UTC (LT ¹ = UTC ² + 2 h)			
Type of operation	Commercial			
Flight rules	Instrument Flight Rules - IFR

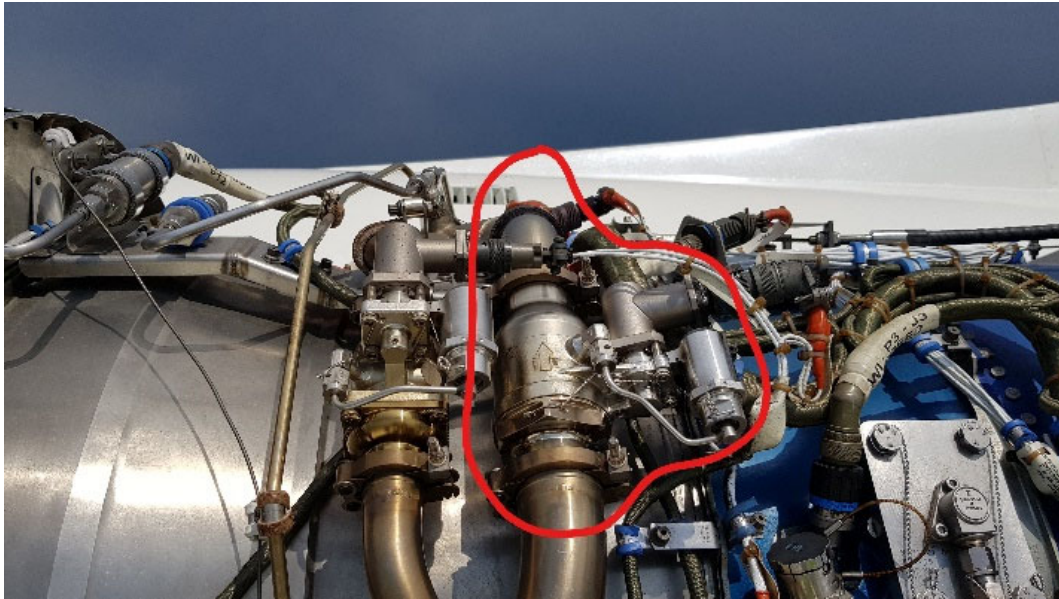
The G-FXAR has been examined after the event in Geneva by an Engineer. He found out that the high-pressure valves on both engines were not working properly. The left one was suspected degraded and the right one was clearly damaged. Furthermore, during the investigation it was noticed that a non-binding Service Bulletin (SB) 21-2015-01 (see Appendix 1) has been published by Nextant Aerospace on 27 May 2016 concerning those valves. The engineer confirmed that the engine type mounted on this aircraft had several issues with those valves.

The loss of cabin pressurisation is explained with the faulty valves causing a loss of pneumatic pressure and flow. Nextant Aerospace recommended the application of the SB 21-2015-01 in order to correct unfavourable reliability issues of the low and high pressure valves.

Figure 1: Situation before SB 21-2015-01 modification

The measure taken on G-FXAR is the appliance of the SB 21-2015-01, and several tests including an engine run-up.

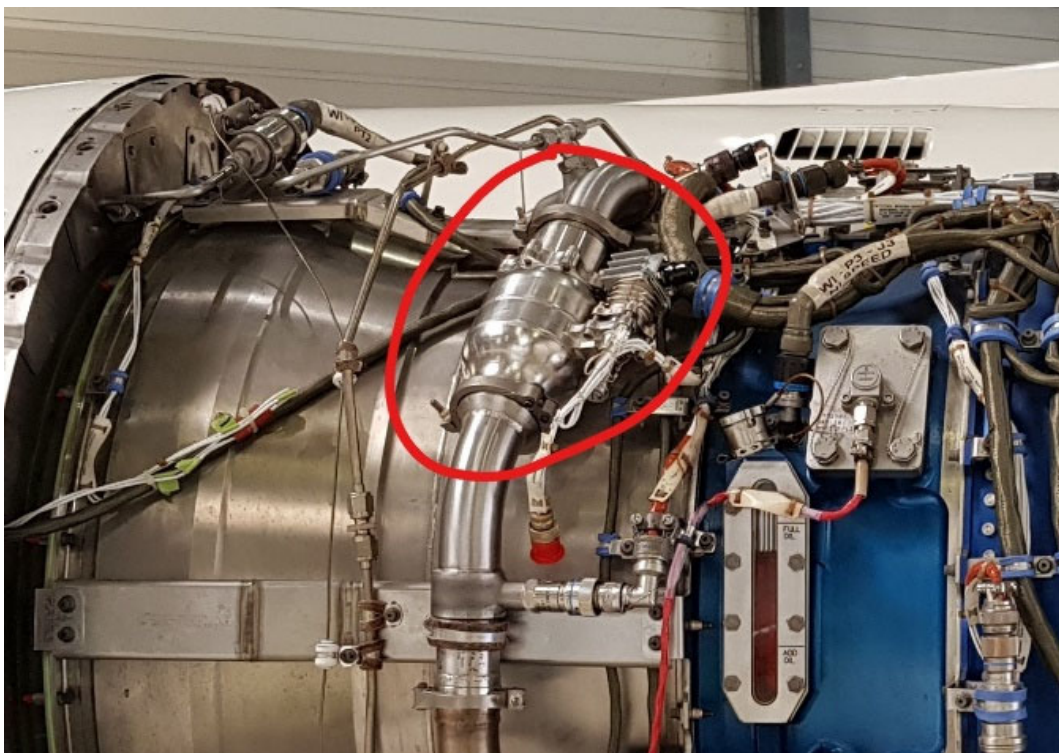
Figure 2: Situation after 21-2015-01 modification

Incorporation of Kit NX0057-KDL0-0100 removes the existing dual Low and High Flow PRSOVs in the engine compartment which control bleed air delivery to the aircraft and anti-ice systems and installs a single in-line Full Flow PRSOV which can handle the bleed air flow comprehensively, thereby reducing parts and maintenance and improving reliability of the bleed air delivery system.
