## Cessation of investigation

**Place, Date, and Time:** Bern Airport (LSZB), Switzerland, 28 December 2021, 14:11 UTC

**Registration:** G-XONE  
**Model:** Bombardier CL-600-2B16 (604 Variant) "Challenger 604"  
**Owner:** Gama Aviation Ltd., Farnborough, UK  
**Owner:** Gama Aviation Ltd., Farnborough, UK

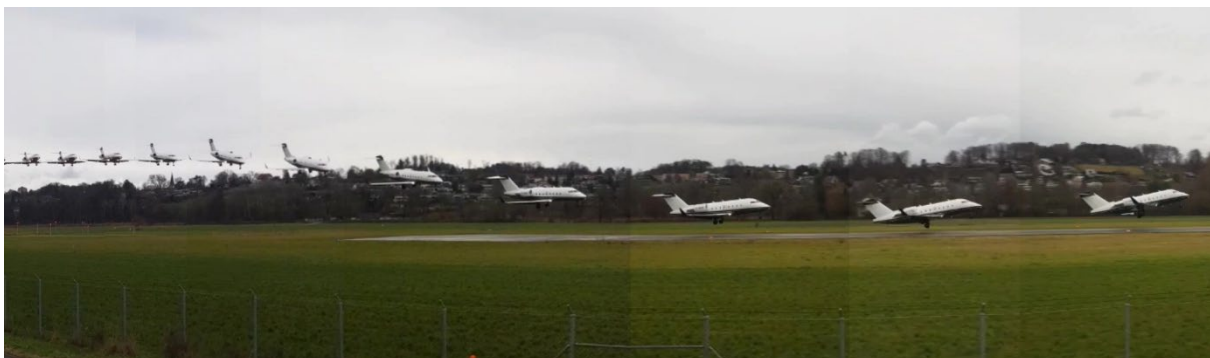
At an altitude of approximately 100 ft above ground level, the stick shaker and stick pusher were activated<sup>3</sup>. As a result, the aircraft’s pitch angle decreased abruptly, and the aircraft descended suddenly at a high rate of descent and in a flight attitude unsuitable for touchdown toward the runway area located in front of the touchdown zone (see Figure 1). The pilots immediately pulled the control column back to the aft stop and increased engine power to maximum. The aircraft subsequently descended to an altitude of 4 ft above the runway and then transitioned into a climb.

**Figure 1:** Video recording by a passerby of the G-XONE’s go-around over the area of Runway 14 located in front of the threshold (eleven individual frames taken one second apart, combined into a single image).
