FINAL REPORT

on investigation into air occurrence to aircraft of a maximum mass below 2250 kg*

ALBUM OF ILLUSTRATIONS
Schempp-Hirth Nimbus 4M glider; HB-2254
9 August 2011, Giby near Sejny

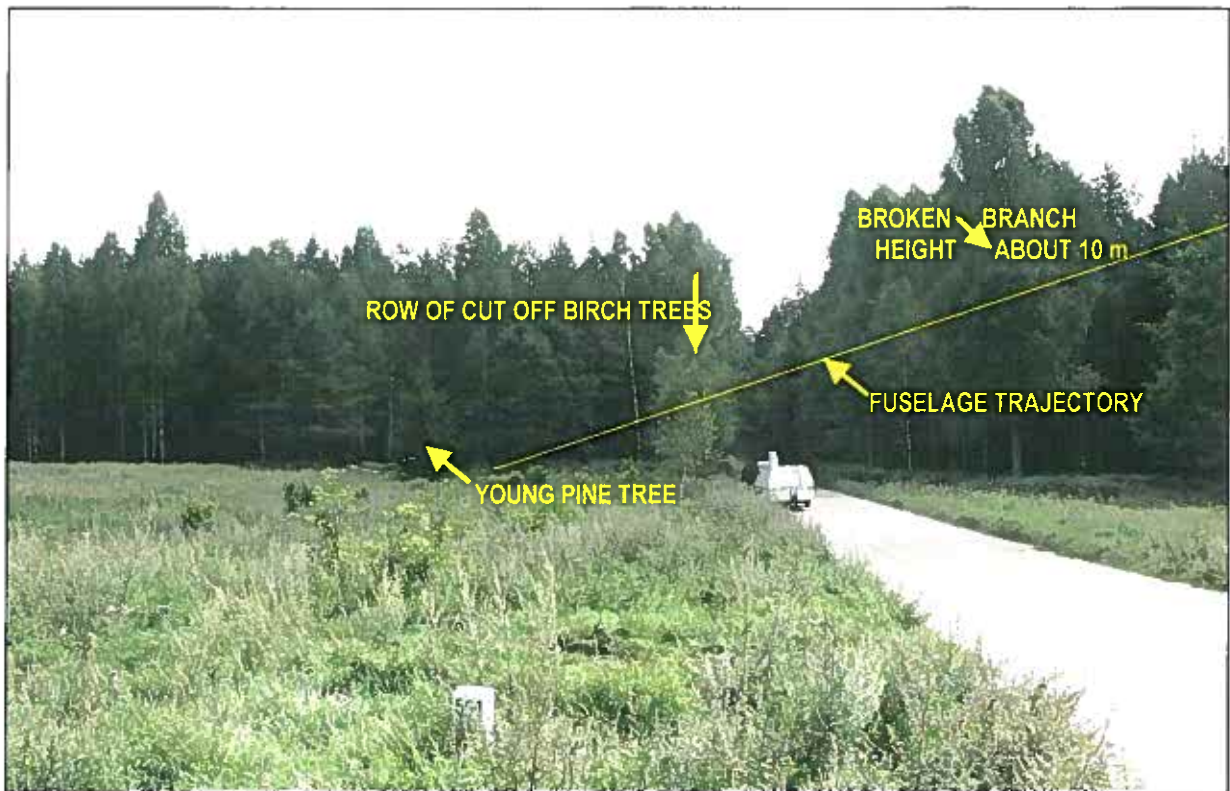
10 – General view of the accident site – marked situation elements

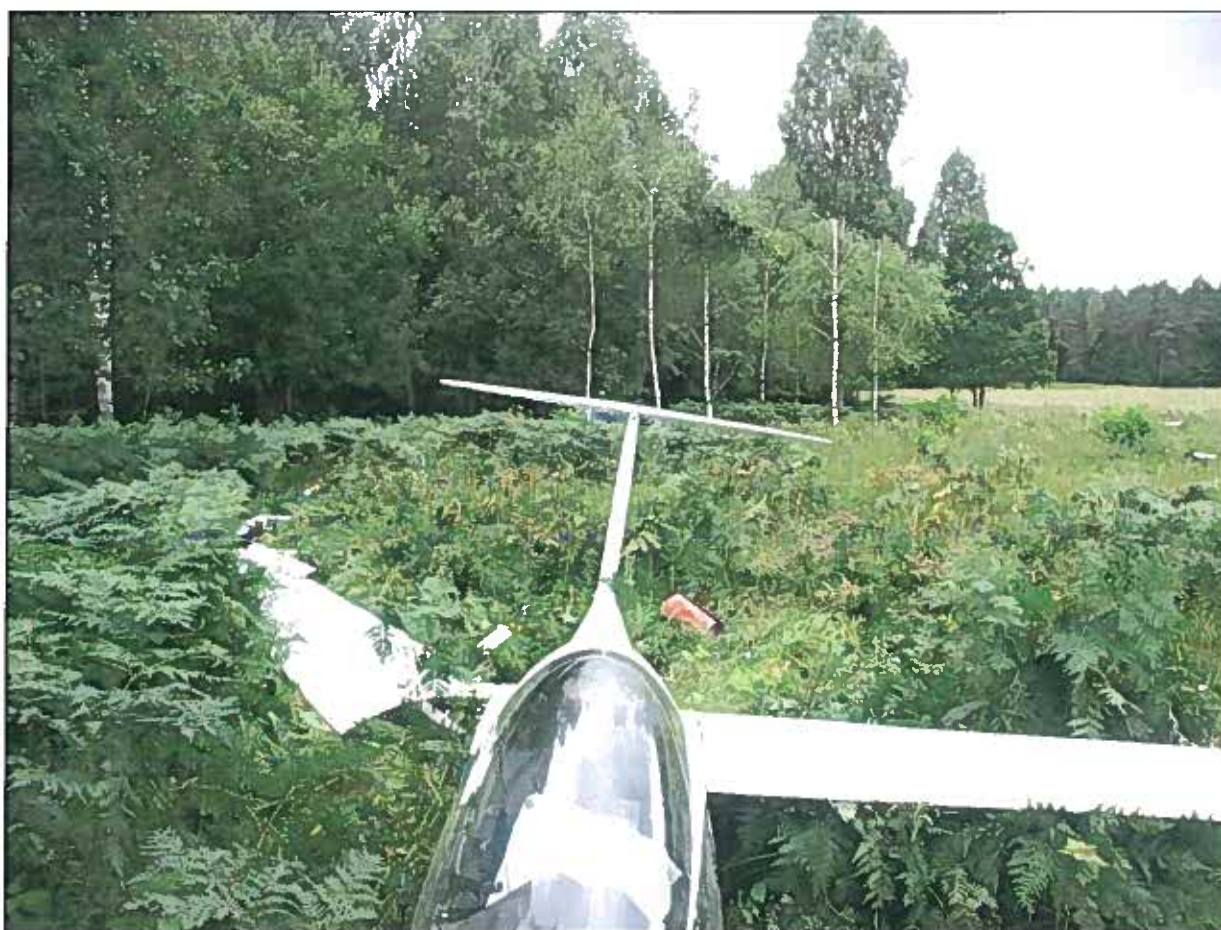
In this configuration the right wing of the glider collided with a high tree branch located at the height of about 10 m (on the edge of the forest on the western side of the road) broke it, and then the left wing came in contact with the ground just behind the road. At the same time the right wing cut down tops of 6 birch trees located along the road on its eastern side (trunk diameter at the base about 12-15 cm) and knocked down one of them. As a result of impact the right wing was separated from the fuselage and broken in two places.

13 – Front view of the glider in the western direction, visible birch trees cut off by the right wing.

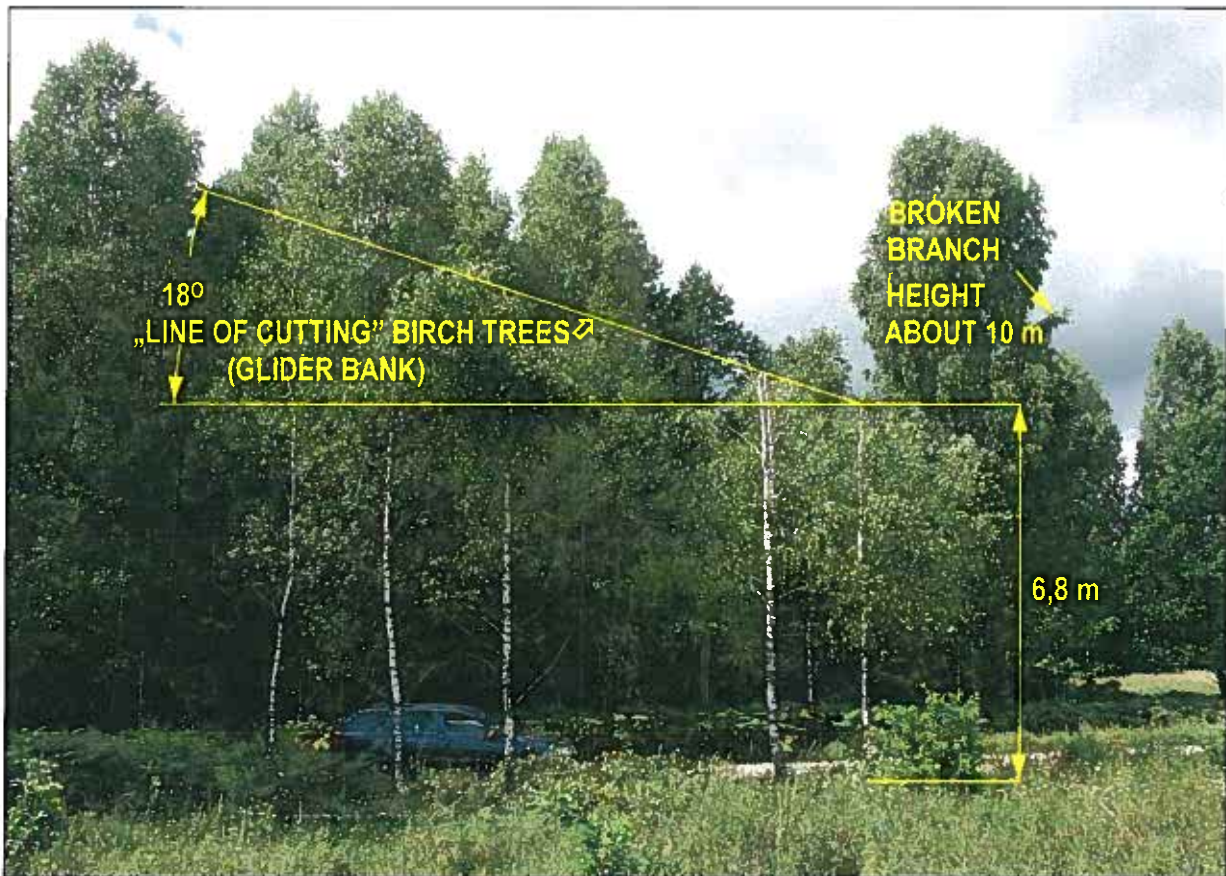
14 – Damage to trees in the vicinity of the accident site .

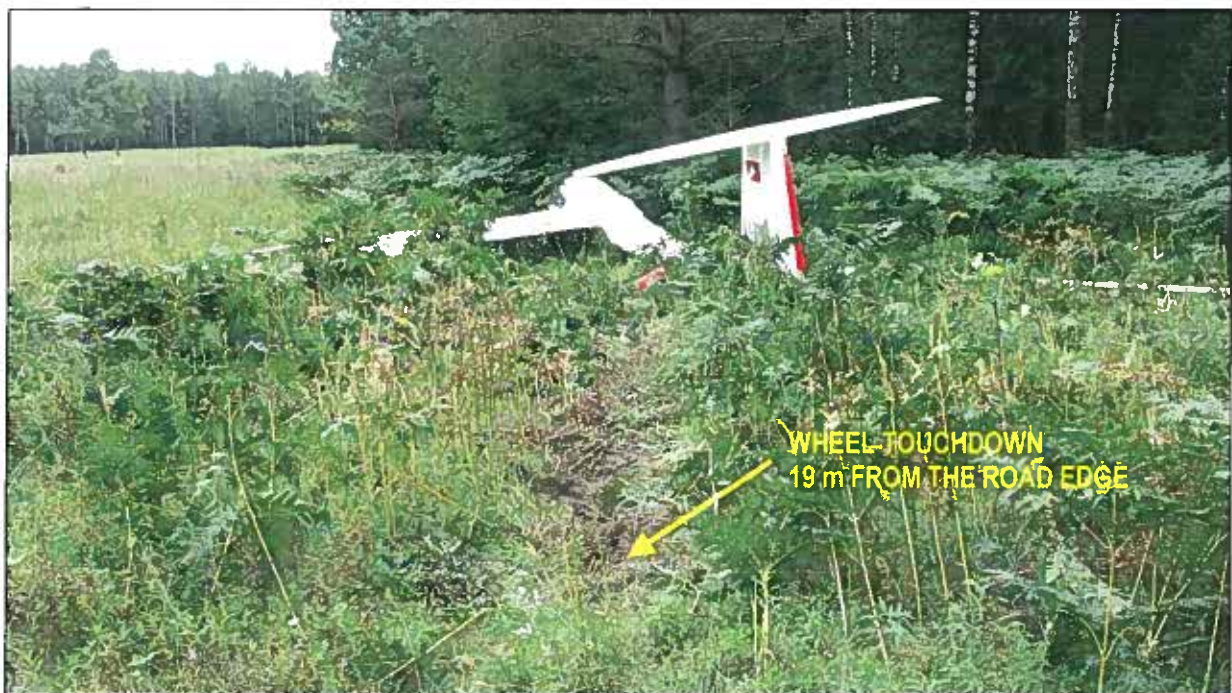
Touchdown on the landing gear was pretty hard, and during the landing roll the glider turned about 15 degrees to the left, setting the fuselage nose in easterly direction.

15 – Landing gear wheel touchdown and its track.

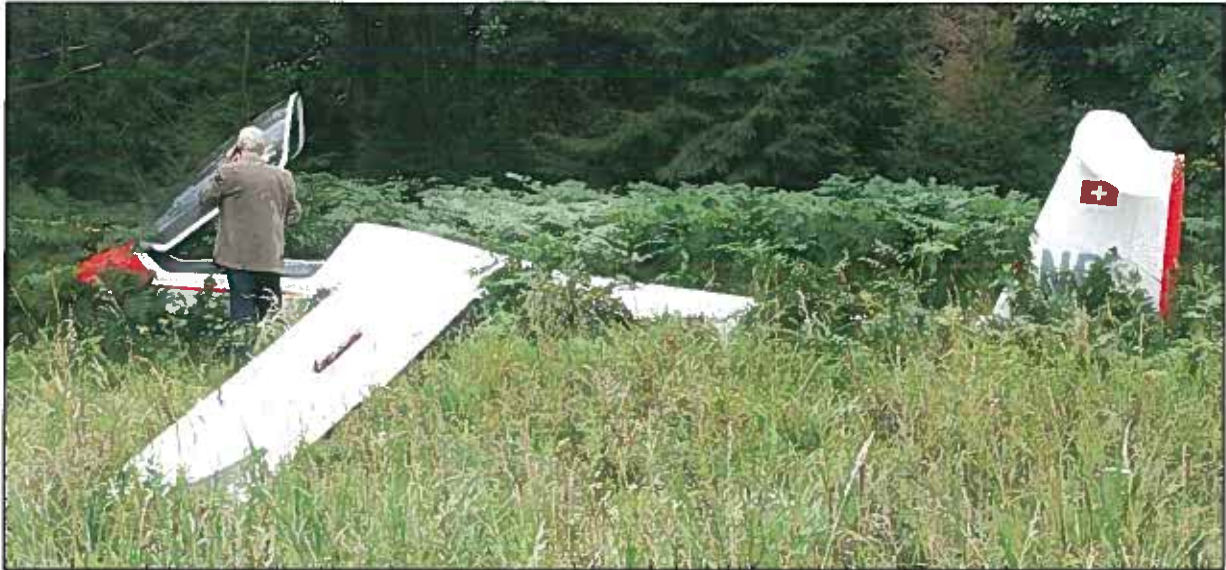
16 – General view of the glider from the left side, in the foreground damaged left wing.

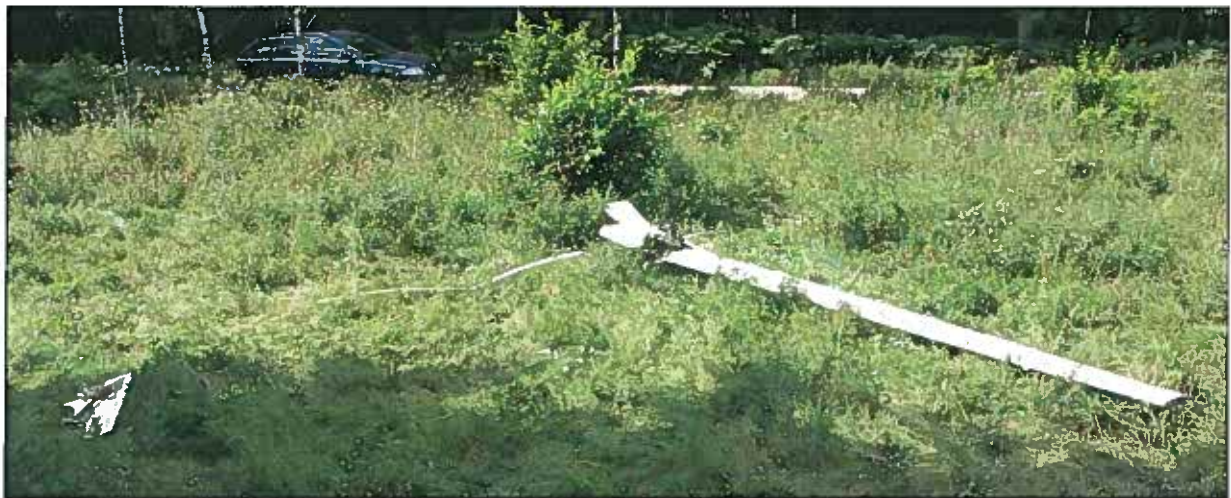
Strongly bent left wing, moving on the ground, collided with a young pine (trunk diameter at the base about 15-18 cm) and as a result of impact was separated about 7 m from the fuselage.

17 – End part of the left wing separated as a result of collision with the ground and pine trunk.

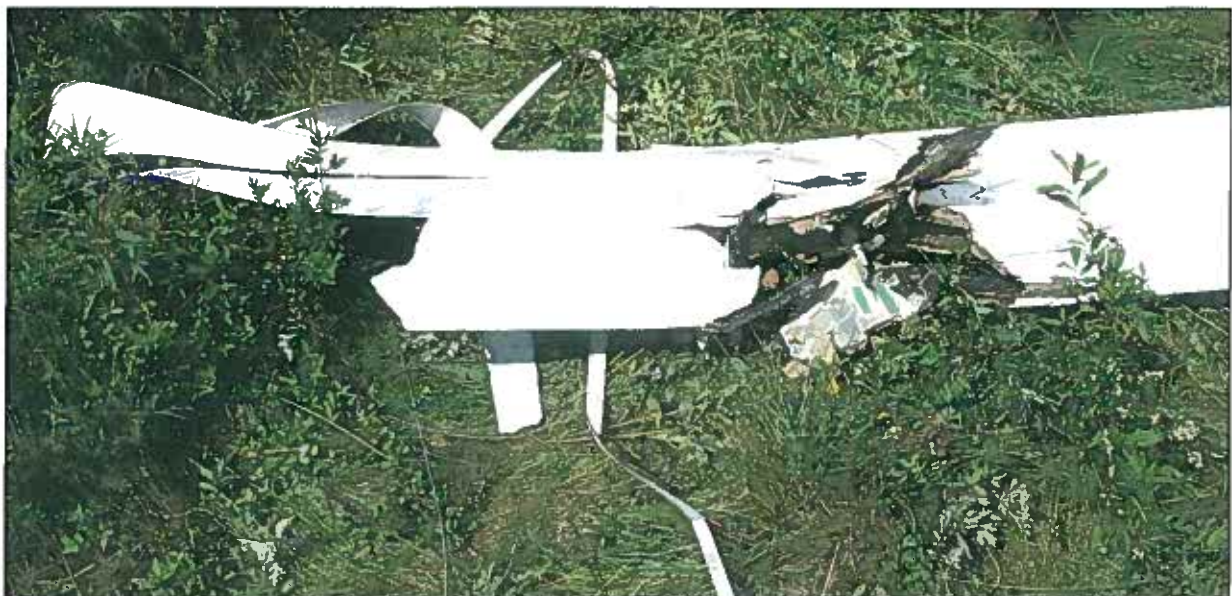
18 – End part of the left wing separated as a result of collision with the ground and pine trunk – close-up.

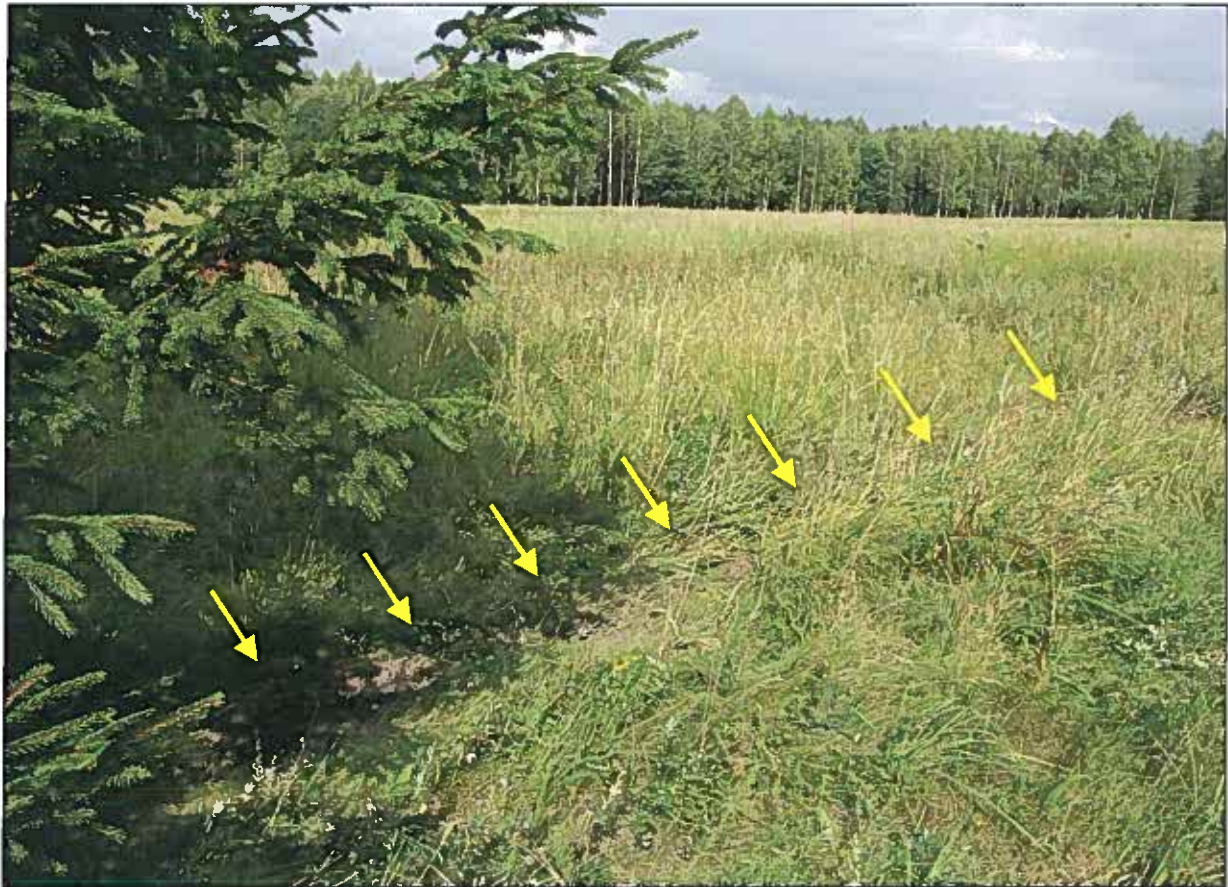
19 – Track of the broken left wing behind the pine tree which caused separation of the wing end part.

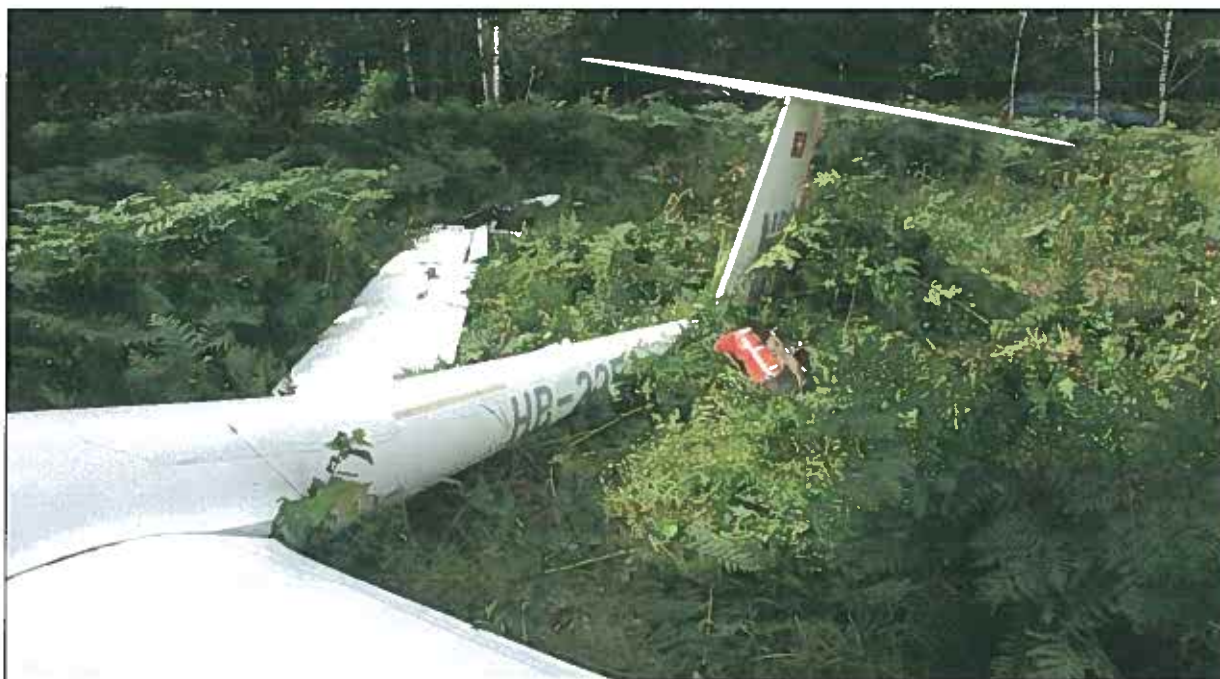
21 – Rear part of the glider fuselage – left side, visible separated right wing.

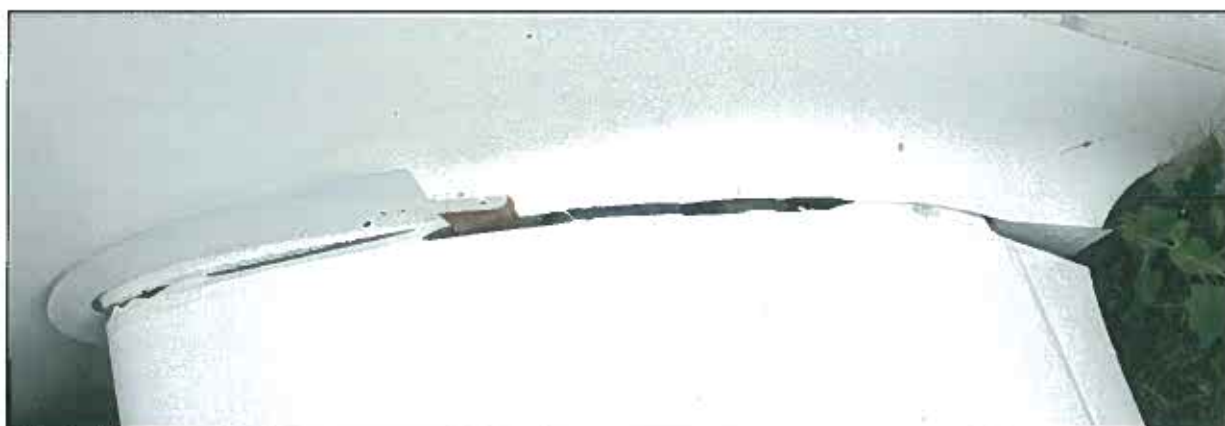
23 – Left wing root – visible damages and deformations.

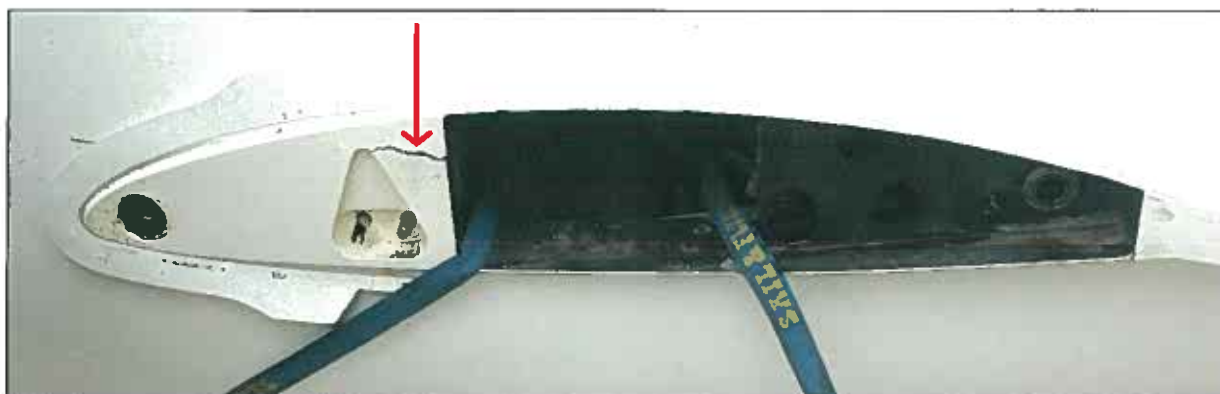
24 – Damage to the fuselage skin in the area of the left wing root.

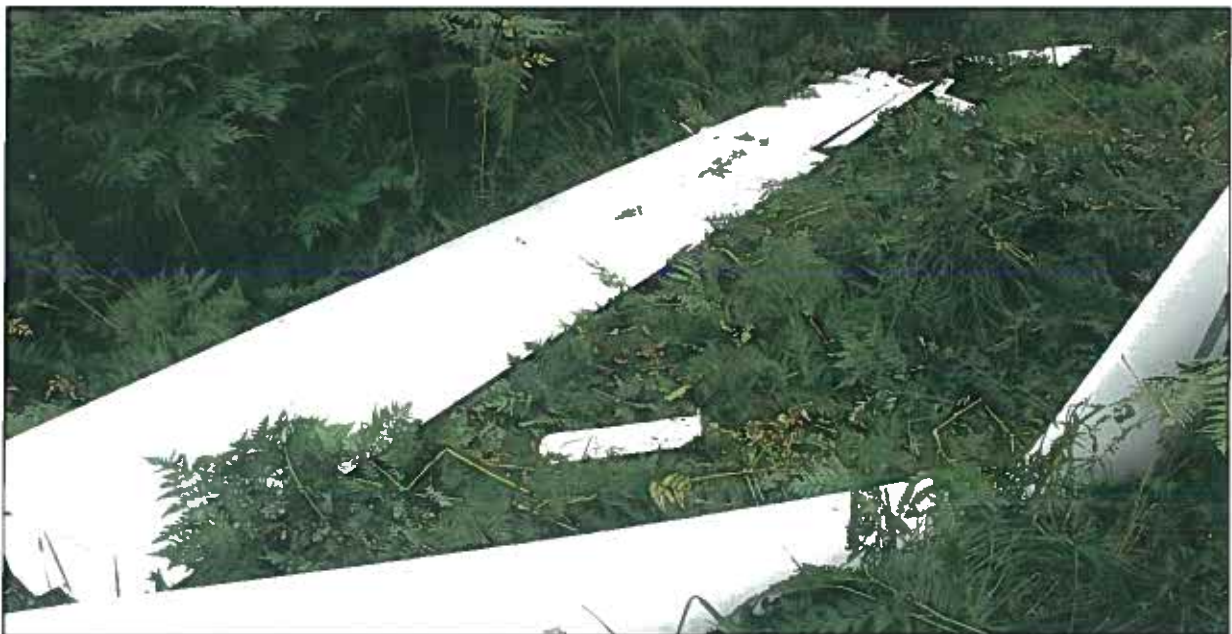
29 – Fuselage and separated right wing. Separated right cover of the landing gear hold visible between wing and fuselage.

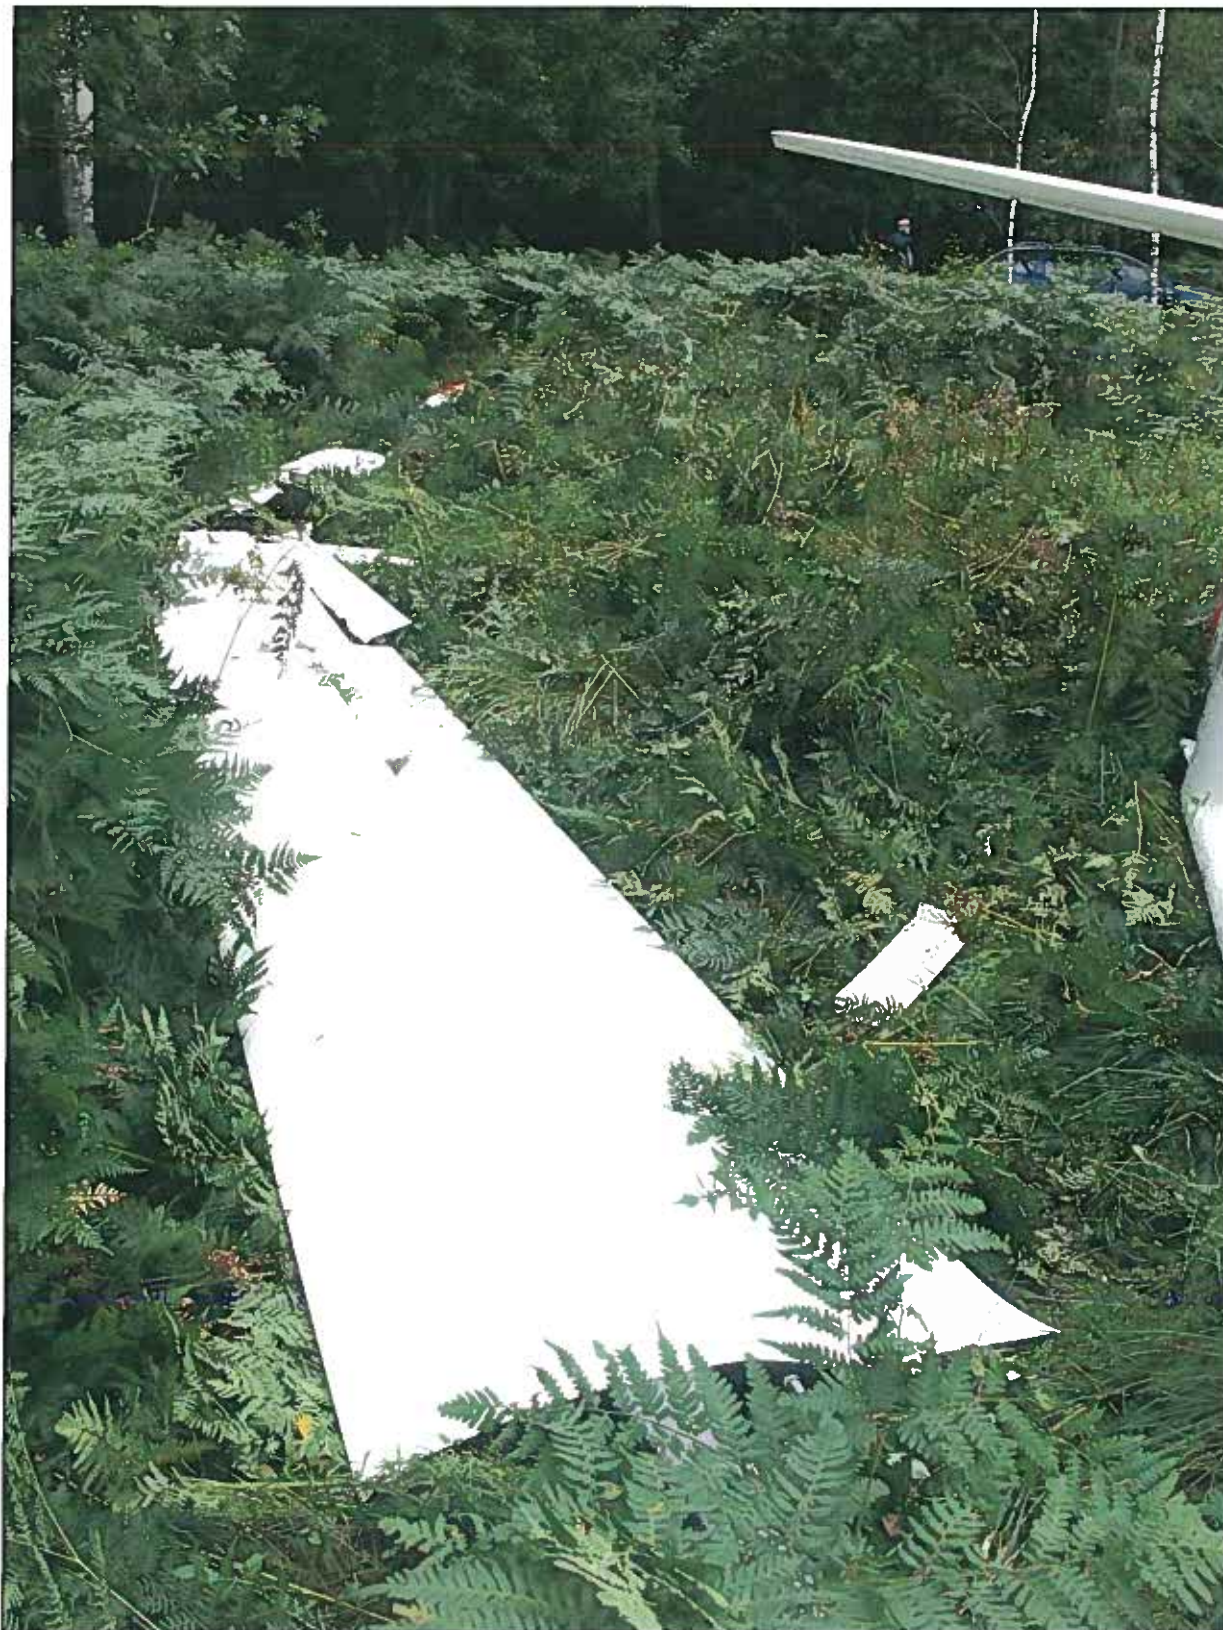
30 – Separated right wing, general view. Separated right cover of the landing gear hold visible between wing and fuselage.

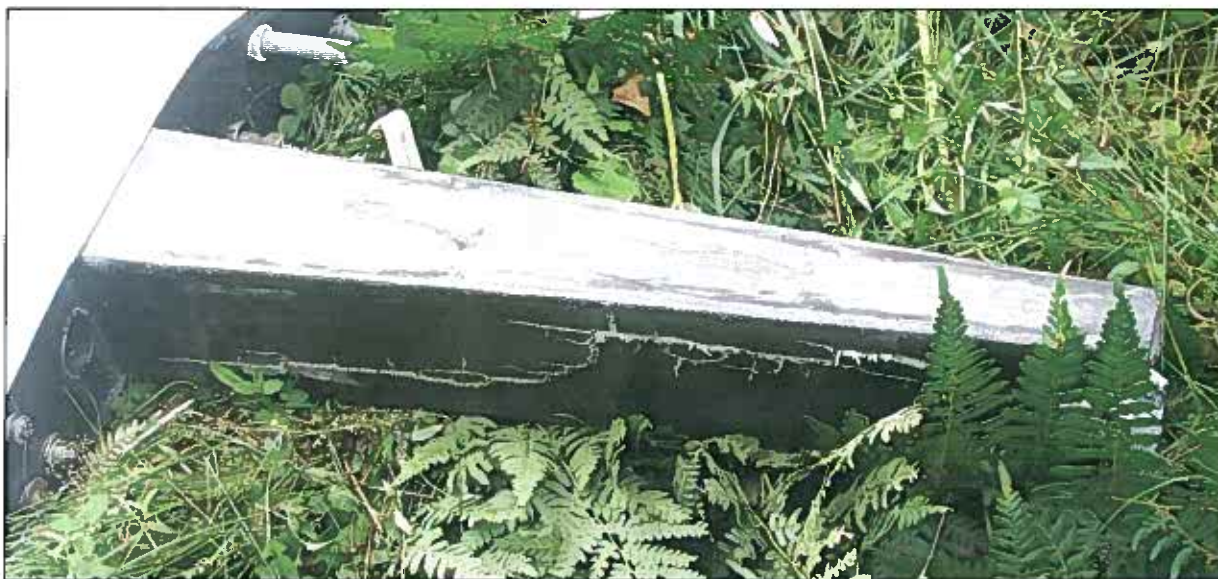
31 – Separated right wing, visible crack of the root part of wing spar.

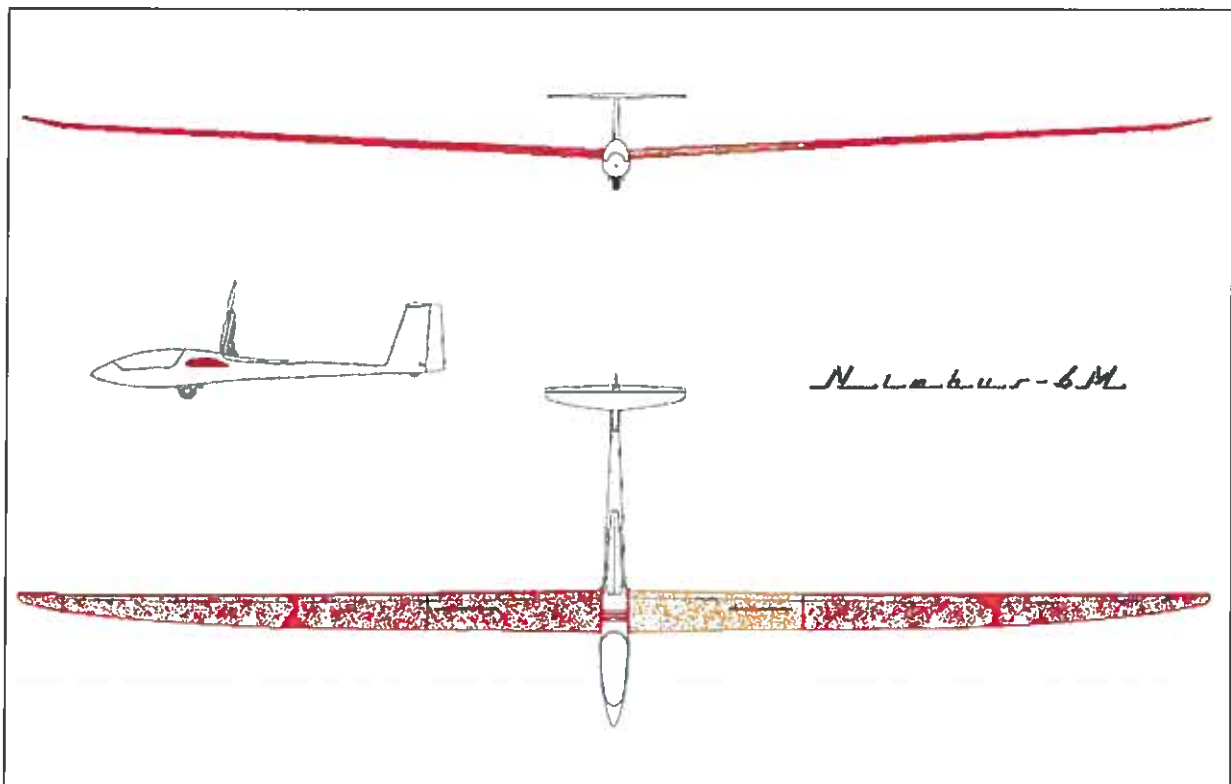
40 – Damages to the glider - the destroyed parts marked with red and the damaged parts marked with yellow.
