## Summary report

<b>Aircraft</b>	Diamond Aircraft Industries GmbH HK36TTC	HB-2314
<b>Operator</b>	Gruppo Volo a Vela Ticino, 6596 Gordola	
<b>Owner</b>	Gruppo Volo a Vela Ticino, 6596 Gordola	
<b>Pilot License</b>	Swiss citizen, born 1958 Private pilot license airplane (PPL(A)) according to the guidelines of the <i>European Union Aviation Safety Agency (EASA)</i> , issued by the Federal Office for Civil Aviation (FOCA)	
<b>Flight hours</b>	<b>total</b> 955:18 h <b>with the type involved</b> 12:24 h	<b>during the last 90 days</b> 49:06 h <b>during the last 90 days</b> 9:24 h
<b>Passenger License</b>	Swiss citizen, born 1952 Private pilot license airplane (PPL(A)) in accordance with the guidelines of the <i>European Union Aviation Safety Agency (EASA)</i> , issued by the Federal Office for Civil Aviation (FOCA)	
<b>Flight hours</b>	<b>total</b> 1331:49 h <b>with the type involved</b> 394:52 h	<b>during the last 90 days</b> 12:42 h <b>during the last 90 days</b> 4:10 h

<b>Location</b>	Locarno Airport (LSZL) <sup>1</sup>	
<b>Coordinates</b>	---	<b>Altitude</b> --- m/M
<b>Date and time</b>	9 July 2021, 13:52 local time (LT <sup>2</sup> = UTC <sup>3</sup> + 2 h)	
<b>Type of flight</b>

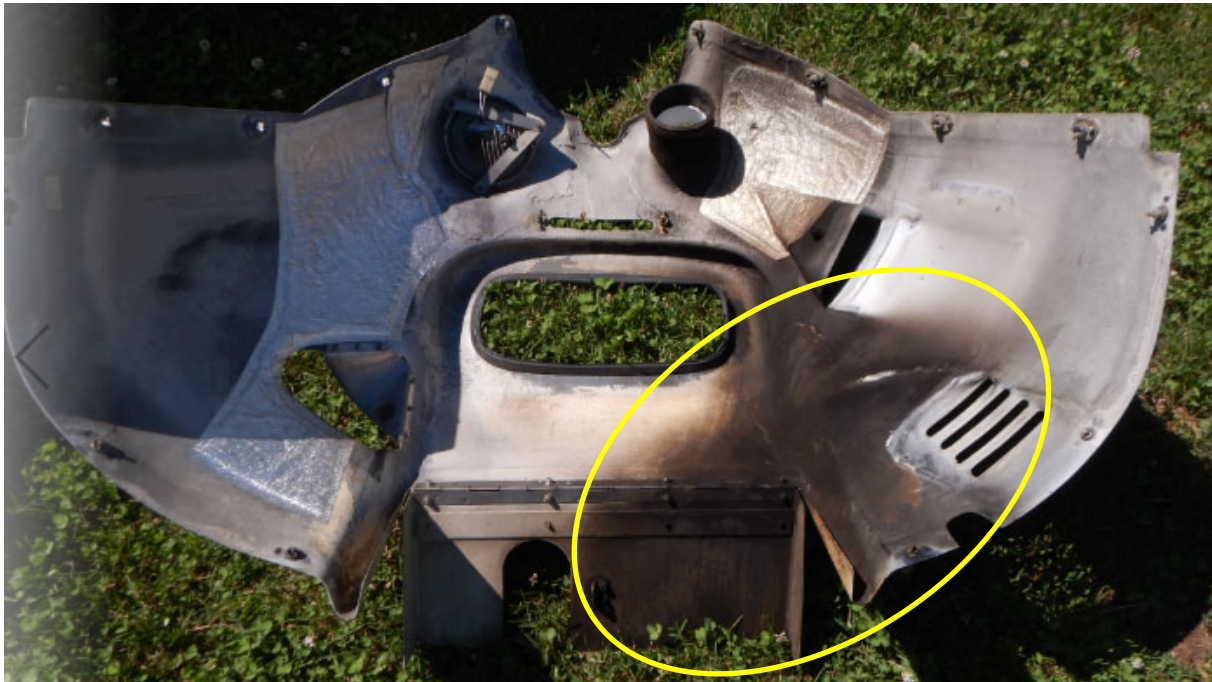
Immediately after landing, black oil was seen dripping from the exhaust pipe, while the oil tank with a maximum content of 3 liters was practically empty. Oily soot was visible in the lower right corner of the engine compartment, in the region of the hot section of the Turbocharger (see Figure 1).

**Figure 1:** Front engine cowling after removal with evident oily soot deposit on the lower right part, in the region of the hot section of the turbocharger (yellow ellipse)

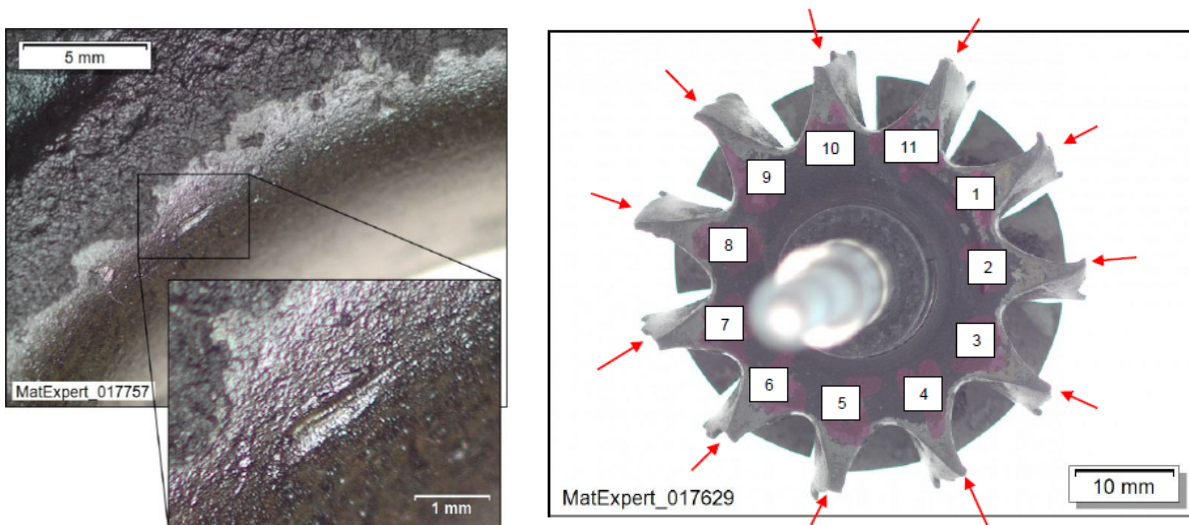
Subsequent inspection, in particular of the turbocharger, revealed significant foreign object damage (FOD) on the impeller on the exhaust side. All impeller vanes were damaged, as well as the impeller housing (see Figure 2). The metallographic analysis showed that the FOD had persisted for an undetermined period of time, but in any case, had not occurred only immediately before the serious failure.

**Figure 2:** The left image shows FOD on the crankcase, the right image shows all 11 vanes also damaged at their outer ends

The turbocharger impeller and crankcase showed clear signs of FOD. In the light of the finding of the exhaust gas temperature probe broken further upstream in the exhaust manifold, it is probable that fragments of the probe, thrown by the exhaust gas flow against the blades of the impeller, was the cause of the damage to the impeller and the crankcase.

The damage certainly caused a significant imbalance in the impeller, resulting in a suboptimal rotation of the impeller, which caused abrasion of material typically used in the construction of bushings and found inside the oil. A further undesired effect could be identified in the increase of the operating temperature of the turbocharger due to friction.

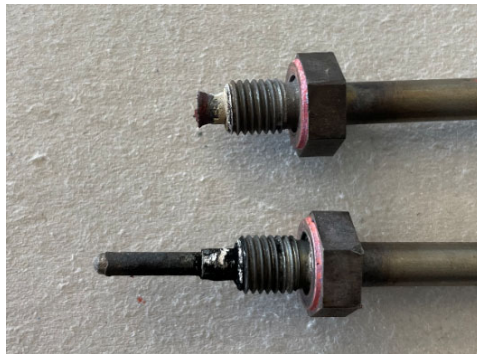
During a subsequent inspection a broken exhaust gas temperature sensor (see Figure 3) was discovered, located upstream of the turbocharger impeller inside the exhaust manifold.

**Figure 3:** Exhaust gas temperature probe. The missing part of the damaged probe (above) is highlighted by comparing the damaged probe to an undamaged probe (below).

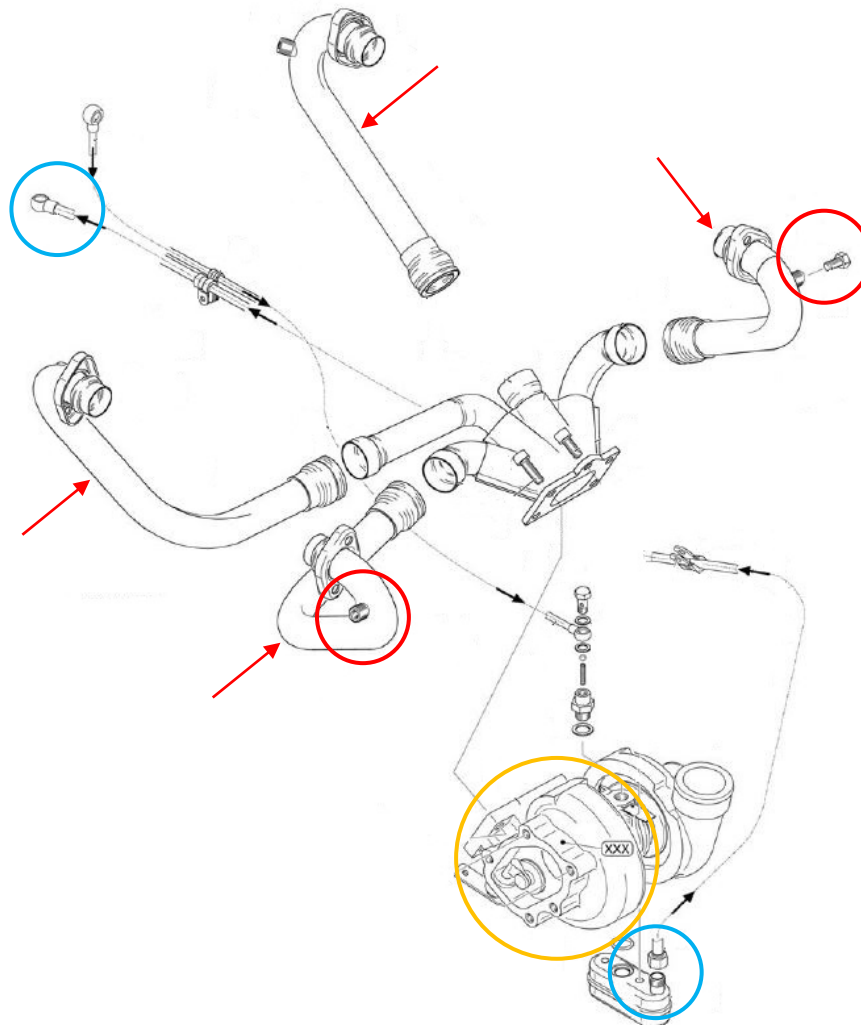
In addition, in the turbocharger oil return line and in the turbocharger oil sump there were significant accumulations of carbonized material, which prevented the oil pump from sucking in the lubricant and returning it to the reservoir (see Figure 4).

**Figure 4:** Exhaust manifolds (red arrows), exhaust gas temperature probes (red circles), return oil line from the turbocharger and the relative pipe header (blue circles). The hot part of the turbocharger is circled in orange. Source: illustrated catalogue of the parts of the BRP Rotax 914 F4 engine, edited by STSB

The unbalanced rotation of the impeller most likely allowed the very hot exhaust gases to come into contact with the lubricating oil, creating charred residue that clogged the oil return pipe between the turbocharger and the oil pump. Once this pipe was completely clogged, the delivery pressure of the "fresh" oil found no other way to discharge than to force the lubricant into the impeller from the exhaust gas side, causing the typical white trail caused by unburned and vaporized oil.

The oil leakage was caused by the clogging of the oil return line from the turbocharger as a result of the creation of carbonization residue generated by contact from the hot exhaust gases that entered the oil circuit through the seal, which in turn was damaged by the unbalanced rotation of the turbocharger impeller, which had most probably previously been struck by a fragment of the exhaust gas temperature probe.
