A1. Factual information

A1.12 Information on the wreckage, impact and accident site

A1.12.3 Technical findings on the wreckage

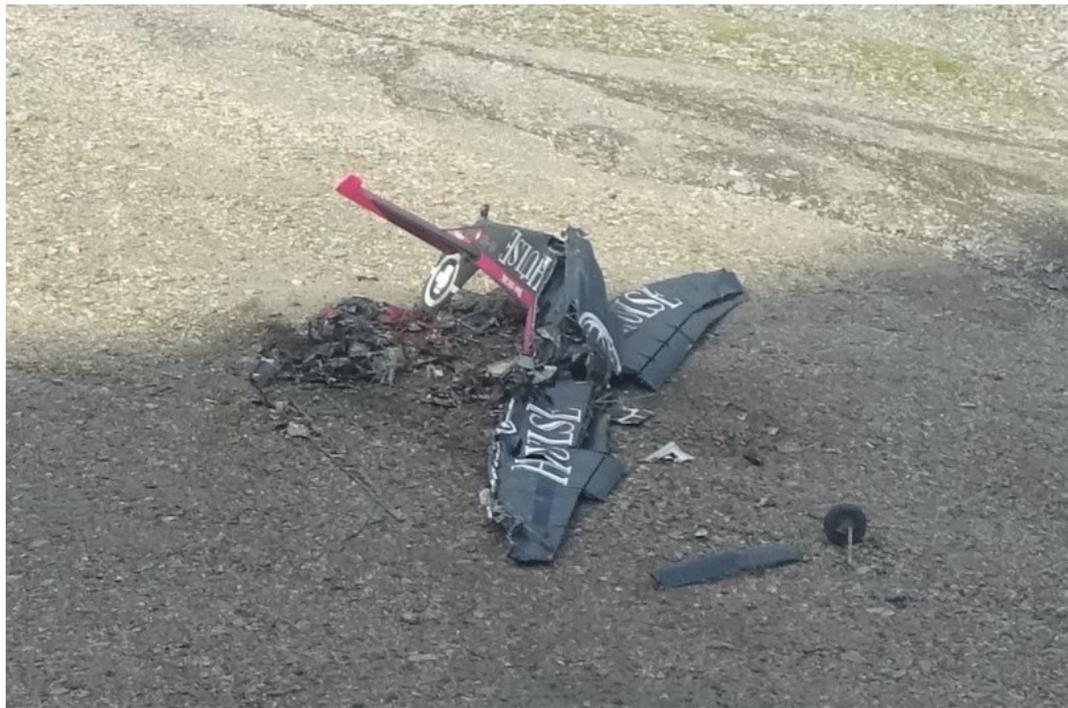
Figure 1: Final position of the wreckage. Looking east towards the scene of the accident.

All evidence at the scene of the accident indicates that the aircraft hit the ground in a vertical flight attitude with an almost vertical flight path. These findings were confirmed by video footage.

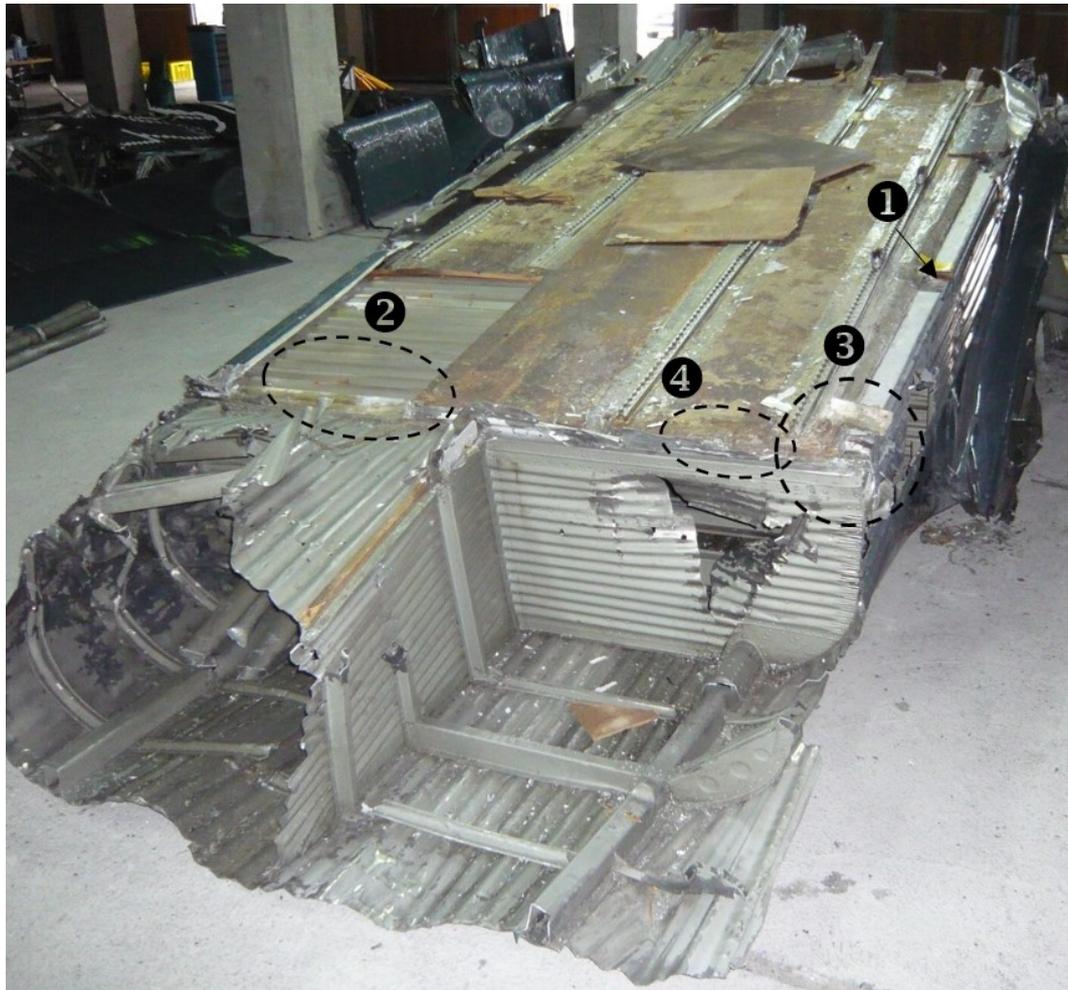
Important structural parts had become corroded, i.e. those made of steel had rusted and those made of aluminium had partially oxidised to powder. The corrosion found was particularly pronounced in the non-visible inner area of hollow sections, in areas of contact between two layers of sheet metal and under the wooden cabin floor (see figures 2 to 8). Several places on the structure of the fuselage exhibited areas that had been repaired using self-fabricated components.

Figure 2: Aft bottom fuselage including cabin floor – severely corroded hinges of the cargo door (1) and (3), as well as severely corroded fuselage structure (2), (3) and (4).

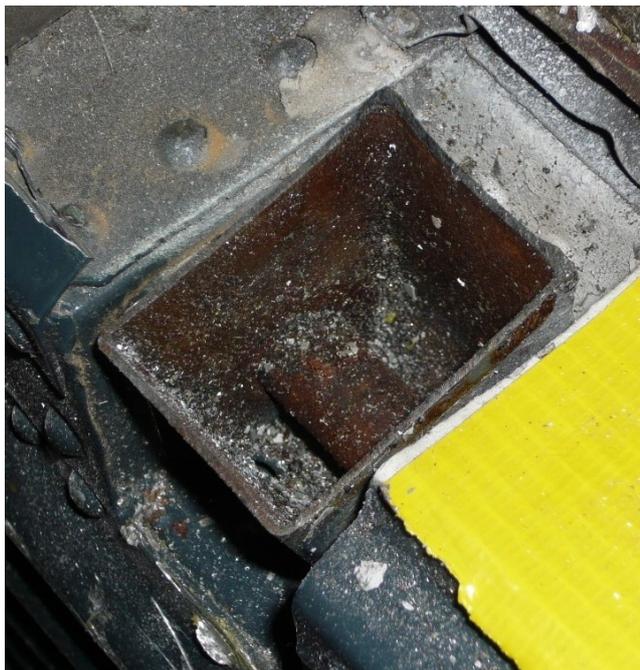
Figure 3: Close-up of figure 2 number (1) – severely corroded hinge of the cargo door on the right-hand side of the fuselage.

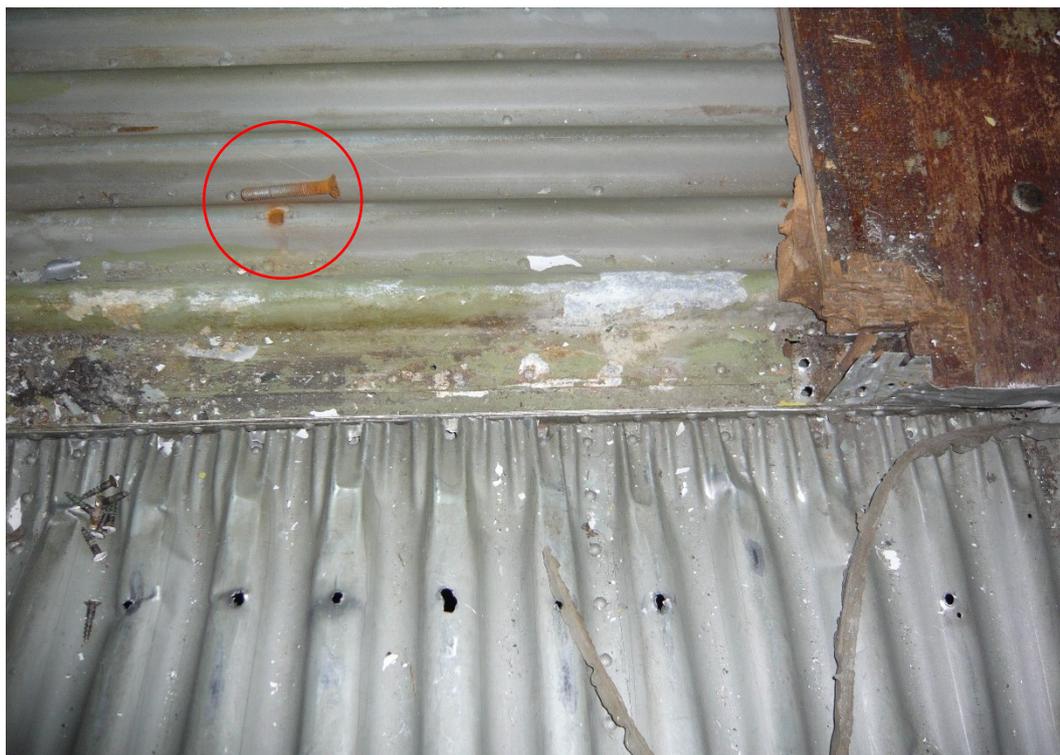
Figure 4: Close-up of figure 2 number (2) – severely corroded floor structure and bolts (red circle).

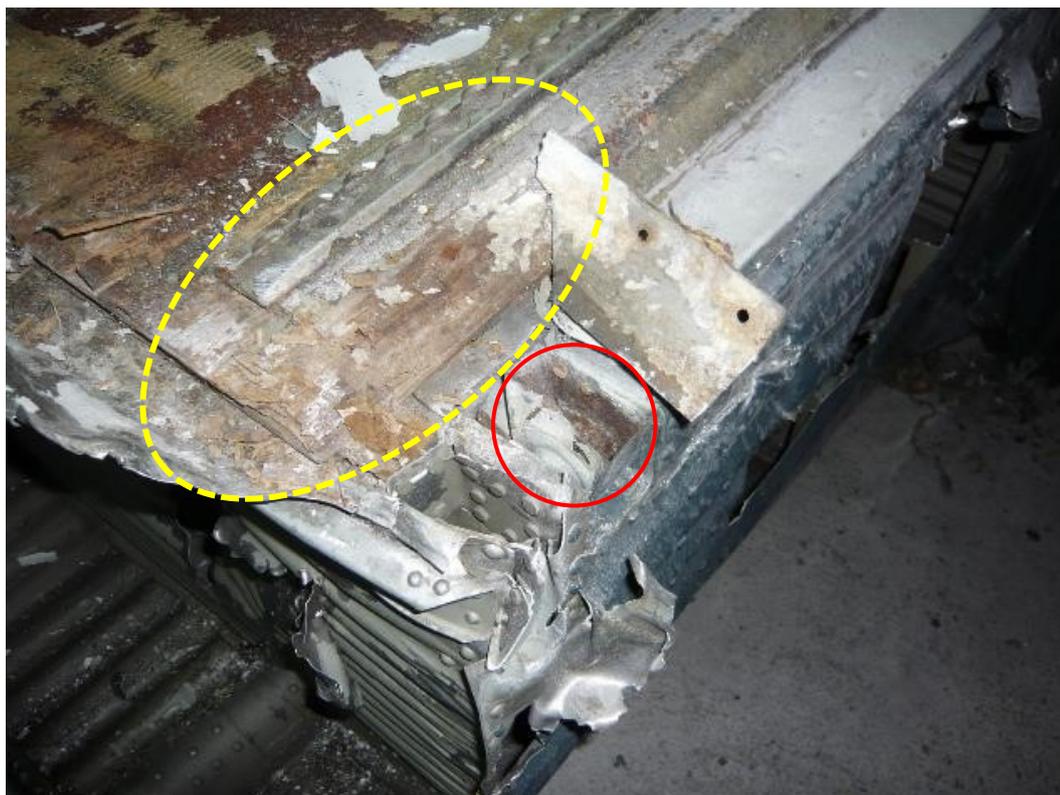
Figure 5: Close-up of figure 2 number (3) – rotten wooden floor (zone marked in yellow), severely corroded hinge of the cargo door (red circle) and severe corrosion on the fuselage structure (powdery, whitish patches of aluminium oxide).

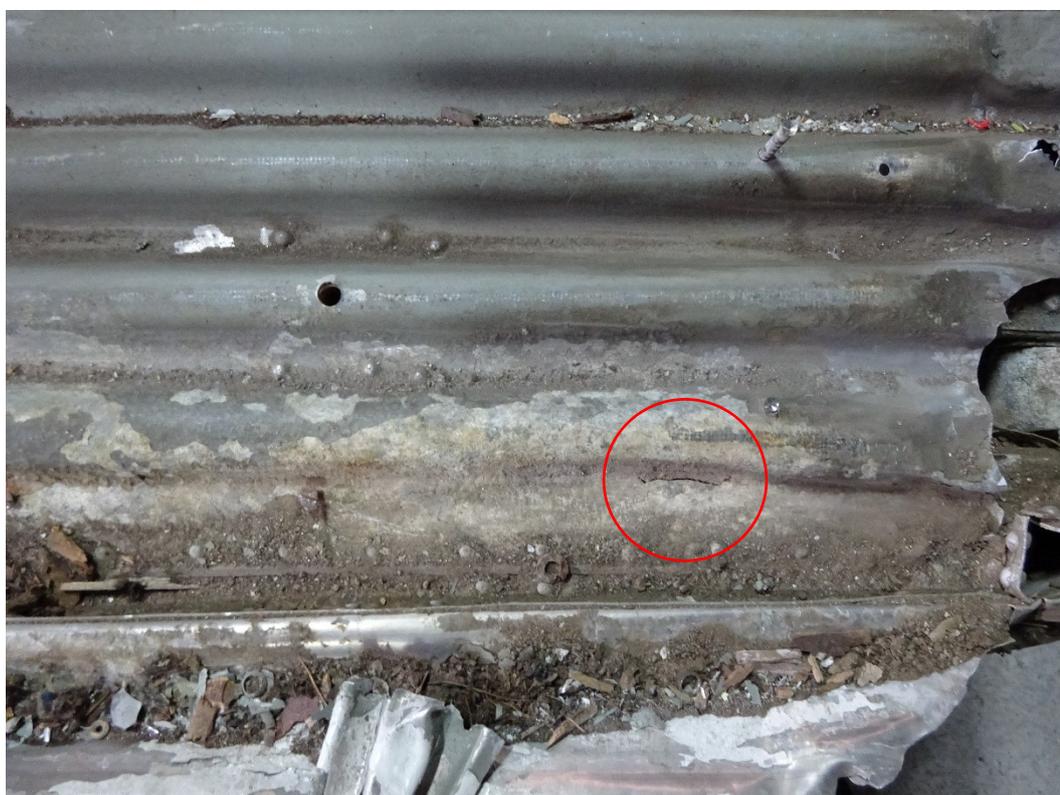
Figure 6: Close-up of figure 2 number (4) – severely corroded floor structure with fracture (red circle).

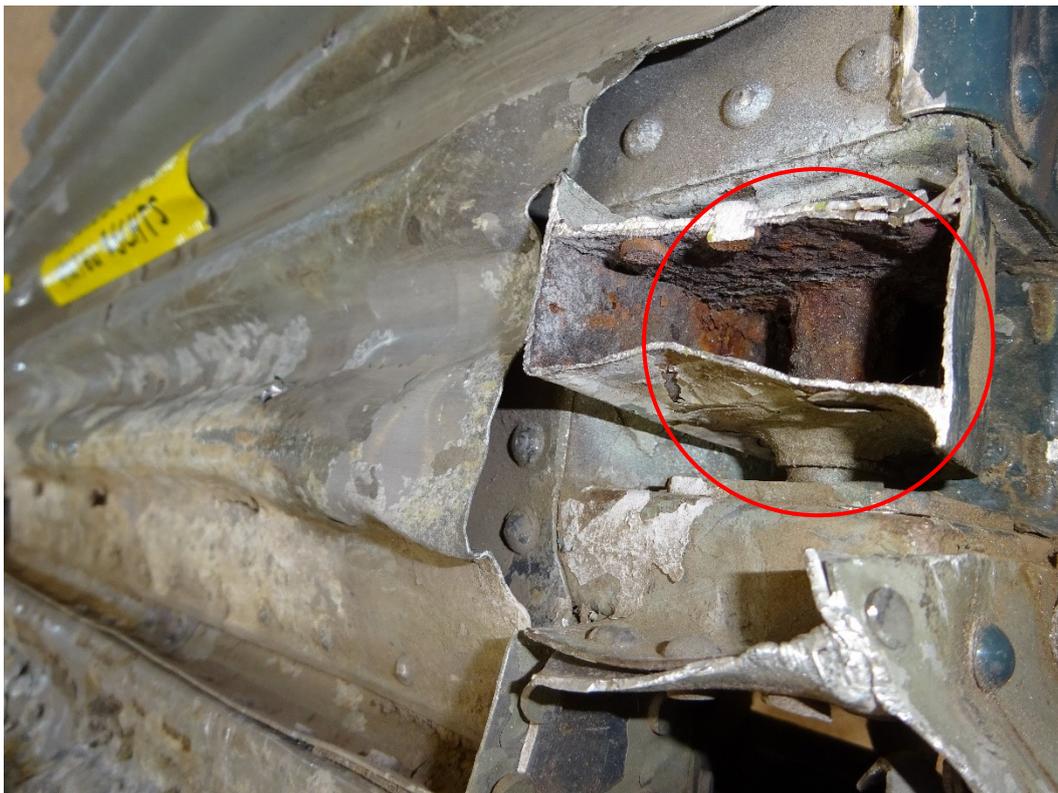
Figure 7: Close-up of figure 5 – severely corroded hinge of the cargo door (red circle).

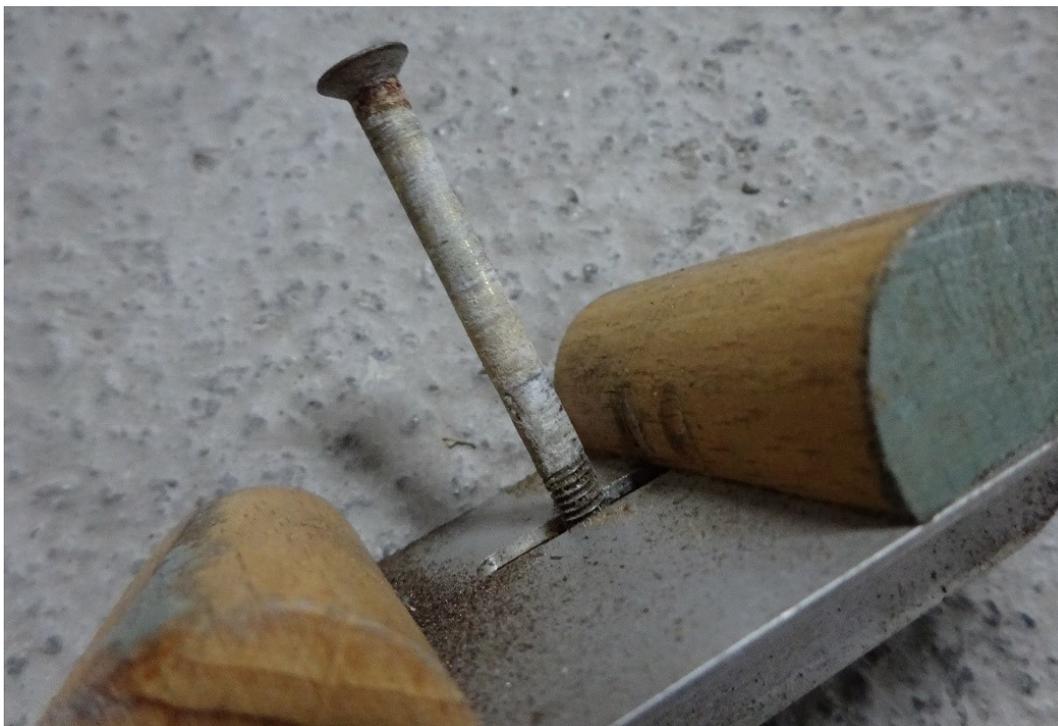
Figure 8: Severely corroded bolt for mounting a seat rail.

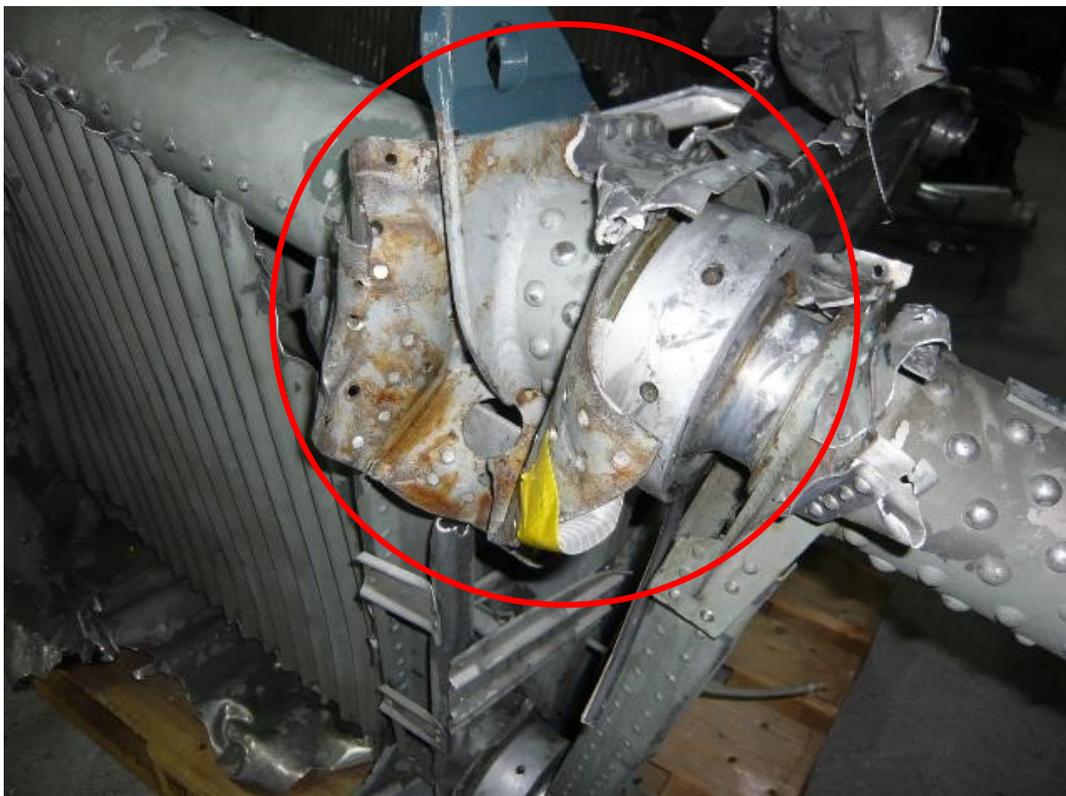
Some of the sheet steel joints and many of the steel rivets were rusty (see figures 9 and 10).

Figure 9: Corrosion over the entire area connecting the outer wing to the centre wing (red circle).

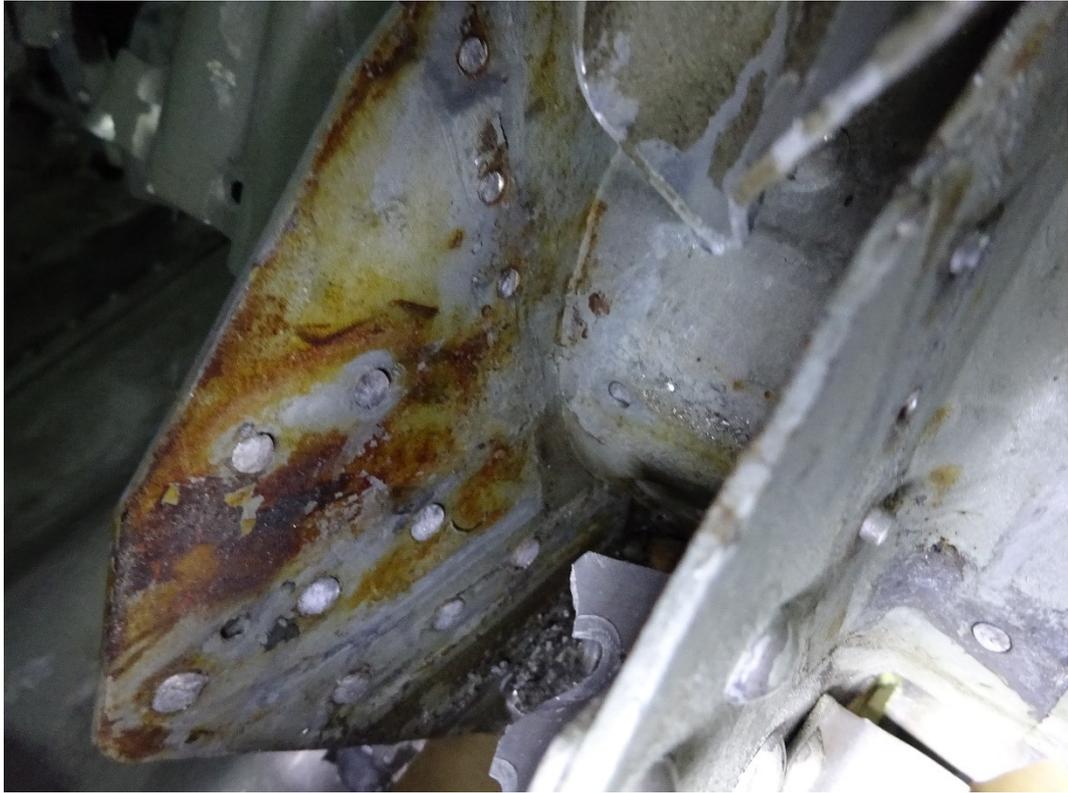
Figure 10: Corrosion in an area connecting the outer wing to the centre wing.

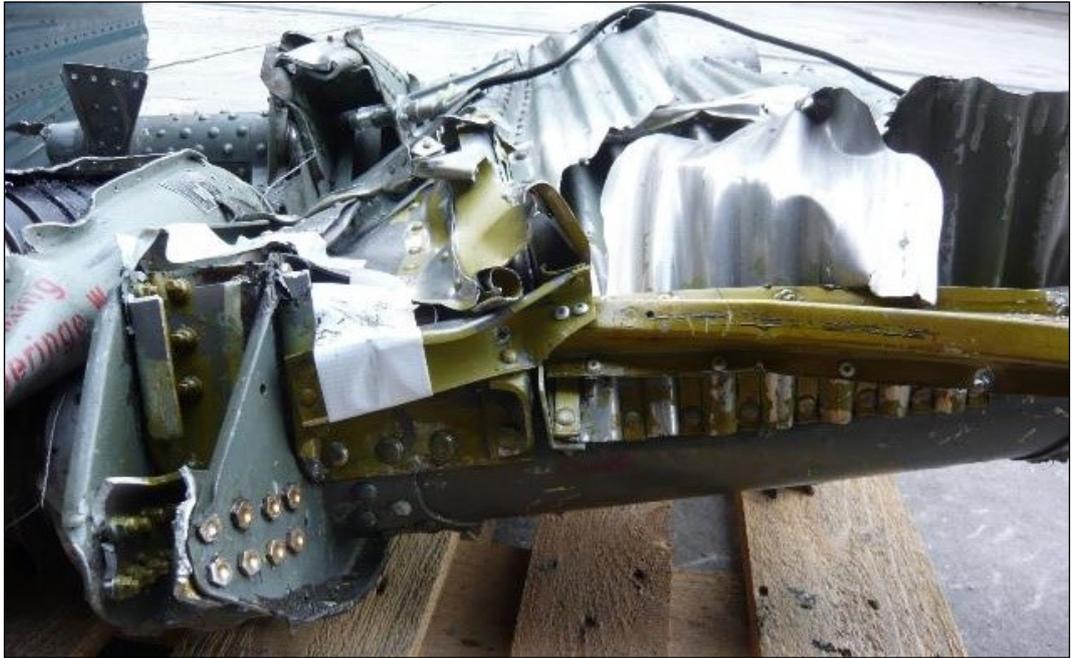
Components subjected to high loads and stress were found to have been repaired (see figure 11). This included sheet aluminium parts that had been attached using blind rivets and sheet-metal screws.

Figure 11: Repairs carried out in the centre wing, apparent by the greenish-yellow structural parts and the golden yellow connecting elements.

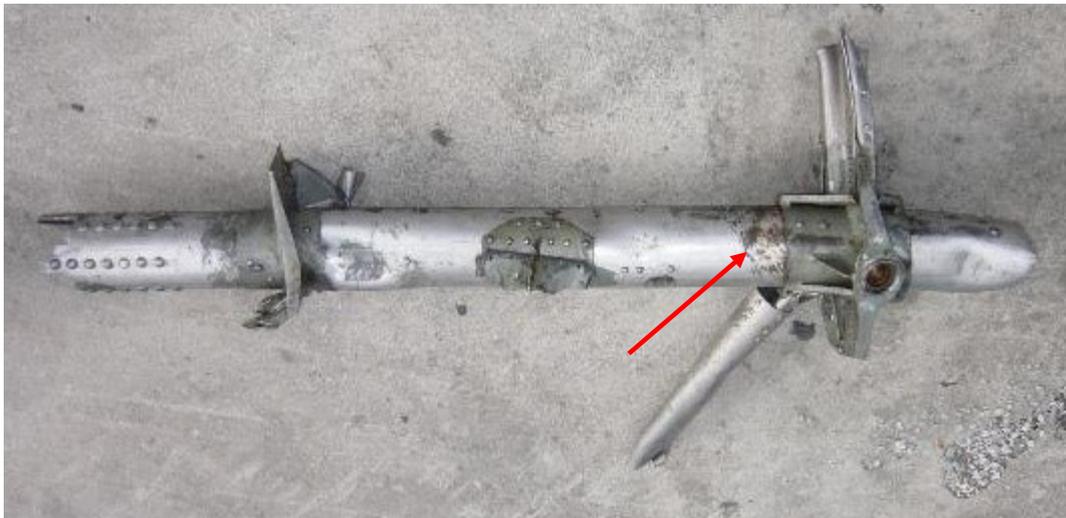
An area featuring fractures was found near the engine frame on the lower spar tube of spar I on the left outer wing (see figures 12 and 13). These fractures were examined from a metallurgical point of view (see annex [A1.16](#)).

Figure 12: Lower spar tube of spar I on the left outer wing. The arrow points to the area of the spar tube with fractures. The outer diameter of the spar tube is 90 mm.

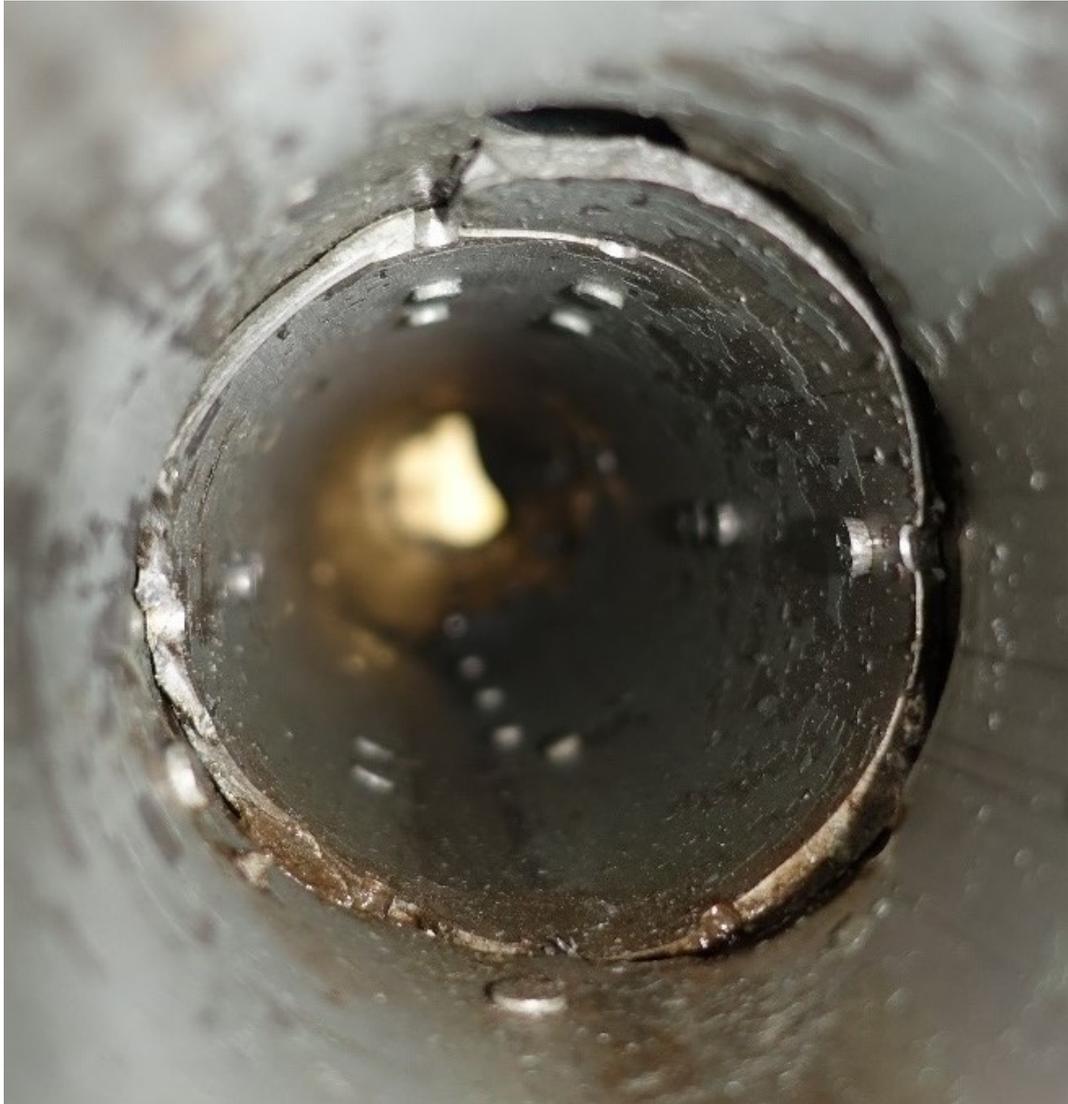
Figure 13: Close-up of the inside of the spar tube where fractures were found.

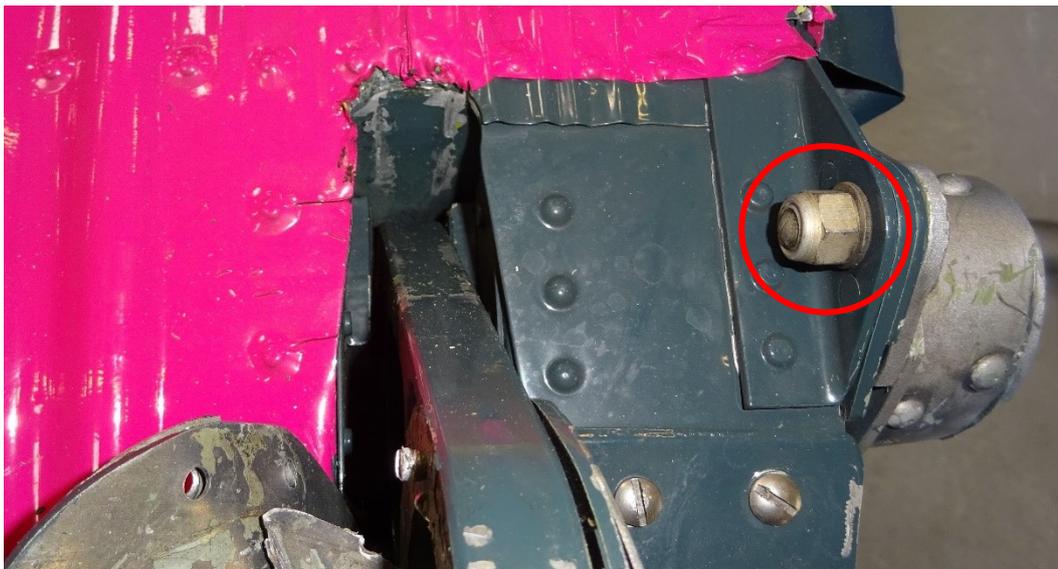
The connecting flanges of the elevator's actuating element were assembled using nuts, bolts and washers. Nylon locknuts had been fitted instead of castellated nuts with locking pins. The thread of the bolts was too short for the use of locknuts (see figure 14).

Figure 14: Right-side elevator with connecting flange of its actuating element, which was mounted using a nylon locknut on a thread that was too short for this purpose (red circle).

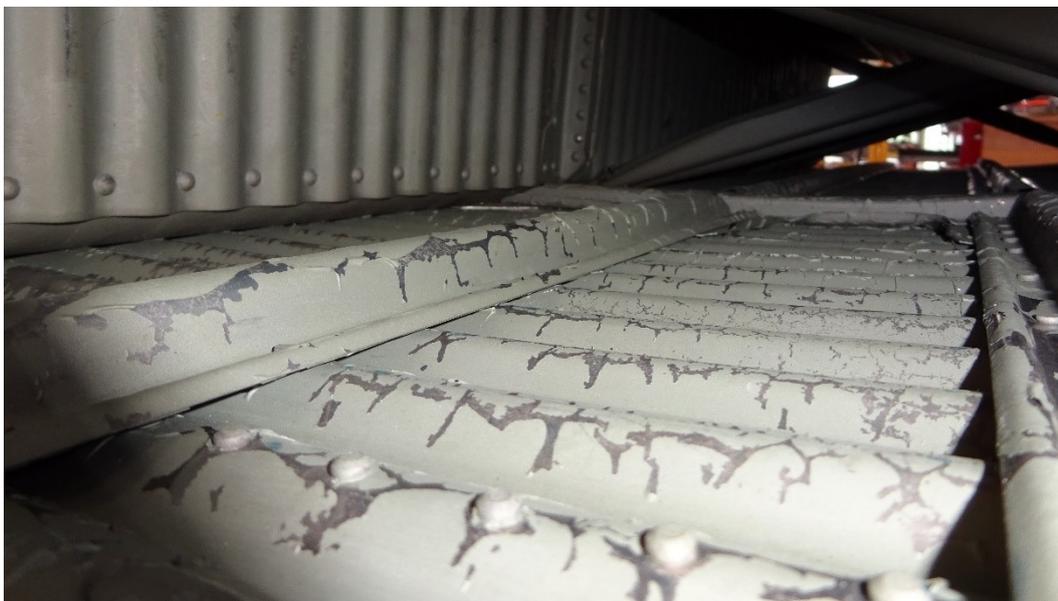
On the inside of the horizontal stabiliser, the anti-corrosion paint had partially flaked off (see figure 15).

Figure 15: Inside of the horizontal stabiliser – areas where the anti-corrosion paint had partially flaked off.

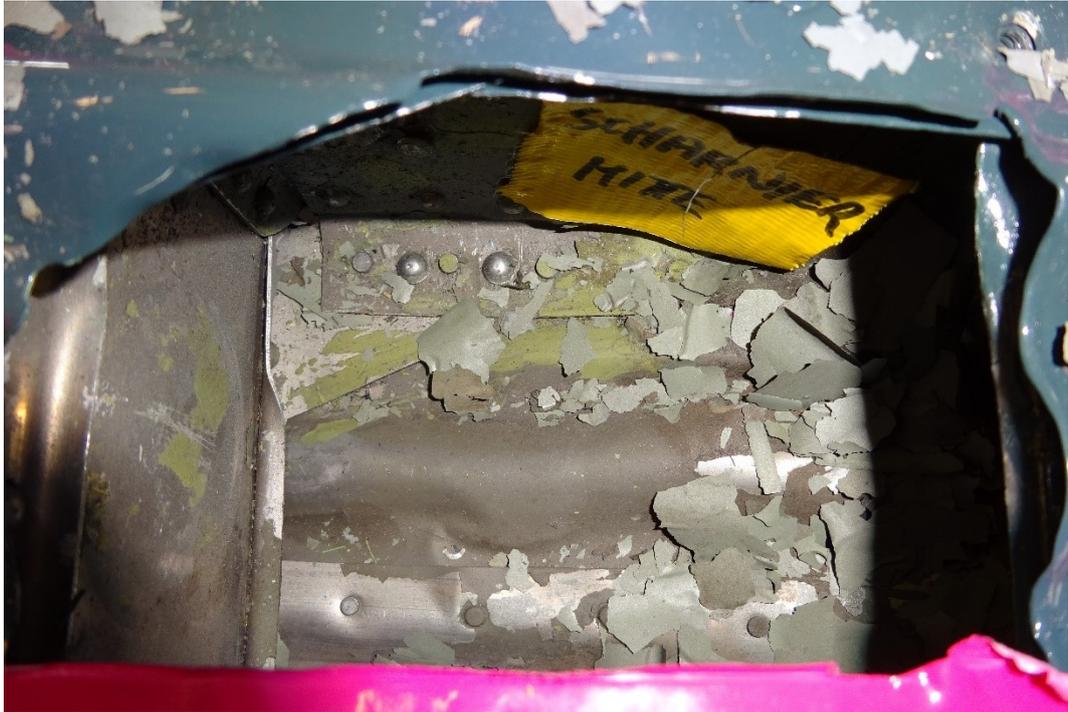
On the inside of the left elevator, the anti-corrosion paint had flaked off extensively (see figure 16).

Figure 16: Flaked off anti-corrosion paint on the inside of the left elevator.

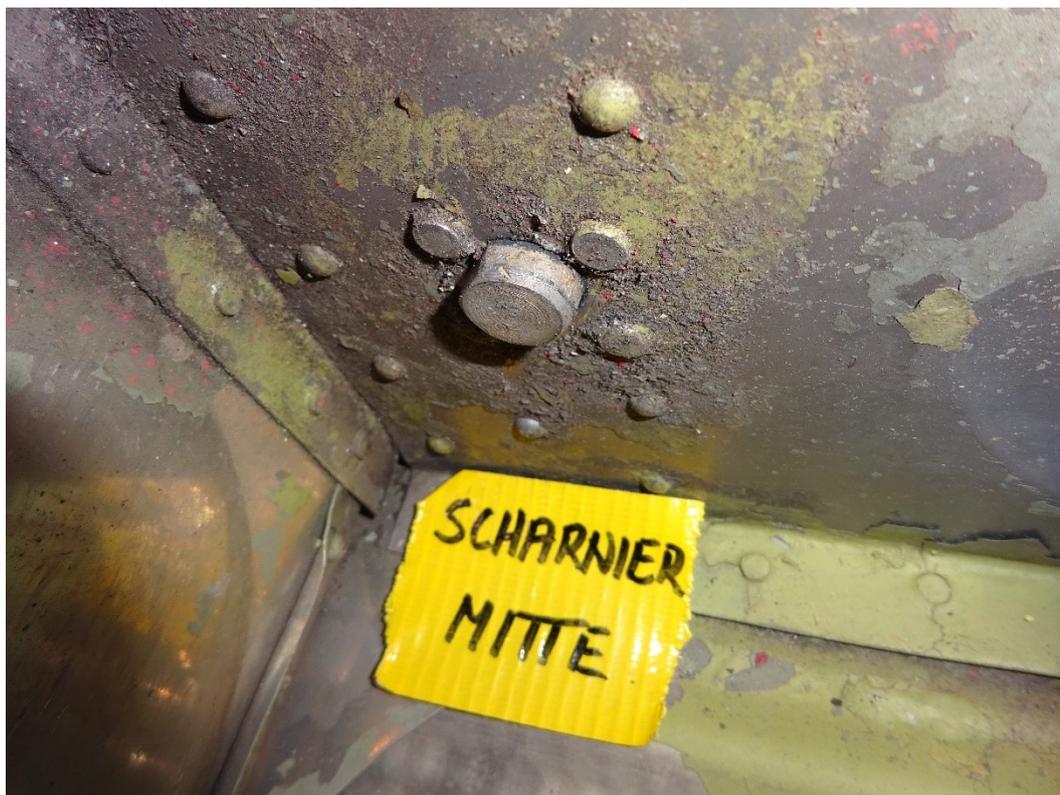
Inside the rudder and vertical stabiliser, the anti-corrosion paint had flaked off in many places and the sheet metal had become corroded (see figures 17 and 18). The bolts at the joints had been secured using nylon locknuts, but the bolt threads were too short to use this kind of nut. Moreover, they were not tightened properly and could be loosened by hand.

Figure 17: Inside of the rudder – head of the bolt for attaching the central hinge; lack of anti-corrosion paint; corrosion on sheet metal, rivets and bolt (label text reads central hinge).

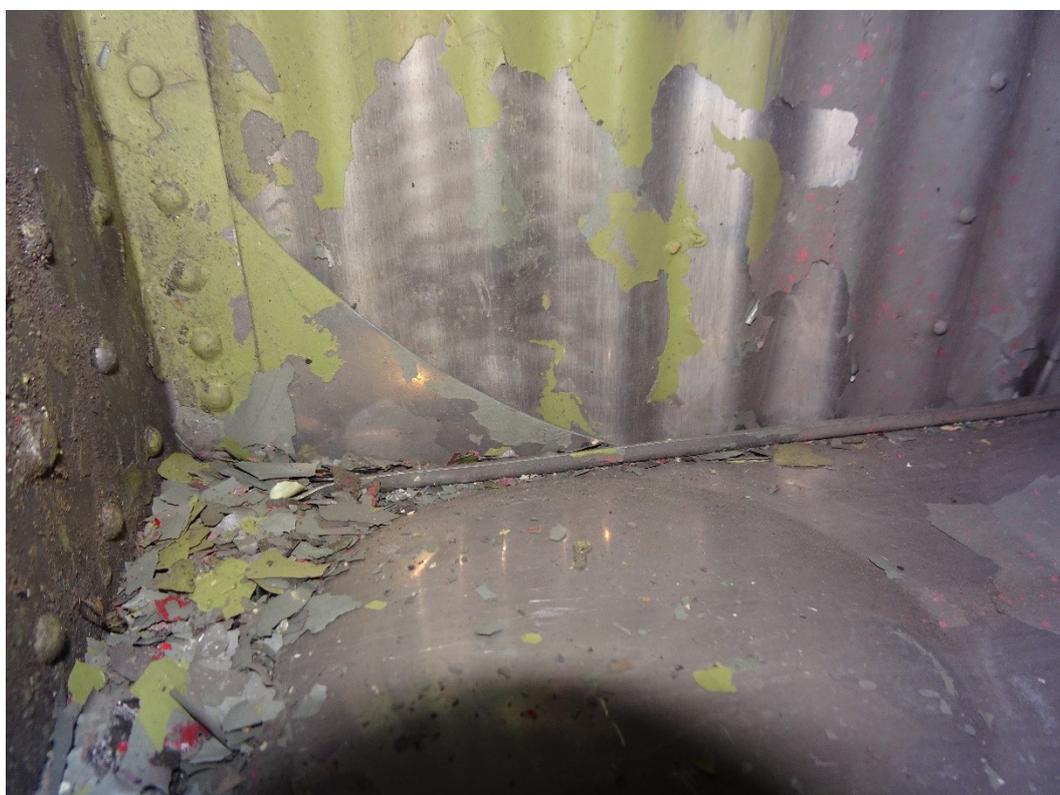
Figure 18: Flaked off anti-corrosion paint on the inside of the rudder.

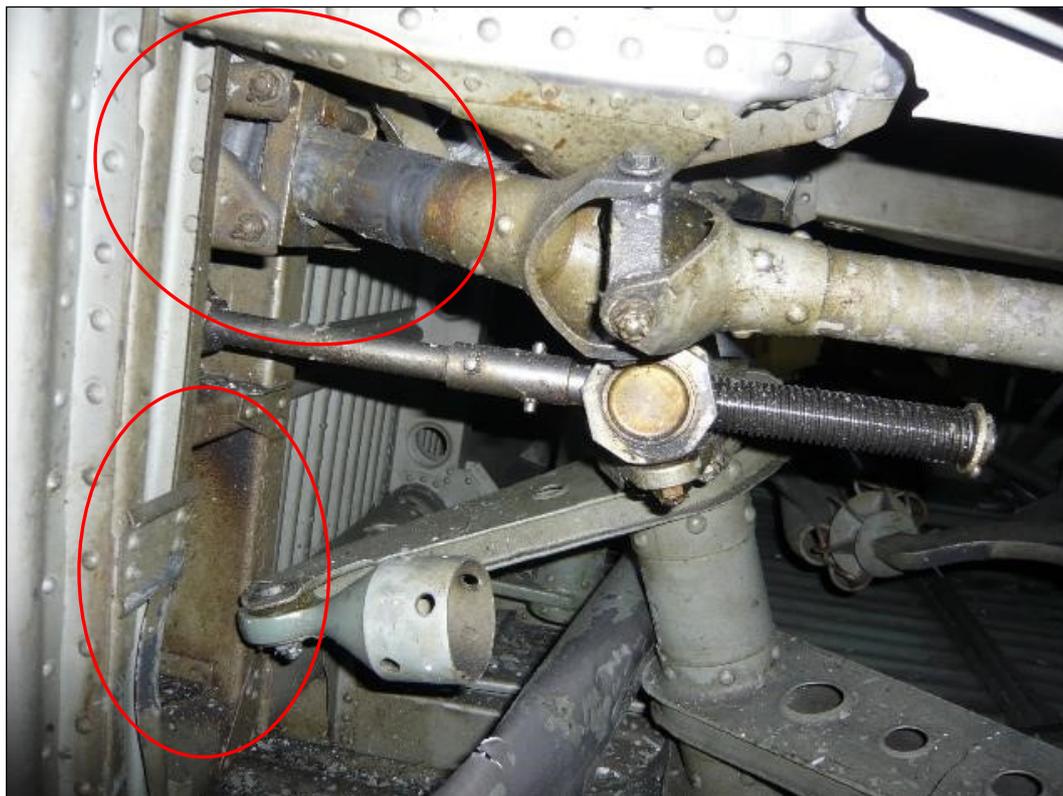
All examined connecting linkages used in controlling the aircraft were in working order but in poor condition. Many elements exhibited corrosion, and rivets were loose or missing. The protective coat of paint had flaked off almost all parts, and the corrosion protection was therefore insufficient (see figure 19). The control cables were old: their production method is consistent with the time when the aircraft was manufactured (see figure 20).

Figure 19: Corrosion (circled in red) in the centre wing and the control elements.

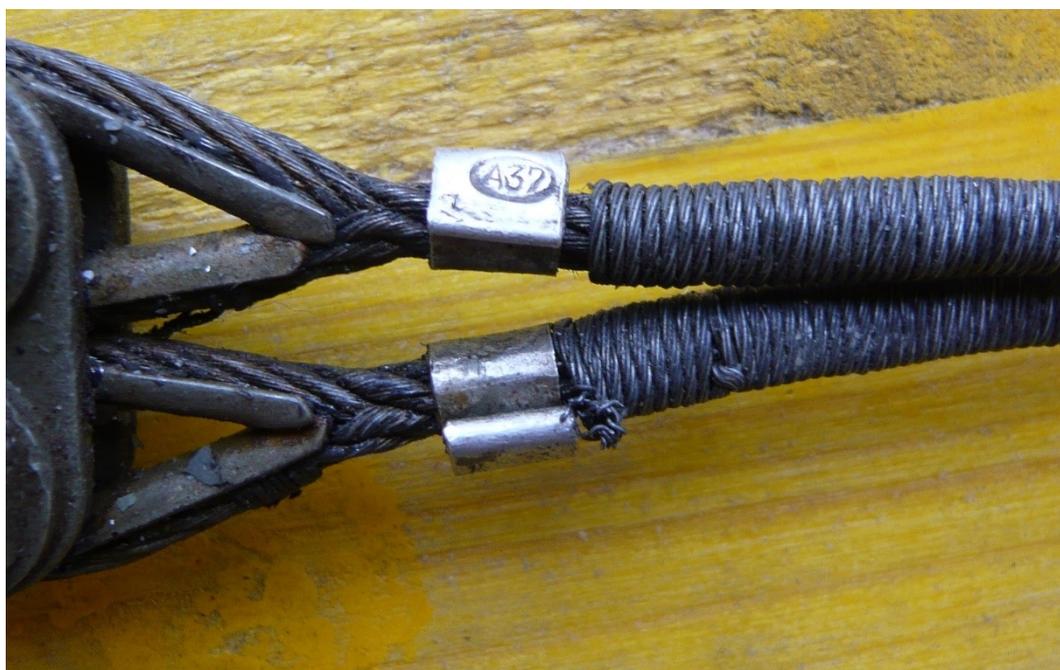
Figure 20: Old control cables, whose production method was consistent with the time when the aircraft was manufactured.

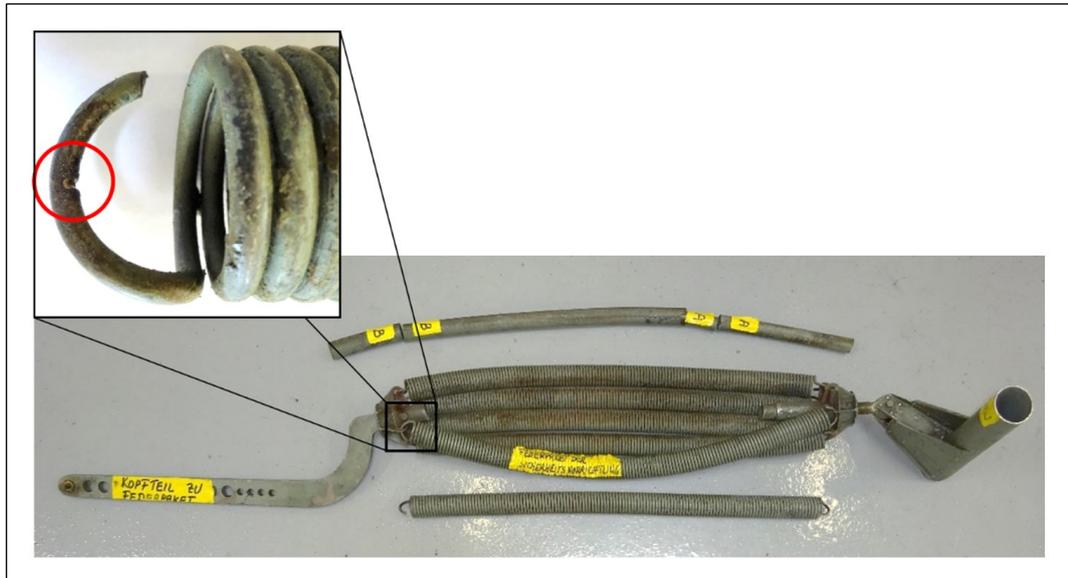
The hooks of the springs for the auxiliary-wing adjustment safety device were heavily worn and were at risk of breaking (see figure 21).

Figure 21: Spring assembly (auxiliary-wing adjustment safety device); spring hooks weakened by wear and tear.

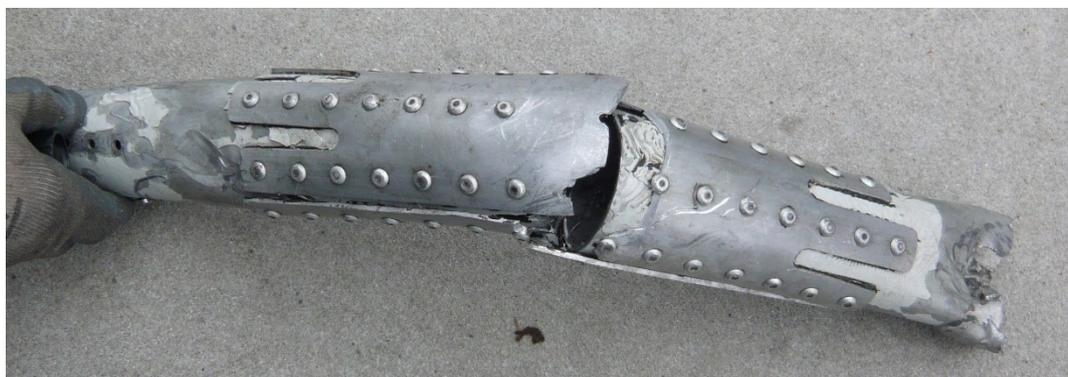
- The fractures as well as the type of plastic deformations were not consistent in all three of the engine mounts.
- The material thickness of the engine mount for the right engine was different to that of the other engine mounts.
- The surface structure of the three engine mounts was different.
- All three engine frames exhibited several areas that had been repaired (see figure 23).
- Parts of the engine frames were painted differently.

Figure 23: Tubular strut from the centre engine frame repaired with a doubler (see annex [A1.6](#)).

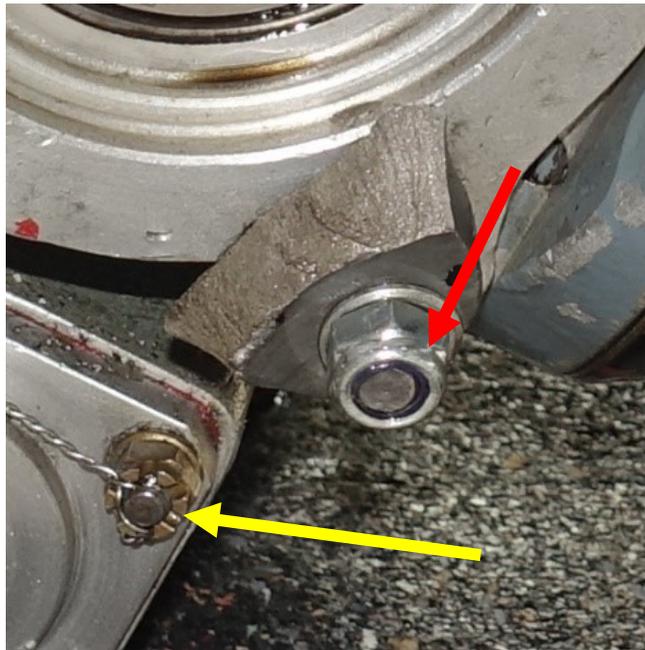
In several cases, nylon locknuts had been used (see figure 25) instead of the castellated nuts with locking-pin retention as per the aircraft's original design. Firstly, the bolt threads were too short to use this kind of nut as the thread does not engage sufficiently with the nylon insert. Secondly, the use of nylon locknuts is not permitted on engine parts that see an increase in temperature. For the castellated nuts fitted, wire had been used instead of locking pins. This method of securing the nut is not standard in the aviation industry.

Figure 25: Engine housing – a nylon locknut (red arrow) on a bolt with a thread that is too short, and a castellated nut secured by wire (yellow arrow).

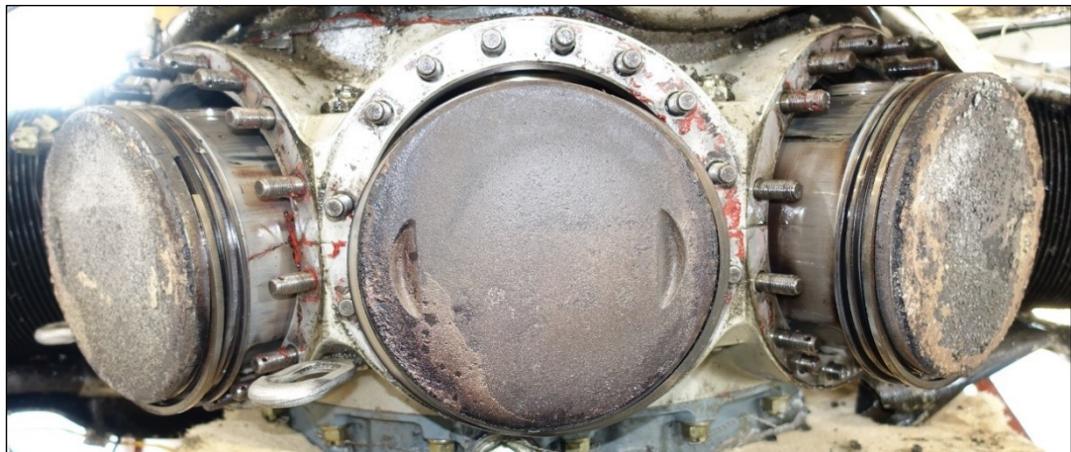
All three engines were dismantled and generally revealed a similar picture. Burn residue was prominent on the pistons and in the cylinders' combustion chambers (see figure 26).

Figure 26: Pistons in cylinder positions 1, 2 and 3 in the right engine.

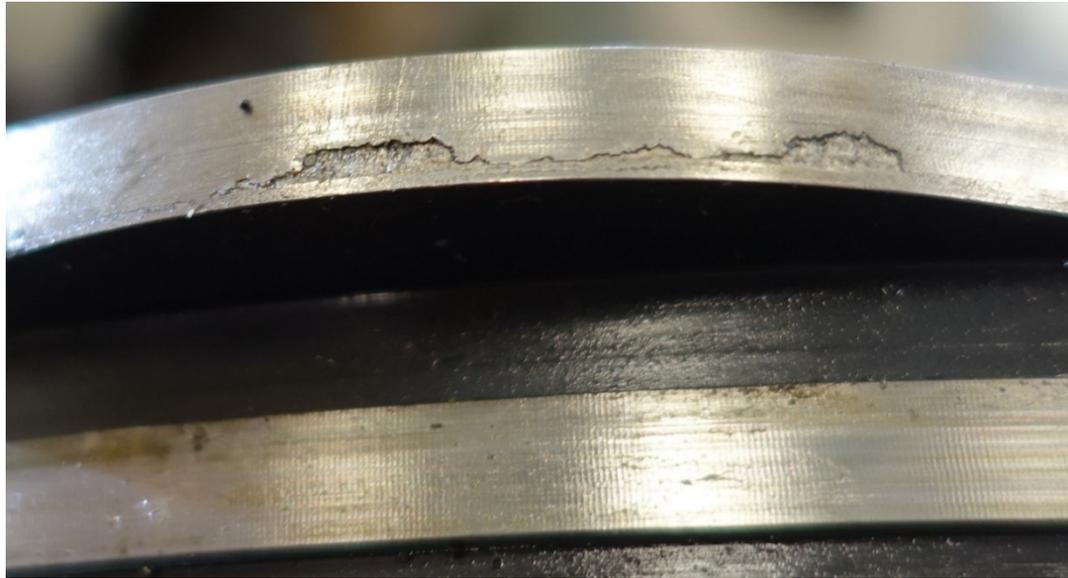
The cam discs are part of the cam drum. On the running surfaces of the cam discs from the centre and the right engines – which had been manufactured according to service bulletin no. 1028 by a company not certified to provide parts for use in aviation – clearly visible machining marks were found (see figure 27). The quality of the surfaces was poor. In several places, the running surfaces of the cam discs for the exhaust and intake valves had broken away.

Figure 27: Cam discs from the centre engine – the machining marks (regular, finely grooved surface) and the chipping on the upper running surface are clearly visible.

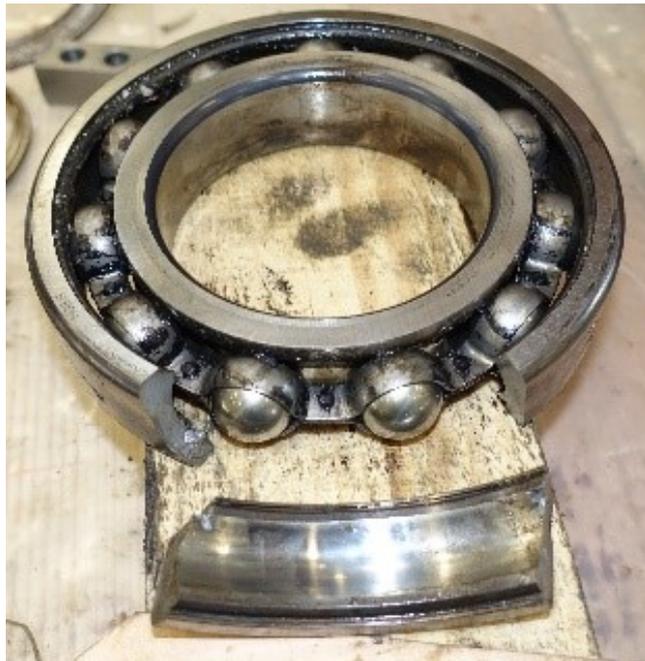
After dismantling the engines, the propeller bearings were visually inspected and were found to be worn and corroded. A crack was found on the outer race of the propeller bearing from the centre engine before disassembly. After disassembling the engine, it became apparent that the outer race was broken into two pieces (see figure 28). When comparing bearings from the left and the right engines, it was evident that the bearing used in the centre engine had eleven balls, but the ball bearings from the other two engines only had ten. All three bearings were subjected to metallurgical investigations (see annex [A1.16](#)). These investigations revealed that there was a high risk of failure for these bearings.

Figure 28: Broken outer race of the propeller bearing from the centre engine.

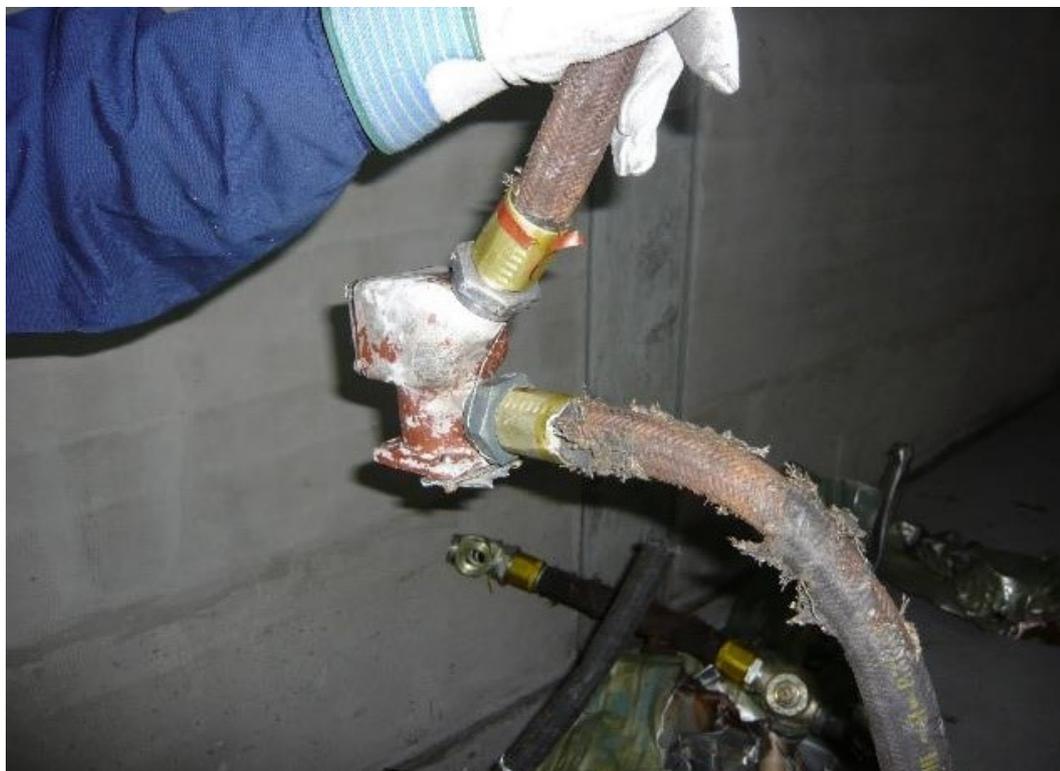
The fuel and oil lines were up to 30 years old and in some cases showed considerable signs of decay due to age (see figures 30 and 31).

Figure 30: Lines show obvious signs of decay due to age.

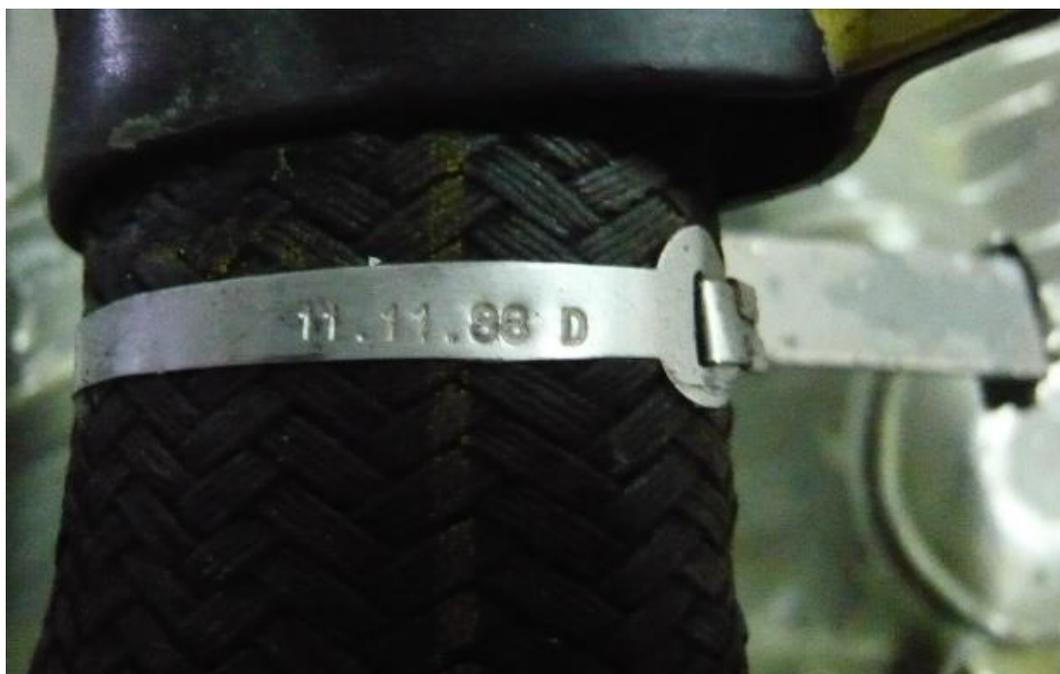
Figure 31: Hardened fuel line dated 11 November 1988.
