A1. Factual information

A1.17 Information on organisations and their management

A1.17.1 Association of the Friends of the Swiss Air Force (VFL) and Ju-Air

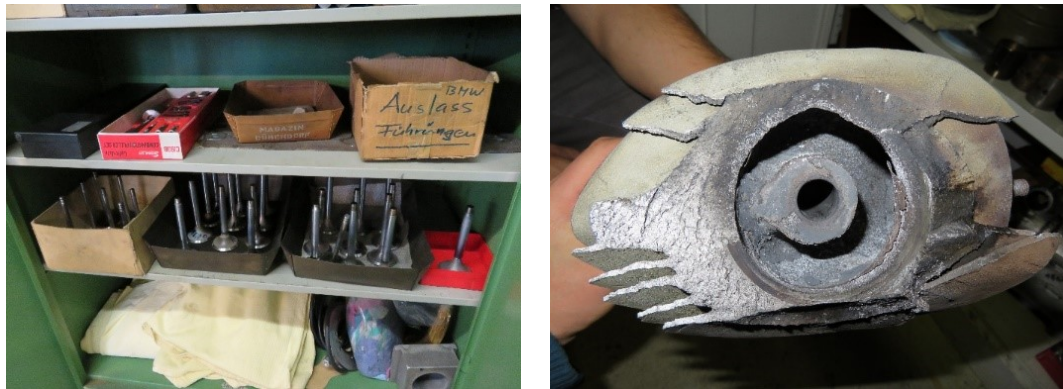
During FOCA audits of the two maintenance organisations over the past years, findings were made regarding the storage and tagging of components (see section A1.17.7.3).

The STSB also discovered after the accident that, at Ju-Air, the components stored in the hangar were neither marked with a tag nor with a release certificate for identification. Furthermore, the spare parts warehouse did not have identification papers for all components. In Naef Flugmotoren AG's engine workshop, there were engine components which were also unidentifiable (see figure 2).

Figure 2: Unidentifiable engine components stored in a cabinet.
