**A1. Factual information**

**A1.19 Useful or effective investigation techniques**

A1.19.1 Use of data memories from mobile phones and cameras

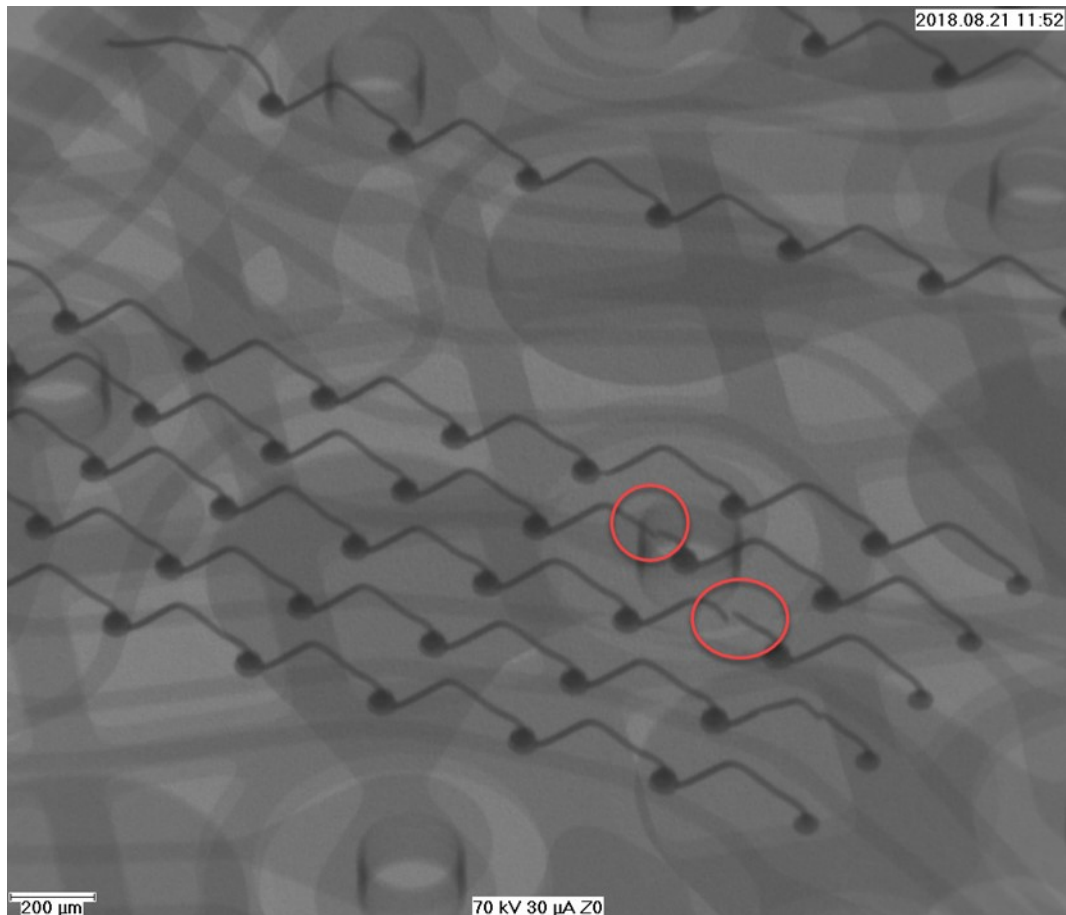
SD cards that could not be repaired using IT forensics were also analysed using a CT device. Their internal circuitry and the silicon blocks in the data storage units were assessed for damage (see figure 2).

**Figure 2:** Heavily magnified CT scan of an SD card. Damage to the circuitry within is circled in red. Source: BEA.

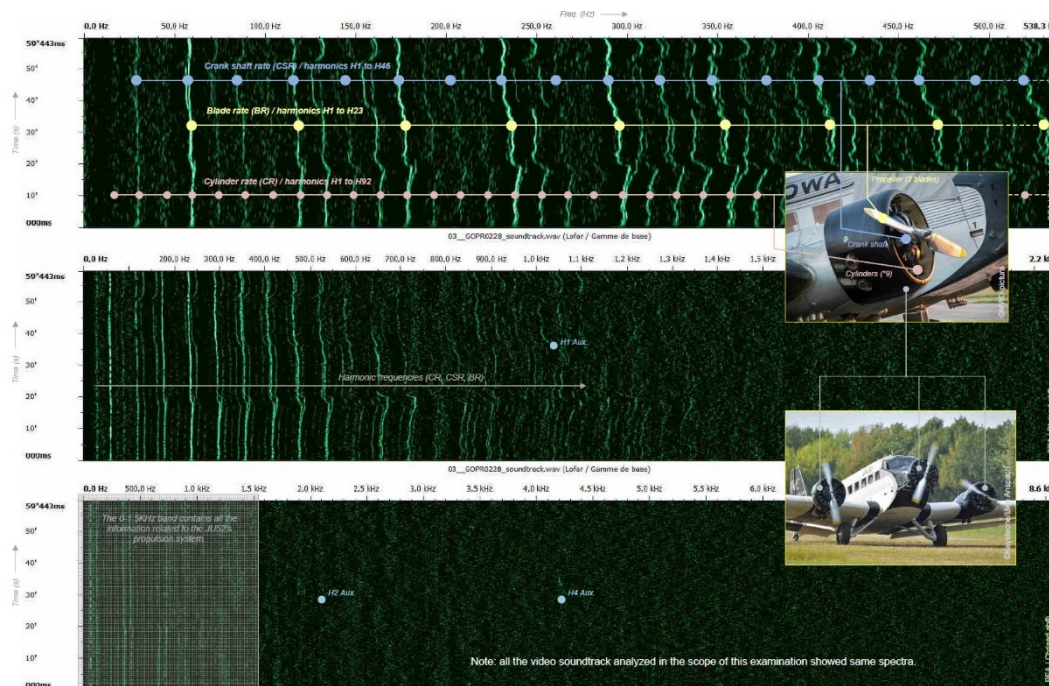
Generally, it was possible to identify each engine's crankshaft rate (CSR), blade rate (BR) of the propellers, and cylinder rate (CR) for all of their nine cylinders. As can be seen in figure 3, the most distinct noises were emitted by the propellers. As the aircraft featured directly driven fixed-pitch propellers, it was possible to determine the identical speed of the propeller and its corresponding engine at known times of the video recordings.

**Figure 3:** Example of a sonogram for a video recording from the cockpit of HB-HOT. The identified components CSR (blue), CR (pale red) and BR (yellow) are labelled. The images of the aircraft show the components. Here, the y-axis describes the time and the three x-axes describe the frequencies in three different amplifications. The harmonic frequencies of the main signal caused by interferences are also visible. Source: BEA.

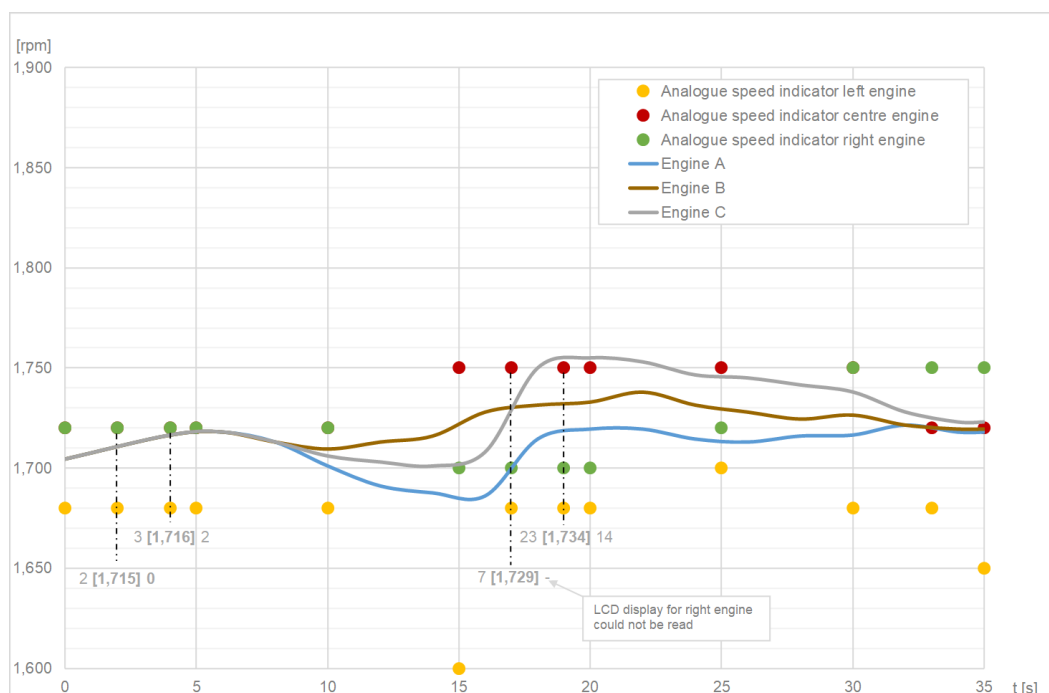
**Figure 5:** Graph of the engine speeds from HB-HOT over the course of the video footage recorded whilst flying past Mount Rigi on 3 August 2018.

In the first phase of the fly-by, the engine speeds were between 1,700 and 1,720 rpm. After 15 seconds, the speeds of engines A and C were increased by 20 to 30 rpm, now ranging between 1,720 and 1,750 rpm. The speed of engine A never exceeded 1,720 rpm.

The graph reveals that there are considerable discrepancies between the speeds determined from sonogram analysis and those read from the still images displayed in analogue form on the gauges. At 20 seconds, for example, the speed from the sonogram ranges between 1,720 and 1,750 rpm, whilst the values read from the analogue gauges range from 1,680 to 1,750 rpm.

At the 2-, 4-, 17- and 19-second marks in the video footage, it was also possible to read the three digital tachometers from the respective still images. This established that the four readings corresponded rather accurately to the respective sonogram analysis speeds.

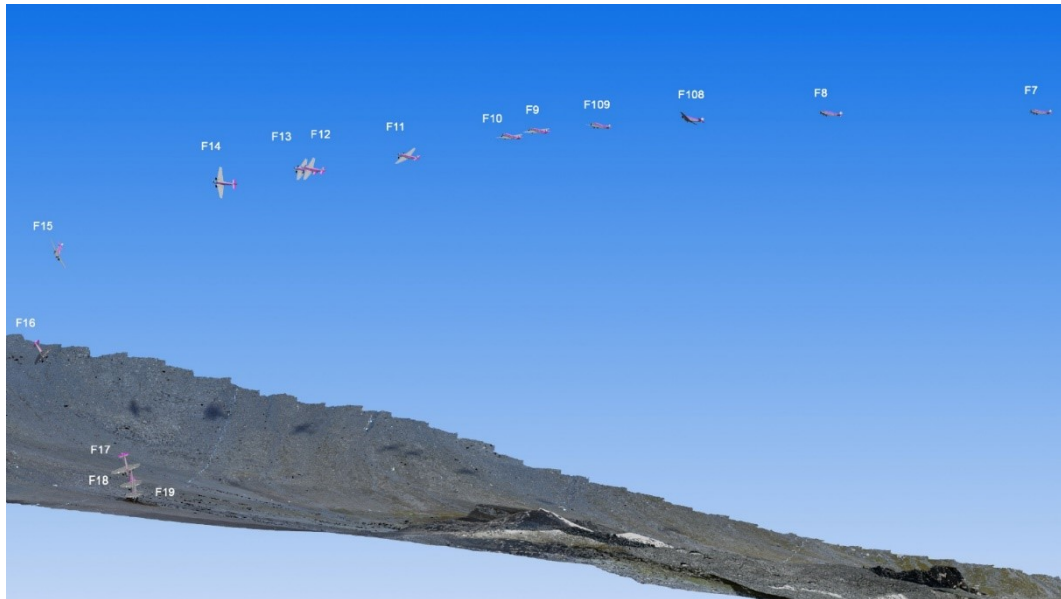
**Figure 7:** Photogrammetrically reconstructed positions and flight attitudes (F7 to F19) of HB-HOT in the last flight phase before the accident, depicted using the scan data of the terrain.
