# **Final Report No. 2370**

## **by the Swiss Transportation Safety Investigation Board STSB**

on the accident involving  
the Junkers Ju 52/3m g4e  
commercial aircraft, HB-HOT,

on 4 August 2018

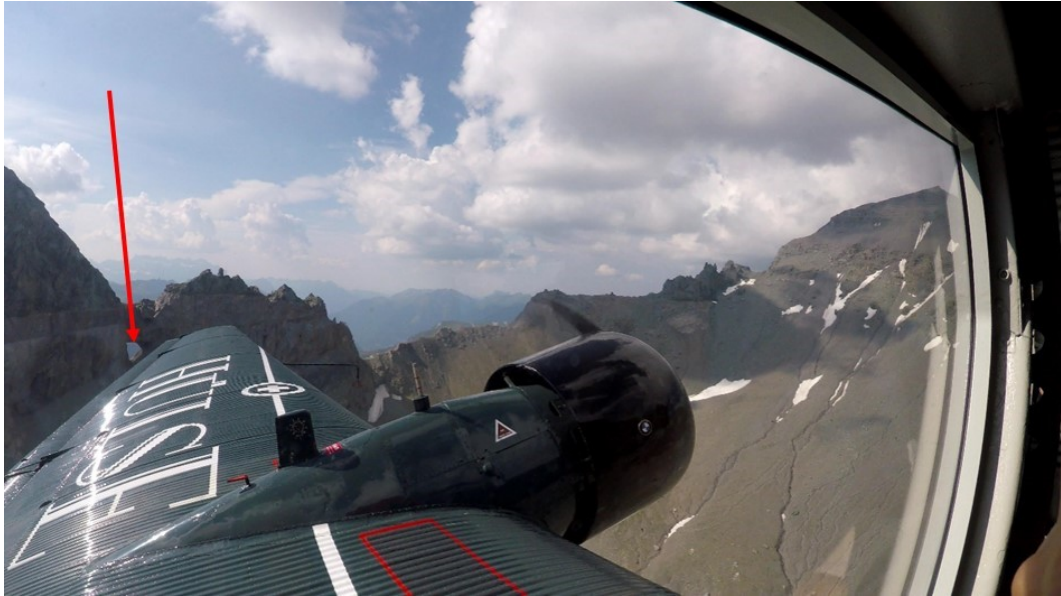
**Figure 3:** Still image from a video at point F10, recorded from the cabin of HB-HOT looking towards the Martinsloch (red arrow). The pitch attitude was 11.0 degrees, the left bank attitude 4.8 degrees and the altitude 2,749 m AMSL. The difference between the flight path angle and the pitch angle was 20.6 degrees.

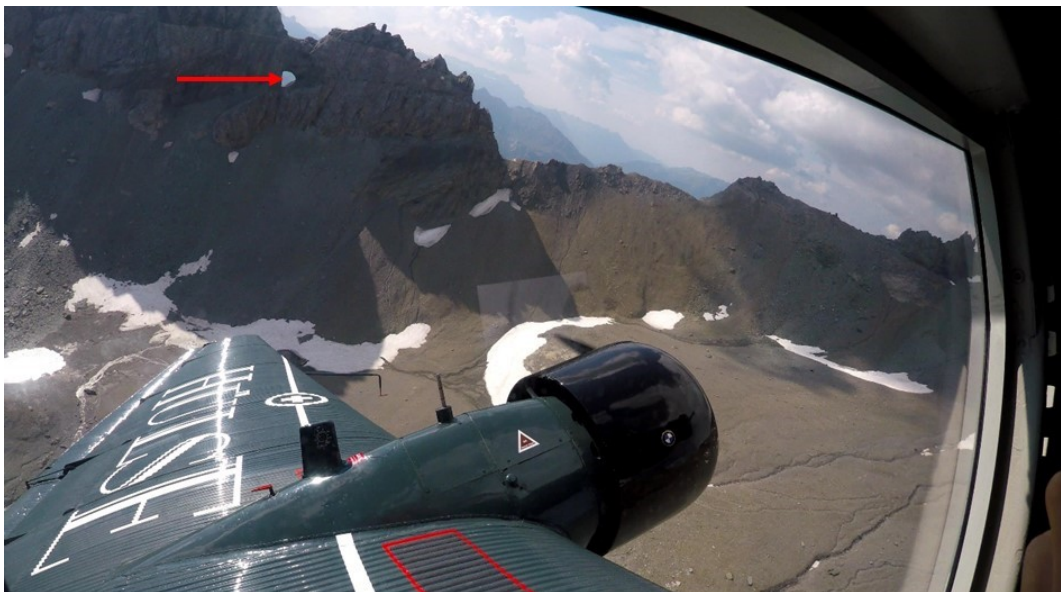
During roughly the next 4 seconds, the aircraft descended by 25 m and the already negative flight path angle became even more negative, which is clearly apparent when comparing figures 3 and 4 as well as in figure 5.

**Figure 4:** Still image from a video at point F13, recorded from the cabin of HB-HOT looking towards the Martinsloch (red arrow), 4.3 seconds after the image shown in figure 3 was taken. The pitch attitude was 12.1 degrees, the left bank attitude 32.7 degrees and the altitude 2,724 m AMSL.

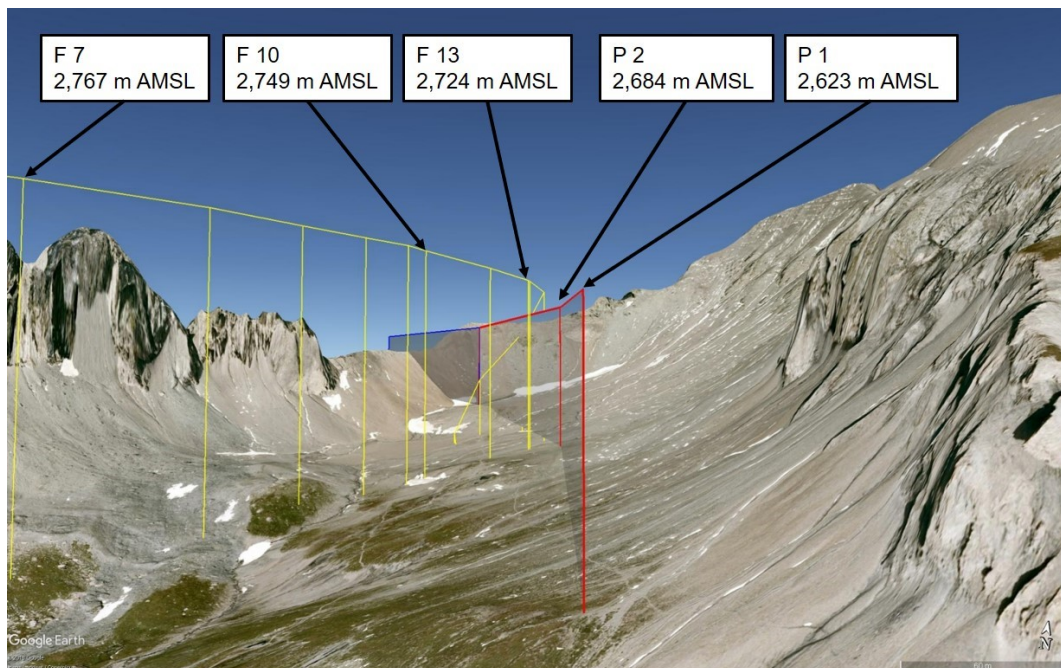
During a climb in sister aircraft HB-HOP on 6 July 2013, pilot B as commander, together with pilot A in the role of co-pilot at the time, entered the basin south-west of Piz Segnas in a similar manner to during the accident flight and flew over the ridge of the Segnes pass at approximately 30 m above ground (see figure 9).

**Figure 9:** Comparison between the reconstructed flight paths of 6 July 2013 (red, points labelled 'P'), including extension of the flight path (blue), and the accident flight on 4 August 2018 (yellow, points labelled 'F'); shown on Google Earth.

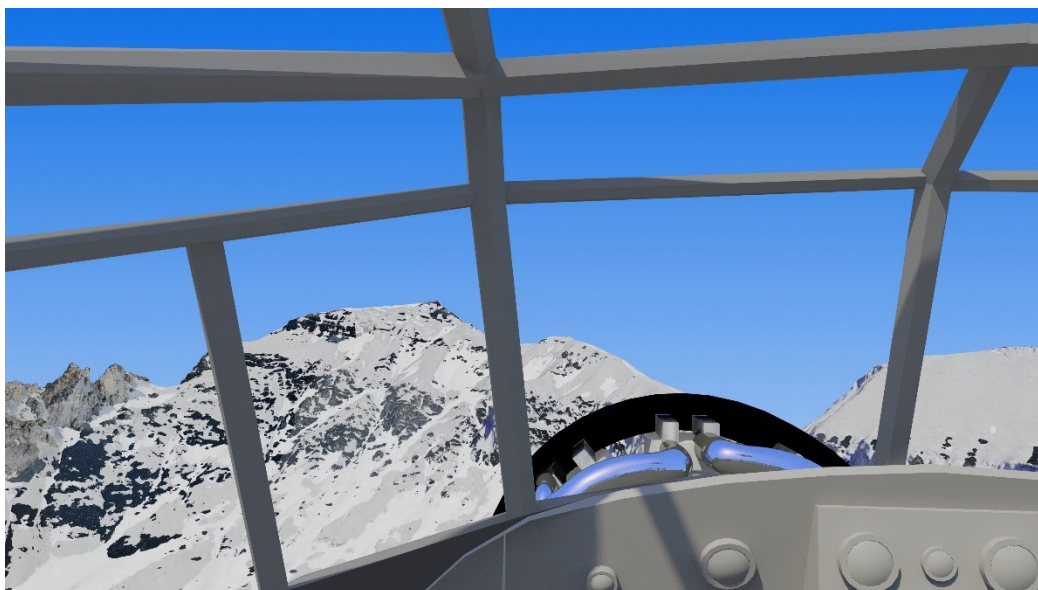
It is conceivable that due to their preoccupation with the engines and the view from the cockpit, which made it difficult to easily recognise the descent, the flight crew's increase in pitch attitude was made subconsciously in order to compensate for this (see figure 21). Furthermore, the fact that the centre of gravity was beyond the rear limit facilitated the process and made the aircraft more unstable around its pitch axis, which represents a factor that directly contributed to the accident.

**Figure 21:** Reconstructed view from the position of the commander of HB-HOT at point F9. Piz Segnas can be seen in the line of sight. Shown using a simplified model of the aircraft and the three-dimensional terrain model. The absence of visible reference points made it difficult to detect the descent caused by the downdraught.

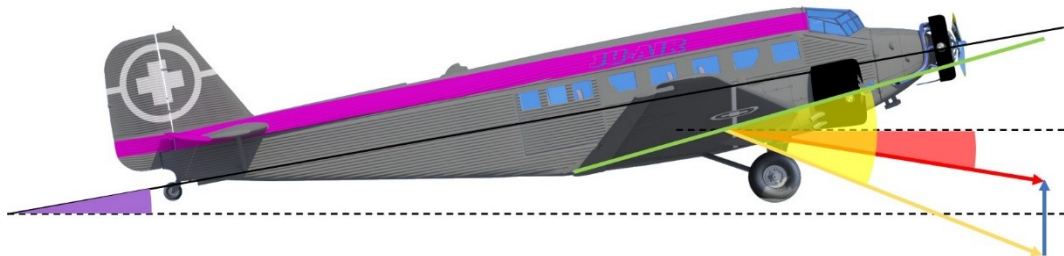
**Figure 23:** Entry into an area of updraught from an area of downdraught. The flight path vector (red) momentarily remains the same because of the inertia of the aircraft; Blue vector: updraught; Yellow vector: vector of movement for the aircraft in relation to the area of updraught. The angle of attack (yellow) increases considerably. Black line: longitudinal axis of the aircraft; Black dashed line: horizontal plane; Green line: chord line; Purple angle: pitch angle (angle between the horizontal plane and the aircraft's longitudinal axis); Red angle: flight path angle (angle between the horizontal plane and the flight path); Yellow angle: angle of attack (angle between the direction of airflow, which is the inverse of the vector of movement for the aircraft in relation to the area of updraught, and the chord line).

It is therefore also one of the fundamental principles of flying in mountainous areas that the airspeed, and thus the energy of the aircraft, must be increased during turbulent conditions and when in closer proximity to the terrain, so that wind shear does not cause a stall, even if it would usually only do so for a short time. It must be ensured that the aircraft is not overloaded by gusts or deflection of the control surfaces, so that the calculated manoeuvring speed lends itself to be the optimum speed. HB-HOT had a true airspeed of approximately 180 km/h during this phase (when it encountered wind shear) which was roughly 55 km/h or 44 % above the stall speed in the prevailing conditions. This level of speed reserve is too small for the turbulence that is common in the mountains.
