Summary Report

Aircraft	Dassault Aviation, Falcon 2000EX	HB-IAU		
Operator	Cat Aviation AG, P.O. Box 2223, 8060 Zurich Airport			
Owner	Private			
Commander	Swiss citizen, born in 1972			
Licence	Airline Transport Pilot Licence Aeroplane (ATPL(A)) according European Aviation Safety Agency (EASA), issued by the Federal office of civil aviation (FOCA)			
Flight hours	total	5580 h	during the last 90 days	91:06 h
	on the type of accident	814 h	during the last 90 days	91:06 h
Copilot	German citizen, born in 1980			
Licence	Commercial Pilot Licence Aeroplane (CPL(A)) EASA), issued by FOCA			
Flight hours	total	3260 h	during the last 90 days	89:25 h
	on the type of accident	1212 h	during the last 90 days	89:25 h
Location	4 NM west of Zurich Airport (LSZH)			
Coordinates	N 47° 26' 34" / E 008° 26' 14" (WGS ¹ 84)	Altitude	Flight Level 70	
Date and time	4 October 2018, 06:45 UTC (LT ² = UTC ³ + 2 h)			
Type of operation	Charter

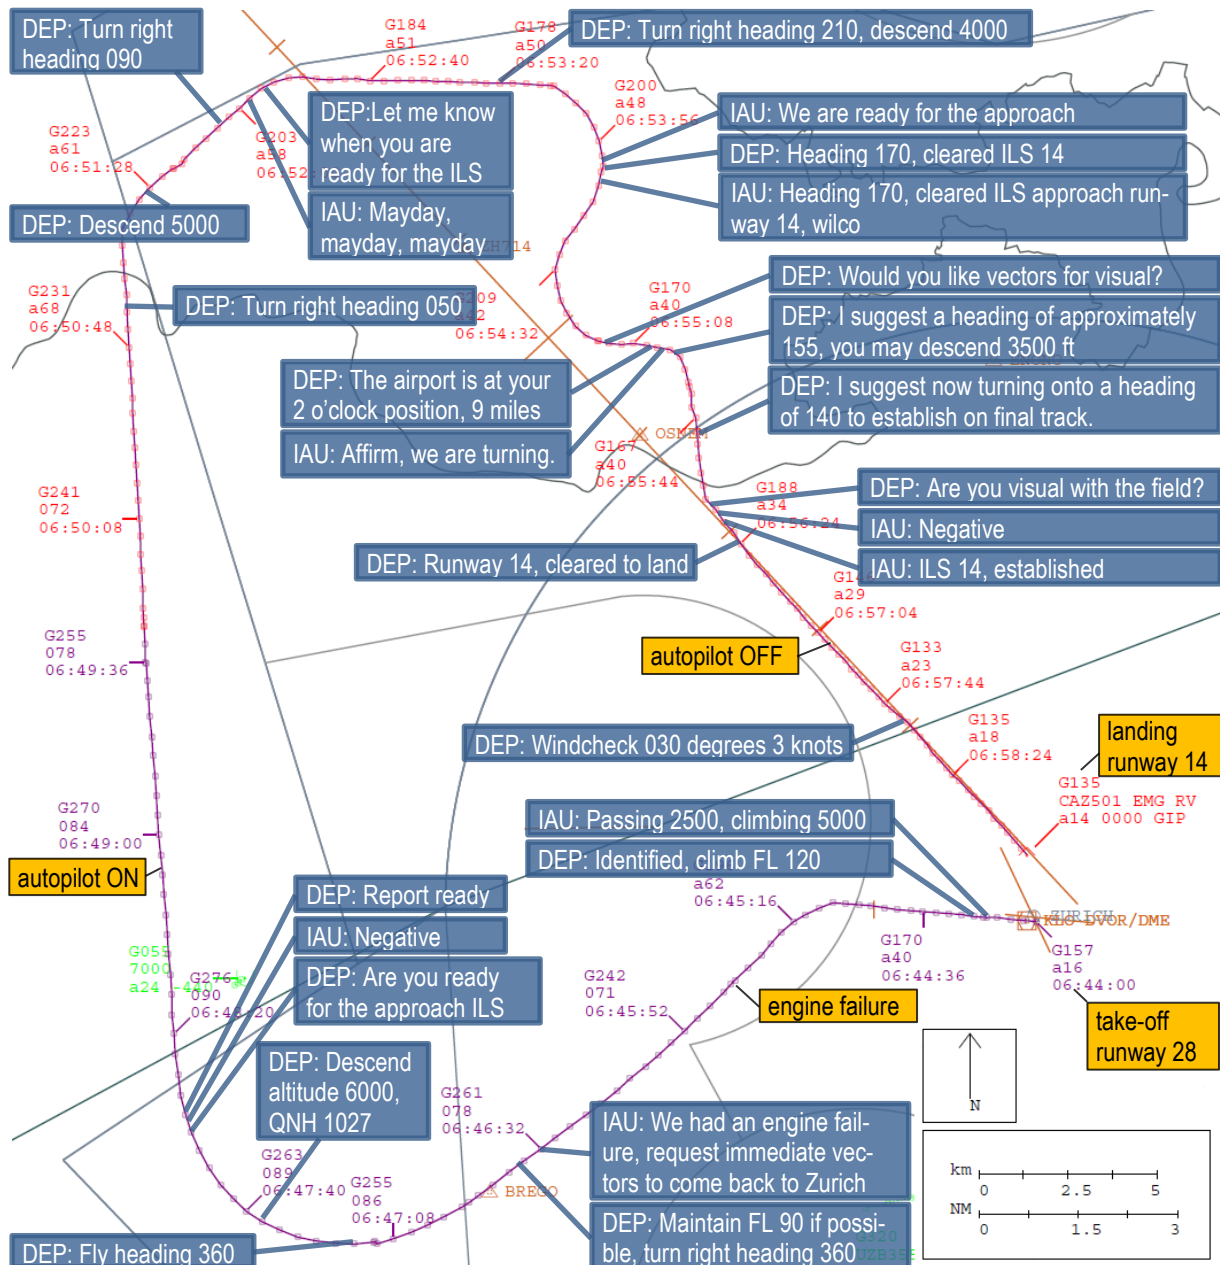
Using radio No. 1, he repeated the transmission, this time successfully, and requested immediate radar guidance for a return to Zurich Airport ("*request immediate vectors to come back to Zurich*", cf. figure 1). Air traffic control responded to this request without delay and told them they could expect an instrument approach to runway 14. At 06:48 UTC, air traffic control asked whether the flight crew was ready for the instrument approach, but they replied in the negative.

Figure 1: Flight path of the Falcon 2000EX according to radar recording with speed over ground in kt (G), altitudes above sea level in 100 ft (a) or flight level, and time in UTC. Selected air traffic control (DEP) and Falcon (IAU) radio transmissions are marked in blue.

Shortly after the engine failure, the flight crew demanded that air traffic control immediately take over the navigation for a return to Zurich with the phrase "*request immediate vectors to come back to Zurich*". This was an appropriate decision and was safety-conscious. However, this wording implied that the return itself should take place as quickly as possible, which subsequently prompted the air traffic controller to ask "*are you ready for the approach?*"

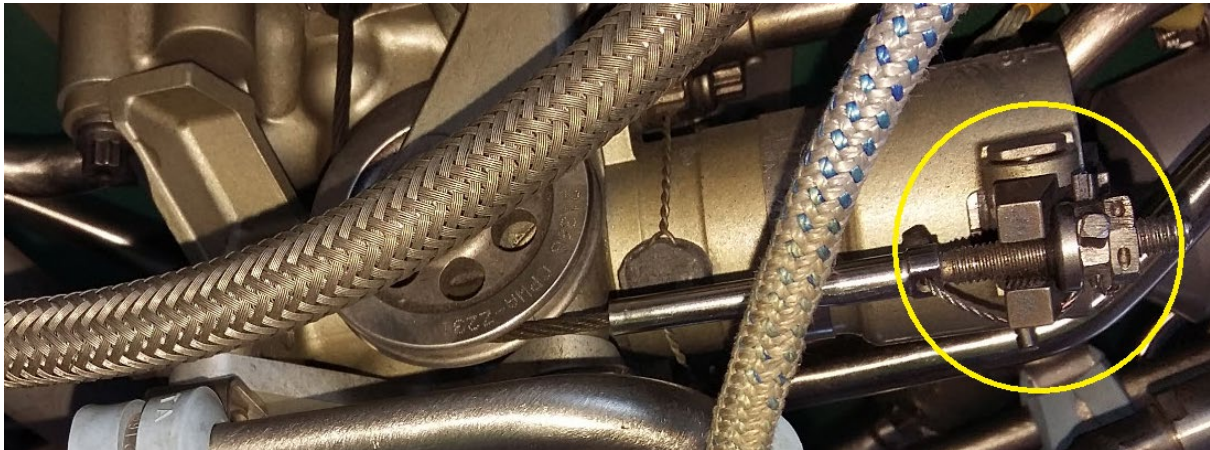
The stored data of the electronic engine control unit did not give any indication of a malfunction of the engine. The visual inspection of the engine, however, revealed that the emergency fuel shut-off valve (cf. figure 2) was closed. The closure of the emergency fuel shut-off valve, which was only intended to interrupt the fuel supply if the low-pressure turbine shaft broke, led to the shutdown of the engine.

After the engine shutdown on October 4, 2018, the valve was reset and it was determined that the rigging was outside the tolerance range. The valve was therefore readjusted in accordance with the maintenance instructions.

A follow-up check carried out after four further flights on 16 October 2018 showed that the rigging had shifted again by 0.050 inches. The subsequent adjustment had to be repeated three times until a stable result was obtained. The description of the adjustment procedure in the current documentation is very complicated.

An in-depth investigation finally revealed, when pulled by hand, the Bowden cable leading to the valve was stiff, difficult to move and jerky, and that the restoring force of a spring installed inside the valve was reduced. As a precautionary measure, both components were then replaced and sent to the manufacturer for investigation.

Figure 2: The emergency fuel shut-off valve with its actuating lever and its adjustable connection (yellow circle) to the Bowden cable via a pulley.

The follow-up inspection carried out on 16 October 2018 revealed that the rigging had shifted 0.050 inches, well less than the required distance to activate the fuel shut-off mechanism. The examination and testing of the emergency fuel shut-off valve and the cable did not identify any deficiencies that would have precluded normal operation or inadvertent tripping of the fuel shut-off valve.

The engine shutdown was due to the fact that the emergency fuel shut-off valve was activated because of its incorrect rigging and, as a result, interrupted the fuel supply. The cause of the incorrect rigging could not be conclusively established.

Since the manufacturer has revised the maintenance specification in October 2019 for ease of comprehension, and plans to supplement the instructions in June 2021 to check the freedom of movement of the Bowden cable during the reset of the fuel shut-off valve rigging procedure, the STSB concludes the investigation based on Art. 45 para. 1 of the OSITl with the present summary report.

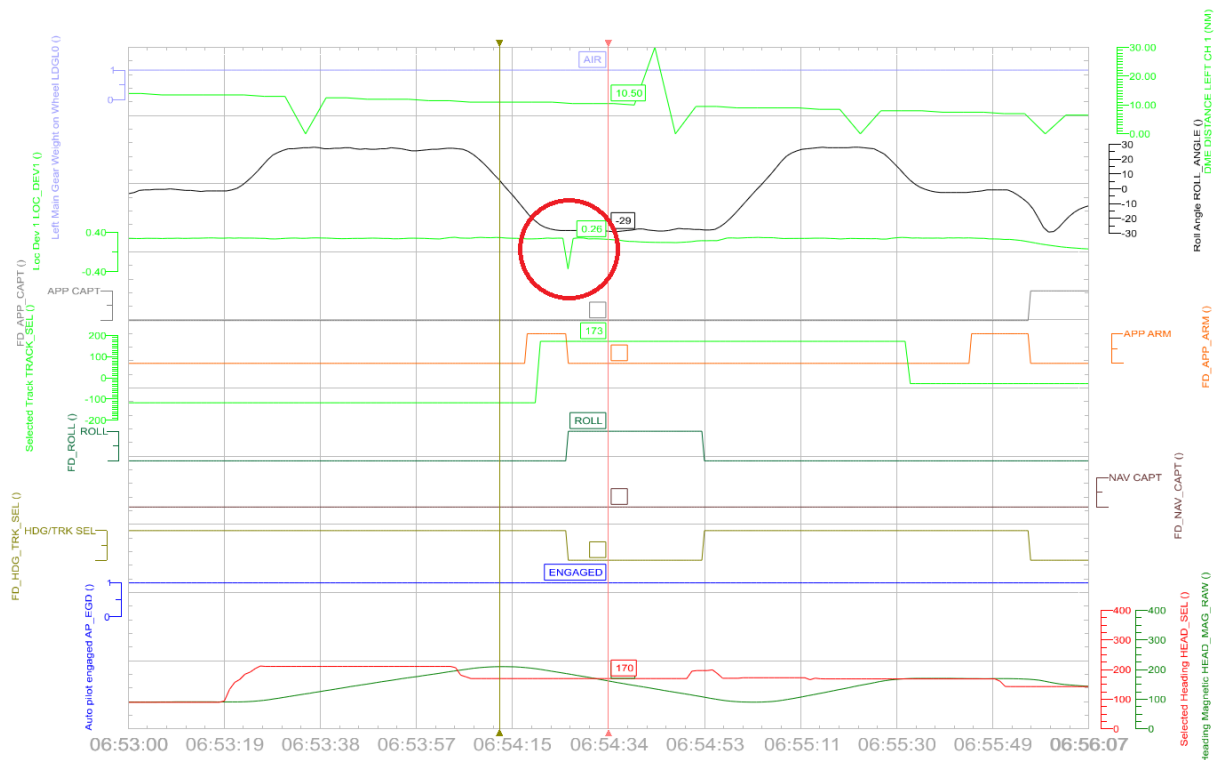
Consequently, the autopilot, which was following a heading of 210°, then initiated a left turn. During the left turn, there was a disturbance in the signal of the localizer which caused a change in the autopilot programming to roll mode engaged and approach mode disarmed. The crew corrected this at 16:54:53 UTC after the aircraft had turned to an easterly heading (cf. figure 3).

Figure 3: The evaluation of the flight data recorder shows a single and short-term disturbance in the signal of the localizer (red circle), which resulted in a change of the programming of the autopilot.

After the flight crew had reported their readiness for the approach when turning to a heading of 210°, the air traffic controller corrected his heading instruction to 170°, which was to lead the aircraft to intercept the localizer. The subsequent deviation of the flight path from this instruction can be explained by a change in the autopilot programming caused by a brief disturbance in the localizer transmitter signal.
