Summary Report

Location	Stadlerberg (ZH); extension of runway 14 centreline at a distance 5 NM from the landing runway threshold		
Coordinates	676 330 / 265 950 (Swiss Grid 1903) N 47° 32' 23" / E 008° 27' 09" (WGS ¹ 84)	Altitude	approx. 3000 ft AMSL ²
Date and time	29 September 2018, 16:57 UTC (LT = UTC + 2 h)		
Type of serious incident	Near miss		
Air traffic control	Final approach control (Zurich Final)		
Airspace	Control Zone (CTR) Zürich, class D air-space		
Closest point of approach	0 m horizontal, approx. 10 m vertical		
Prescribed minimum separation	3.0 NM between IFR ³ /IFR traffic, none between IFR/VFR ⁴ and VFR/VFR		
Airprox category	ICAO ⁵ Category A		
Aircraft 1	Airbus A319	HB-IPT	
Owner	Wells Fargo Bank Northwest, National Association, 299 South Main Street, 5 th Floor, Salt Lake City, UT 84111, USA		
Operator	Swiss International Air Lines Ltd., Malzgasse 15, 4052 Basel, Switzerland		
Relevant equipment	Traffic Alert and Collision Avoidance System (TCAS)

Type of operation	Commercial flight		
Flight rules	IFR		
Departure airport	Berlin Tegel airport (EDDT)		
Destination airport	Zürich airport (LSZH)		
Flight phase	Approach

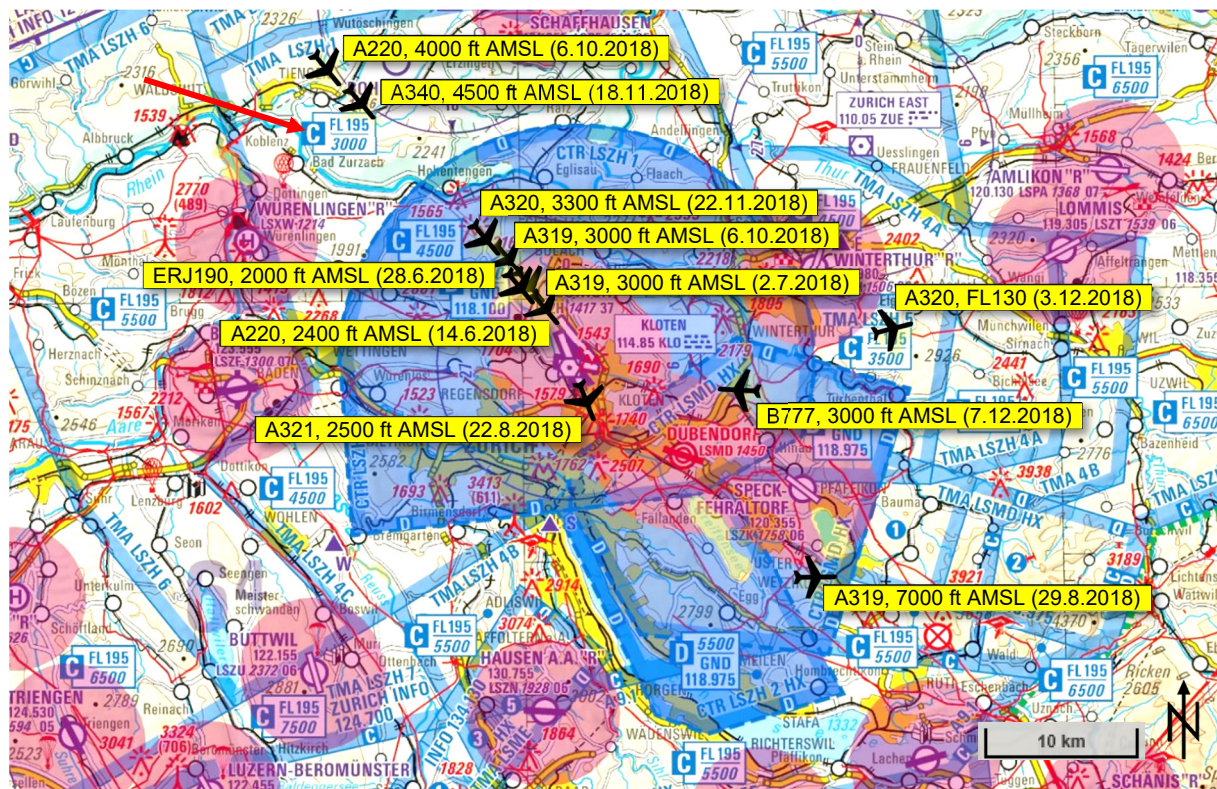
The airspace structure around Zurich airport and the associated restrictions on the operation of drones are shown in Figure 1.

Figure 1: Geographical positions of eleven of the dangerous proximity incidents reported to the STSB in 2018 in the Zurich area (aircraft type, altitude, date) entered on the aeronautical chart of Switzerland, with the restricted areas for drones superimposed: Zones within a radius of 5 km around aerodromes (red circular areas) and CTR Zurich (blue areas). The TMA Zurich sectors are shown as blue shaded lines with their upper and lower limits (e.g. TMA Sector 1, red arrow). Source of the base map: Swiss Federal Office of Topography.

The TMAs are not shown on the [interactive drone map of Switzerland](#). The operation of drones in these airspaces is therefore not excluded (see Figure 1).
