Summary Report

Aircraft	Avro 146-RJ100	HB-IYT	
Main operator	Swiss Global Air Lines AG, Malzgasse 15, 4052 Basel (Switzerland)		
Main owner	Triangle Regional Aircraft Leasing Limited, 1 Bishop Square, St Albans Road West, AL10 9NE, Hatfield, Hertfordshire (UK)		
Pilot	Swiss citizen, born 1955		
Licence	Airline transport pilot licence aeroplane (ATPL(A)) according to European Aviation Safety Agency (EASA), issued by the Federal Office of Civil Aviation (FOCA)		
Flying hours	Total 15 500 h	During the last 90 days 104 h	
	On the incident type 5 750 h	During the last 90 days 104 h	
Co-pilot	Italian citizen, born 1993		
Licence	Multi-crew pilot licence aeroplane (MPL(A)) according to EASA, issued by the FOCA		
Flying hours	Total 188 h	During the last 90 days 188 h	
	On the incident type 167 h	During the last 90 days 167 h	
Location	6 NM east of London City Airport (EGLC)		
Coordinates	N 51° 29' 55.79" E 0° 13' 28.79" (WGS 84)	Altitude approx. 3000 ft AMSL ¹

Date and time	19 June 2016, 13:26:20 UTC		
Type of operation	Scheduled flight		
Flight rules	Instrument flight rules (IFR)		
Flight phase	Approach		
Type of incident	Near collision with drone		
Point of departure	Zurich (LSZH)		
De

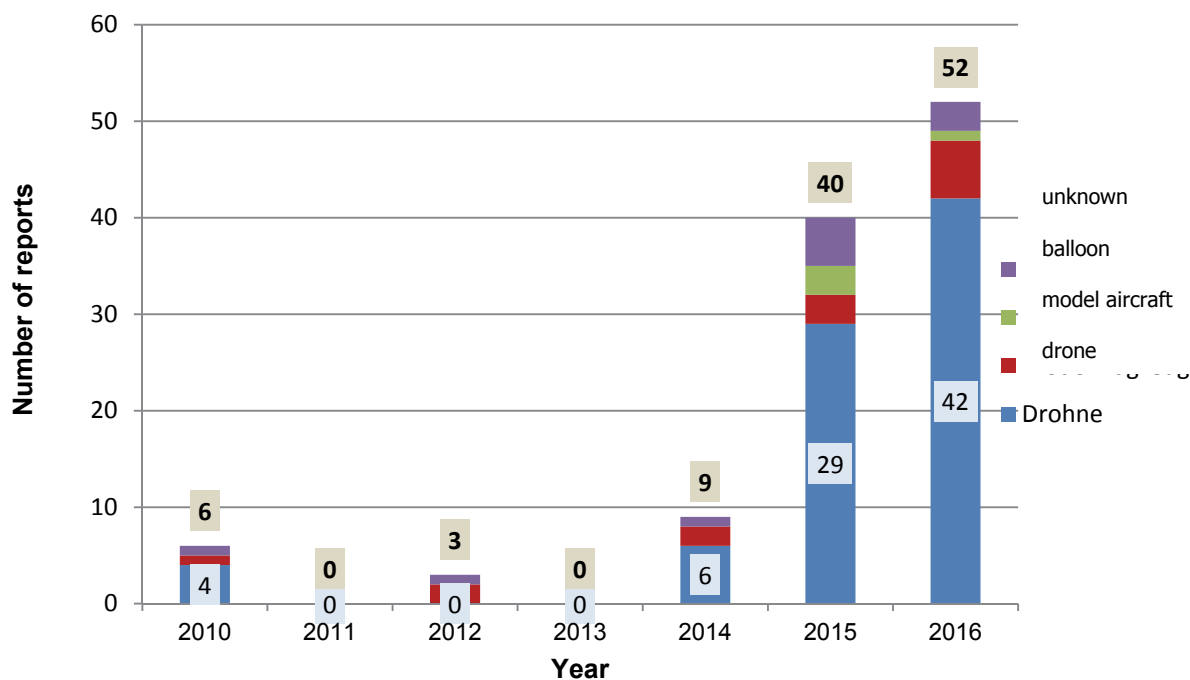
The reports of air proximity hazards (airproxes) between aircraft and other flying objects that have been recorded by the United Kingdom (UK) Airprox Board clearly reflect the increasing number of global occurrences of unmanned aircraft (UA). Drones account for the majority of these incidents.

Figure 1: Reports regarding airproxes between aircraft and drones as well as other flying objects, recorded by the UK Airprox Board (as at July 2016)

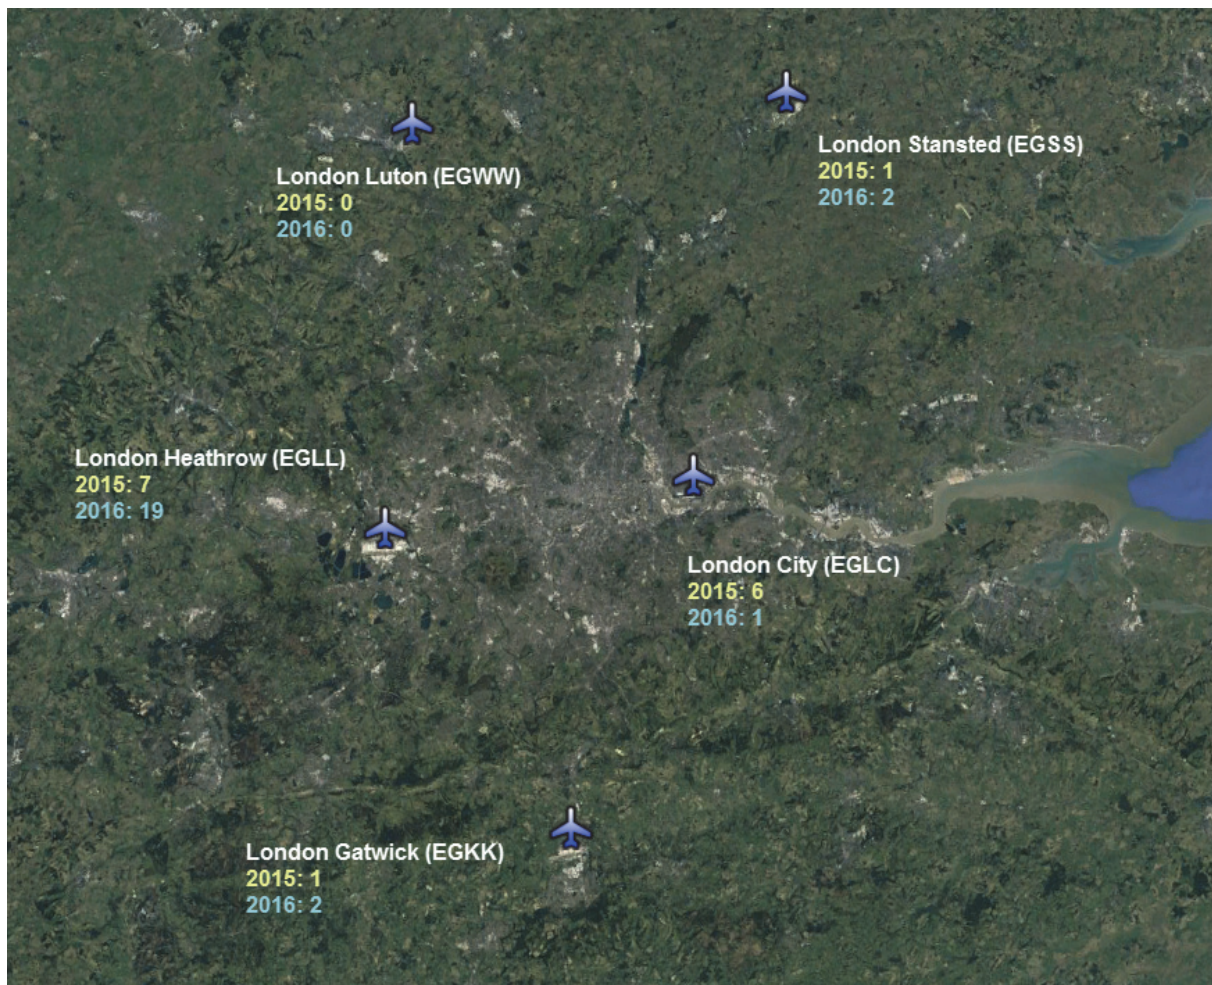
According to the statistically compiled data, the majority of reported airproxes occurred outside the vicinity of airports. The number of reported airproxes between drones and, predominantly, airliners in 2015 and 2016 (as at July) within the vicinity of London airports (cf. Figure 2) can nevertheless not be disregarded.

Figure 2: Reports concerning airproxes between aircraft and drones within the vicinity of London airports in 2015 and 2016 (as at July)

The number of reported airproxes between drones and aircraft within the vicinity of London airports in 2015 and 2016 (cf. Figure 2) indicates a significant risk of collision.

On account of the fact that unmanned aircraft are difficult to detect visually due to their small size and cannot be captured by collision warning devices at an early enough point, prompt sending of a relevant radio message – similar to a pilot weather report (PIREP) – is recommended in order to immediately gain the attention of other flight crews.

Measures to ensure that unmanned aircraft can be detected on radar and on board aircraft at an early stage using collision warning devices are absolutely imperative for flight safety reasons.
