Summary Report

Aircraft	AVRO 146-RJ100	HB-IYU
Operator	Swiss Global Air Lines AG, Malzgasse 15, 4052 Basel	
Owner	Triangle Regional Aircraft Leasing Limited, St Albans Rd W, Hatfield, AL10 9NE, United Kingdom	
Pilot	Swiss citizen, born 1974	
Licence	European Aviation Safety Agency (EASA) airline transport pilot licence aeroplane (ATPL (A)), issued by the Federal Office of Civil Aviation (FOCA)	
Flying hours	Total 9525 h	During the last 90 days 132 h
	On the incident type 5878 h	During the last 90 days 132 h
Co-pilot	German citizen, born 1992	
Licence	EASA commercial pilot licence aeroplane (CPL(A)), issued by FOCA	
Flying hours	Total 796:40 h	During the last 90 days 136:55 h
	On the incident type 475:15 h	During the last 90 days 136:55 h
Location	Approx. 8 NM west of waypoint DOPIL	
Coordinates	---	Altitude Flight level (FL) 140
Date and time	3 rd September 2016, 14:17 UTC (LT ¹ = UTC ² + 2 h)	
Type of operation	Scheduled flight

Flight rules	Instrument flight rules (IFR)	
Point of departure	Geneva (LSGG)	
Destination	Zurich (LSZH)	
Flight phase	Cruise flight	
Type of serious incident	Fume smell in the cockpit, use of oxygen masks	
Injuries to persons	Crew	Passengers
Minor	0	0
Non

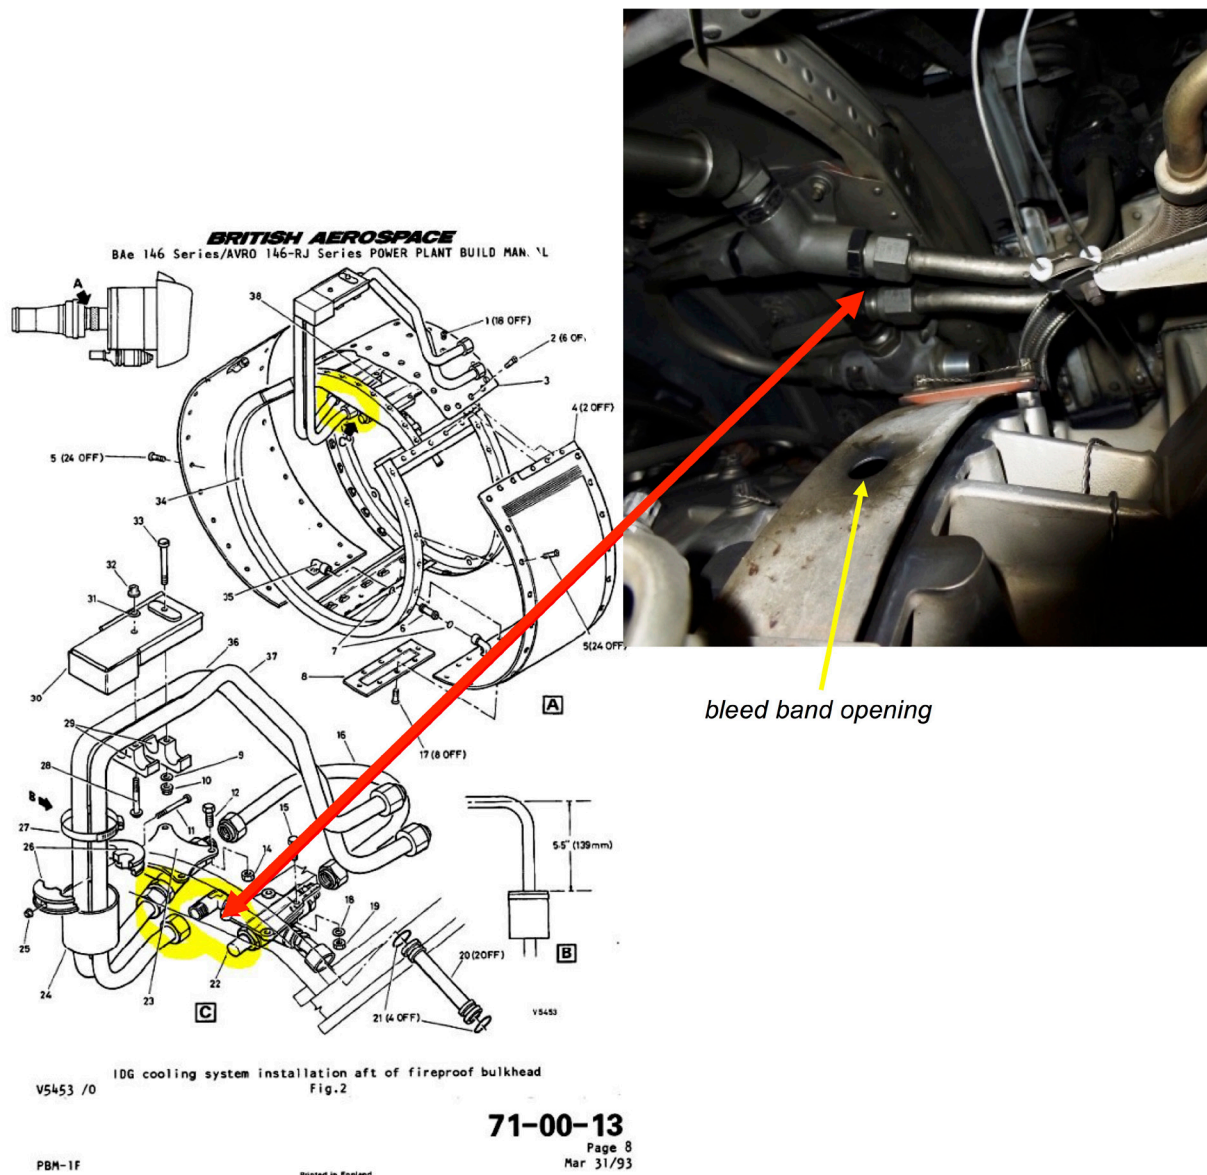
The extensive checks showed smaller discrepancies that could possibly have led to a fume smell. Most notable, however, was a leak in engine 1's IDG⁴ oil system. The IDG oil system works independently of the engine oil system and its components are arranged around the engine compressor. The temperature control valve is situated exactly in the twelve-o'clock position directly above the engine compressor. It was found that the oil pipe connections for this temperature control valve had not been tightened using sufficient torque. Oil was therefore able to drip onto the engine compressor and get through the bleed band openings into the engine compressor, therefore also reaching the engine bleed air and the air conditioning circuit (see Figure 1).

Another possible contributory factor was recorded: instead of flowing overboard, the contaminated air was able to get into the air conditioning circuit because the APU breather and the engine oil cooler ventilation pipes had not been correctly aligned.

Figure 1: Oil leak in the connection (red arrow) for the IDG oil cooler's temperature control valve
