Final Report No. 2435

concerning the serious incident involving
the airliner Airbus A330-343 , HB-JHI ,

on 13 September 2024

approx. 50 NM west-northwest of Basel

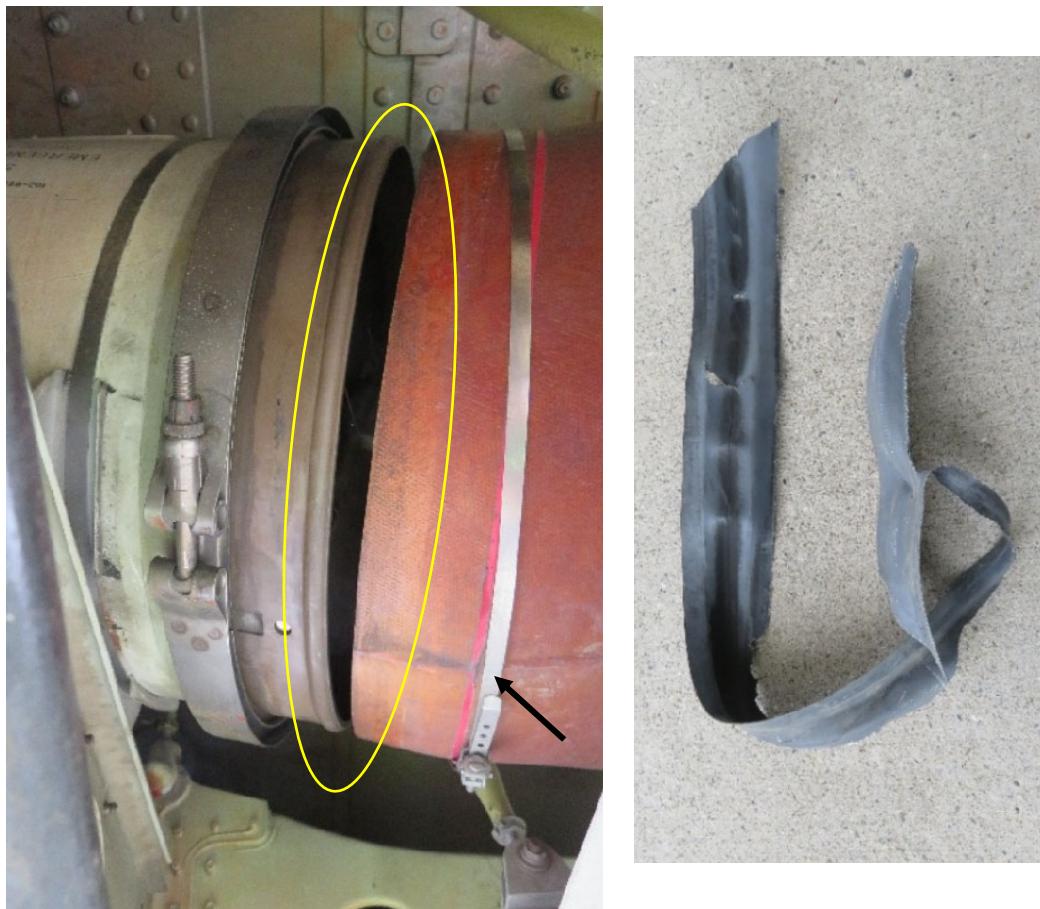
The sealing sleeve and one of two screw clamps were missing at the location between the low-pressure manifold and the check valve of the emergency ram air inlet (see figure 1). The sealing sleeve was found badly damaged inside the aircraft fuselage (see figure 2). The remaining screw clamp on the side of the low-pressure distributor was loose. The second screw clamp could not be found.

Figure 1: Position between the low-pressure manifold (right image side) and the check valve of the emergency ram air inlet (left image side) with missing sealing sleeve (circled in yellow) and the screw clamp (black arrow) still in place.

The sealing sleeve at the connection between the low-pressure manifold to the check valve of the emergency ram air inlet was found to be severely damaged inside the aircraft. Furthermore, one screw clamp was loose and the second was missing and could not be found inside the aircraft. The torn sealing sleeve can be attributed to the defective skin check valve, as the sealing sleeve was no longer able to withstand the air pressure. The service bulletin refers to this possible damage (see chapter 1.6.3.2). The escaping air meant that the cabin pressure could no longer be maintained.

It could not be determined why one screw clamp was loose and the second clamp was completely missing. It is presumed that the necessary work was not completely carried out during the last maintenance work on the low-pressure manifold.

As immediate preventive measure, the Maintenance Program Taskcard (TC) 215500-04-1 got modified with an additional step to check the condition of the sleeve connecting emergency ram air inlet and manifold, additionally the torque of the clamps in September 2024.

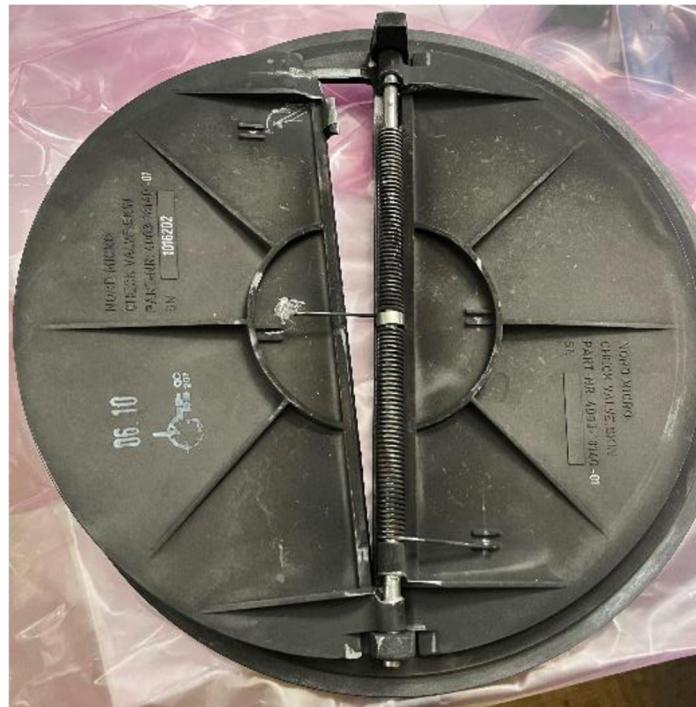
On the skin check valve, located between the low-pressure manifold and the mixer unit of the cabin pressure system, one of the two flaps was open more than 90° upwards. The flap was movable and could be closed. The hinge was defective (see section 1.3.2).

On the removed skin check valve, it was found that the hinge on one flap was broken, and the hinge pin was bent (see figure 3). Furthermore, the leaf spring on the broken hinge, which ensures that the flap closes, was also broken off. The entire hinge, the flaps, the contact surfaces and the end stops were severely damaged.

A severely damaged and non-functional skin check valve was found in the aircraft. The first signs of damage are likely to have been present for some time. However, it is probable that this skin check valve was still functional and closed during the last flight before the serious incident, enabling the cabin pressure system to build up sufficient cabin pressure.

When the aircraft was supplied with air at the gate by means of a preconditioned air unit (PCA), the skin check valve opened. However, after the air hoses were disconnected, the skin check valve remained open due to a defective flap hinge and a broken spring, which went unnoticed. A defective or open skin check valve is not visible from the outside due to the closed check valves of the two ground connectors. An open skin check valve can only be detected by pressing one of these check valves by hand. However, there was no procedure for such a check.

On 9 November 2016, the aircraft manufacturer published Service Bulletin No. A330-21-3179 recommending that the skin check valve with part number 4063-18140-01 be replaced with a modified valve with part number 24328-01⁹. This was due to a large number of reports to the aircraft manufacturer of skin check valve failures in A330 aircraft due to broken flaps and springs. Extensive tests by the aircraft manufacturer also revealed vibrations in the skin check valve flaps, particularly during normal operation. This resulted in damage to the emergency ram air inlet check valve and the low-pressure manifold with the ground connectors, which led to a drop in cabin pressure and, consequently, to the flight being aborted. The aircraft manufacturer recommends that the service bulletin be implemented as soon as possible to avoid significant operational disruptions.¹⁰

- Reduction of the valve opening angle from 85 degrees to a maximum of 75 degrees;
- Reinforcement of parts prone to wear: hinges, contact surfaces and end stops;
- Reduction of friction between the valves and the hinge axis by the use of a special surface coating;
- Reduction of spring force by using only one spring instead of two springs;
- Re-arrangement of the flap ribs to prevent flap flutter during normal operation.
