## Summary Report

<b>Aircraft</b>	Airbus A319-111	HB-JYK	
<b>Operator</b>	EasyJet Switzerland SA, route de l'Aéroport 5, 1215 Genève 15 Aéroport		
<b>Owner</b>	EasyJet Airline Company Limited, Hangar 89/Luton Airport, LU2 9PF Bedfordshire, Great Britain		
<b>Commander</b>	Dutch citizen, born 1976		
<b>Licence</b>	Airline Transport Pilot Licence Aeroplane (ATPL(A)) according European Aviation Safety Agency (EASA), issued by the Civil Aviation Authority (CAA) of the United Kingdom		
<b>Flight hours</b>	<b>total</b> 10 652 h	<b>during the last 90 days</b> 179:46 h	
	<b>on the type of incident</b> 7470 h	<b>during the last 90 days</b> 179:46 h	
<b>First officer</b>	Swiss citizen, born 1978		
<b>Licence</b>	ATPL(A) according EASA, issued by Federal Office of Civil Aviation (FOCA) of Switzerland		
<b>Flight hours</b>	<b>total</b> 5148 h	<b>during the last 90 days</b> 201:03 h	
	<b>on the type of incident</b> 3341 h	<b>during the last 90 days</b> 201:03 h

<b>Location</b>	15 NM northwest of Thessaloniki (LGTS)		
<b>Coordinates</b>	---	<b>Altitude</b> 7000 ft AMSL <sup>1</sup>	
<b>Date and time</b>	30 may 2017, 08:14 UTC <sup>2</sup> (Local Time = UTC + 2 h) All information in this report

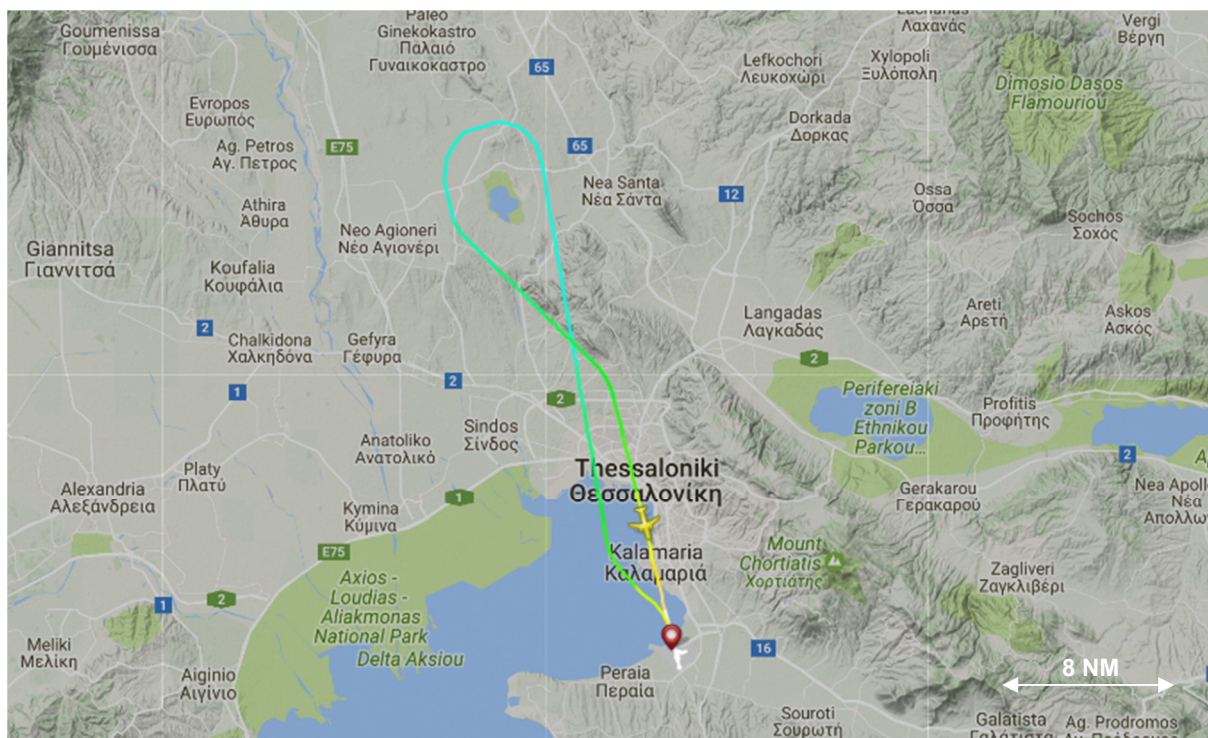
**Figure 1:** Flight path of HB-JYK as depicted on FlightRadar24
