## Summary Report

<b>Aircraft</b>	Diamond Aircraft DA40 NG	HB-SGD
<b>Operator</b>	Motorfluggruppe Zürich, Postfach, 8058 Zürich	
<b>Owner</b>	Motorfluggruppe Zürich, Postfach, 8058 Zürich	
<b>Pilot</b>	Swiss citizen, born 1981	
<b>License</b>	Air Transport Pilot License – ATPL(A) with Instrument Rating – IR(A) according the rules of the European Union Aviation Safety Agency (EASA), issued by the Federal Office of Civil Aviation (FOCA)	
<b>Flying experience</b>	<b>total</b> 6172:10 h	<b>during the last 90 days</b> 13:56 h
	<b>on type</b> 53:17 h	<b>during the last 90 days</b> 12:56 h
<b>Location</b>	Bern-Belp Airport (LSZB)	
<b>Coordinates</b>	---	<b>altitude</b> ---
<b>Date and time</b>	25 February 2022, 12:17 LT (LT <sup>1</sup> = UTC <sup>2</sup> + 1 h)	
<b>Type of operation</b>	Private	
<b>Flight rules</b>	IFR)	
<b>Point of departure</b>	Zürich Airport (LSZH)	
<b>Destination</b>	Bern-Belp Airport (LSZB)	
<b>Flight phase</b>	On ground / taxing on ground

<b>Occurrence category</b>	Collapse of the nose landing gear	
<b>Injuries to persons</b>	<b>Crew</b>	<b>Passengers</b> <b>Third persons</b>
<b>Minor</b>	0	0                      0
<b>None</b>	1	1                      not applica

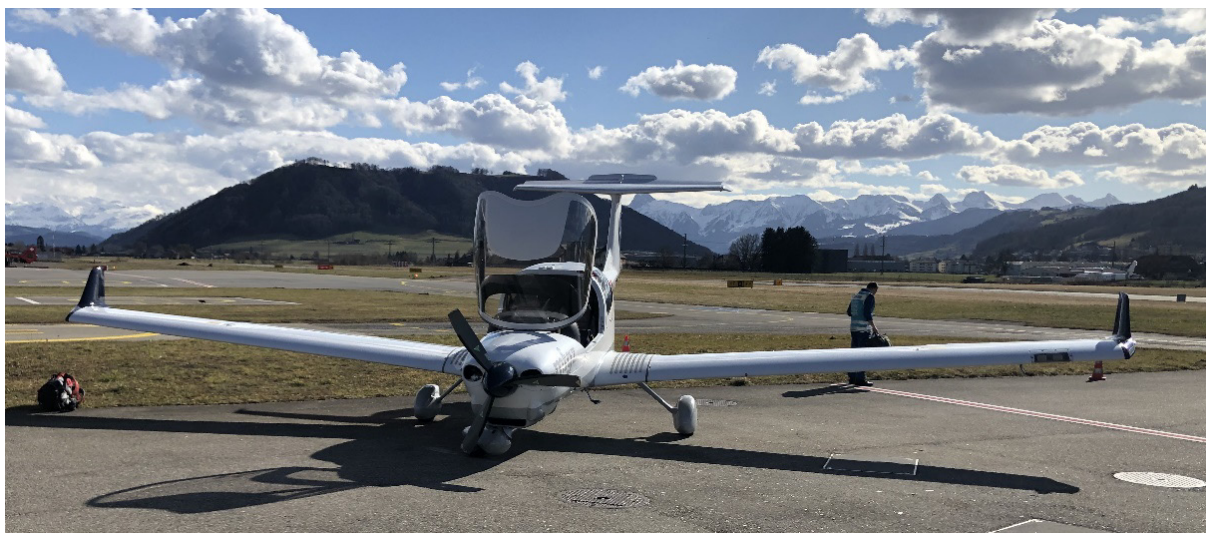
On February 25, 2022, at 11:30 LT, the pilot, together with a passenger, took off with a Diamond DA40 NG aircraft, registered as HB-SGD, from Zurich Airport (LSZH) and flew to Bern-Belp Airport (LSZB). At 12:12 LT, the landing took place without any abnormalities and in good weather conditions. During a turn into the final parking position the nose landing gear collapsed, causing the propeller to touch the ground (ref. Figure 1).

**Figure 1:** HB-SGD with collapsed nose gear on the apron of Bern-Belp Airport, view direction south.

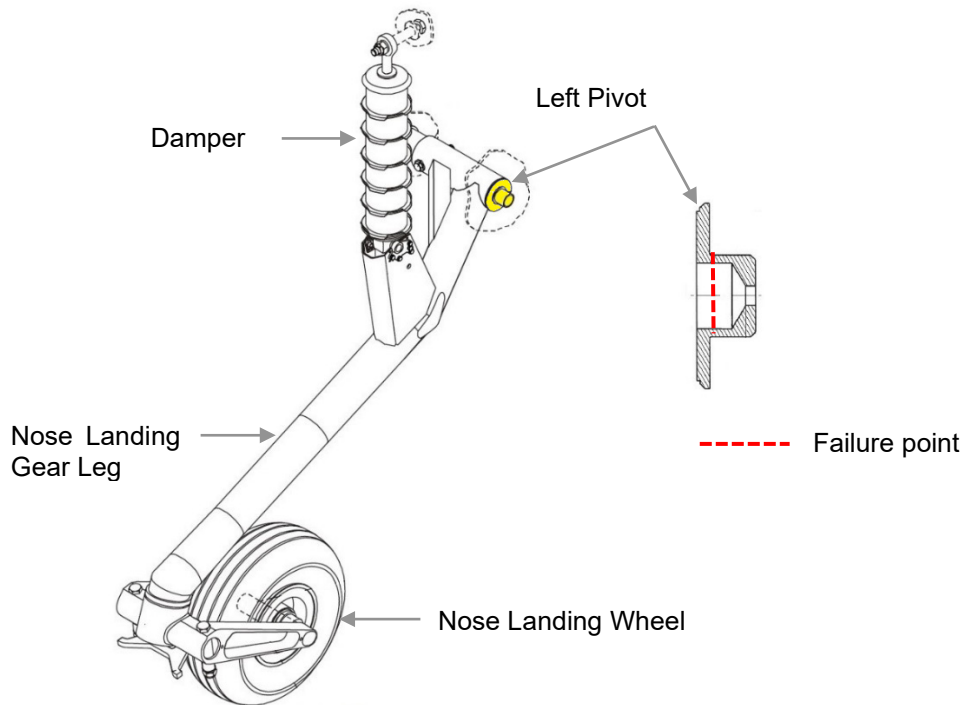
The nose landing gear consists of a landing gear leg, an elastomer spring assembly as damper and a nose wheel which can be freely deflected within  $\pm 30^\circ$  (ref. Figure 2). The landing gear leg is connected to the fuselage of the aircraft by two pivots. This connection is made via plain bearings installed on the fuselage, which accommodate the pivots.

In the present incident, the left pivot failed. According to the manufacturer's drawing, the pivots are made of a low-alloy heat-treatable steel and the surfaces are chemically nickel-plated. The transition radius between the pivot-axle and shoulder is specified as 0.5 mm with a tolerance of +0.0/-0.1 mm.

**Figure 2:** Illustration of the nose landing gear from the aircraft manufacturer's maintenance manual (flight direction to the left). The left bearing pin (marked yellow and additionally shown in section) was broken.

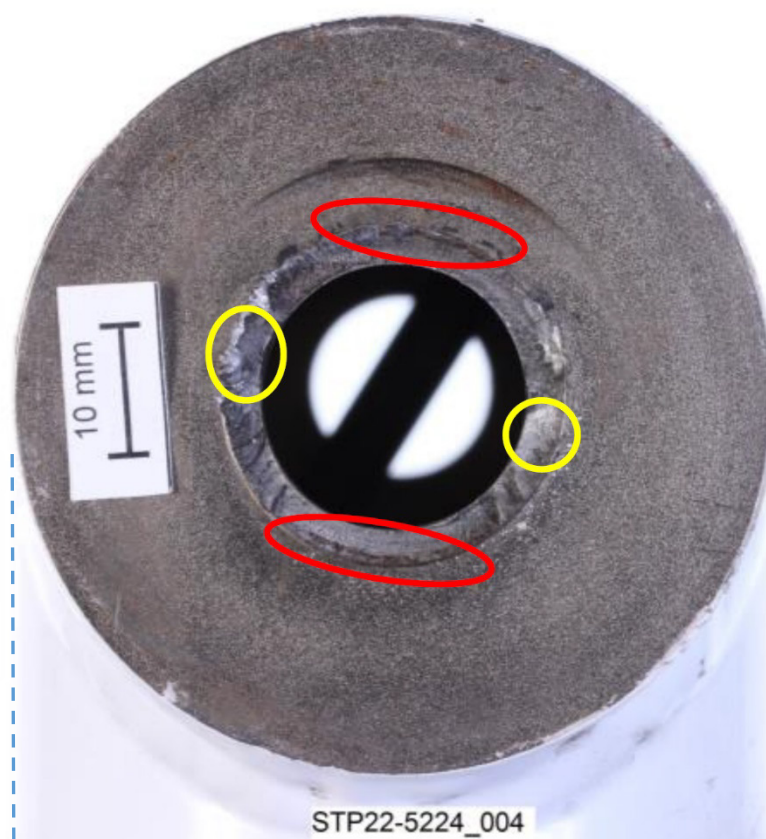
The fracture of the left pivot occurred at the transition radius between the pivot and shoulder. The fracture surface had two large fracture initiation zones and was partially corroded. Within these zones, steps were present, which can be interpreted as individual fatigue fracture initiations. The area of these zones was clearly larger than the residual ultimate fracture zones (ref. Figure 3).

Further examination of the fractured journal showed that the material was a low-alloy quenched and tempered steel, as specified by the manufacturer, and that the transition radius was 0.5 mm. The right bearing journal was inspected at the transition radius by means of dye penetrant testing; no cracks were detected.

**Figure 3:** landing gear leg (area between the dashed lines) with its annular surface of the pivot shoulder with the failed section. The fracture surface has large fracture initiation zones (marked in red) and small ultimate fracture zones (marked in yellow).

The serious incident, in which the nose gear collapsed during taxiing and the propeller touched the ground, was caused by a fatigue failure of a pivot. According to the corrosion traces on the fracture surfaces, the fatigue-related initial damage had occurred over a longer period of time. The location of the fracture initialization zones indicates an alternating bending stress on the nose landing gear, as it can occur due to nose wheel shimmy.
