Final Report No. 2399

by the Swiss Transportation Safety Investigation Board STSB

concerning the accident of the aircraft
Diamond DA20-C1, HB-SGI,

on 17 June 2021

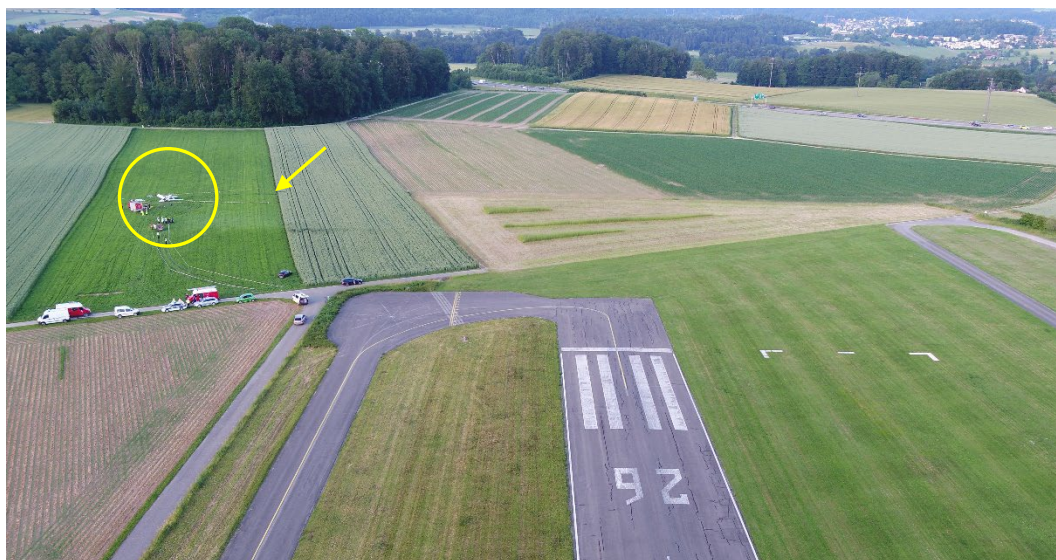
Figure 1: Final position of the HB-SGI northeast of runway threshold 26 of Birrfeld Airfield (circle) and location of impact (arrow). The A1 motorway runs about 500m behind the end of the runway, with the Reuss river behind and parallel to it (drone image of the Aargau cantonal police looking east).

At 6:22 p.m., the aircraft struck a meadow 170 m north-east of runway threshold 26, left wing first, and came to rest shortly afterwards. The pilot was seriously injured. The left wing was separated from the fuselage on impact and the fuselage broke in two behind the wing. No fuel spilled and there was only minor third party damage.

Shortly after take-off, the engine failed due to lack of fuel. The pilot then headed for the fields and meadows to the left behind the runway. This choice of flight path may have seemed advantageous in view of the obstacle situation, but it led to a loss of control close to the ground due to the stalling speed increased by the bank angle.

The choice of flight path after the engine failure required a turn near the ground, which encouraged a loss of control.

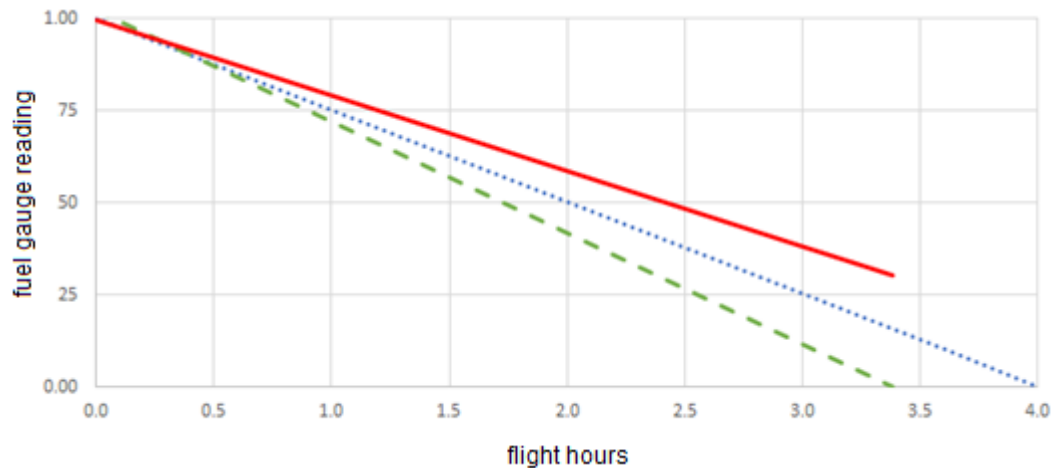
The tank gauge, a single pointer instrument graduated in quarters, was checked by filling and emptying the tank. It showed good accuracy at fill levels of over $\frac{1}{2}$. However, at lower fill levels, the instrument consistently showed too much; when the tank was completely empty, it showed around $\frac{1}{4}$ (cf. also Figure 2). After filling to overflow, the tank held a total of 95.2 liters.

At this point, the fuel supply had already dropped to less than $\frac{1}{4}$ of what could not be seen on the display (cf. Figure 2). However, on the basis of the mentioned flight times and the pilot's calculation, it was recognisable that only about the legal final reserve of 30 minutes would be available when landing in Birrfeld, and that consequently an emergency situation⁸ would arise due to further delays.

Figure 2: Fuel gauge readings of the HB-SGI, plotted over the flight time assuming constant consumption values: Correct indication at 22.75 litres per hour (consumption according to pilot's assumption, dotted blue), correct indication at 28 litres per hour (actual consumption, dashed green), and erroneous indication at 28 litres per hour (from checking the fuel gauge after the accident, indication error taken into account, red).

During the flight, the fuel gauge can be checked for plausibility by comparing the previous flight time with the endurance calculated in advance. Instruments that measure the fuel flow and calculate the remaining fuel quantity (fuel totalizer) serve the same purpose. In the present case, the pilot did not have such instruments at his disposal; moreover, the recognition of the additional consumption towards the end of the flight was made difficult by the excessively high fuel gauge (cf. Figure 2).
