Summary Report

Location of the serious incident (airprox)	Bern Belp Airport (LSZB)		
Date and time	21 November 2016, 18:06 UTC		
Coordinates	---	Altitude	Approximately 1700 ft above mean sea level
Air traffic service	Bern aerodrome control tower		
Airspace	Class D		
Closest proximity of the two aircraft	Approx. 300 m horizontally		
Separation minima	None		
Airprox category	ICAO ¹ category B		
Aircraft 1	AT-3 R100	HB-SRB	
Main operator	Alp-Aircraft GmbH, 3123 Belp		
Main owner	Alp-Aircraft GmbH, 3123 Belp		
Type of operation	Training		
Flight rules	Visual Flight Rules (VFR)		
Flight phase	Approach		
Point of departure	Bern Belp Airport (LSZB)		
Destination	Bern Belp Airport (LSZB)		
Crew members	1		
Pilot	Swiss citizen, born 1978		
Licence	Private Pilot Licence Aeroplane (PPL(A)) according European Aviation Safety Agency (EASA), issued by the Federal Office of Civil Aviation (FOCA)		
Flying hours	Total	79:30 h	During the last 90 days 5:07 h

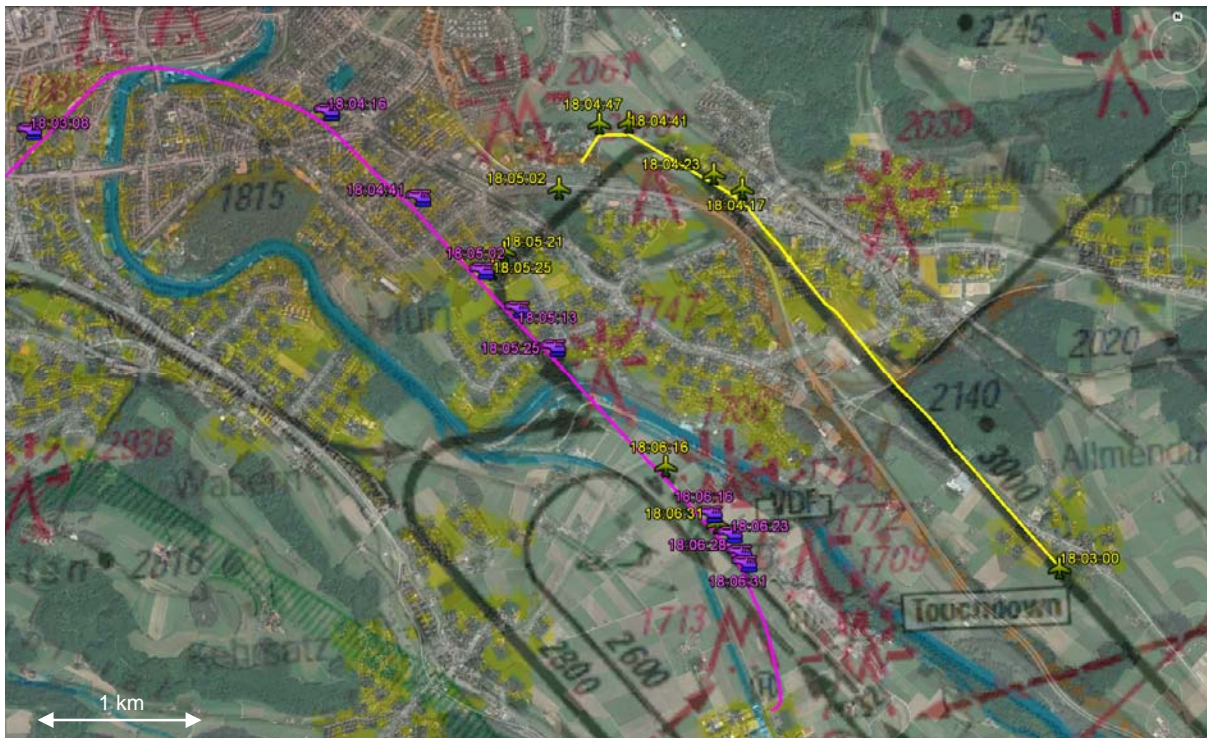
At 18:00:58 UTC, the air traffic controller instructed the crew of HB-ZIE to fly directly the right base leg of runway 14 once they had crossed waypoint W1 (see figure 1). At 18:02:56 UTC, the pilot of HB-SRB, which was on the left downwind leg, contacted the air traffic controller to request a full stop landing. At 18:03:00 UTC, the air traffic controller informed the pilot of HB-SRB that he was scheduled to be number 2 following a helicopter on a long final approach and that he should report once he had the helicopter in sight. The pilot of HB-SRB acknowledged this by saying, "*Number two, Hotel Romeo Bravo*".

Figure 1: A radar record of the aeroplane HB-SRB (yellow) and GPS data² of the helicopter HB-ZIE (pink) projected onto the aerodrome circuit geometry in accordance with the specifications of Bern Belp Airport's (LSZB) visual approach chart, displayed in Google Earth; HB-SRB's further positions along the aerodrome circuit (yellow dots) were extrapolated assuming the typical approach speed of 65 knots; all times given in UTC. Overlay reproduced with the permission of the Swiss Federal Office of Topography Swisstopo (JA150149).

The air traffic controller later stated that he had observed HB-SRB turning into the left base leg (see black line in figure 1) following the normal geometry of Bern Belp Airport's (LSZB) visual approach chart (VAC). After having informed the pilot of HB-SRB of the traffic situation several times and once the pilot had reported visual contact with the helicopter and had acknowledged the approach as number 2 behind, the decision about a landing on runway 14 was now at the discretion of the pilot of HB-SRB. He did not want to put the pilot under pressure with a possibly

Despite the two instructions to the pilot of HB-SRB to continue flying on the left downwind leg, the fact that the pilot turned into the base leg in accordance with the visual approach chart (VAC) (see black line in figure 1) shows that he had obviously not understood the air traffic controller’s instruction. When giving the second instruction at 18:04:38 UTC, “*Hotel Romeo Bravo, you are now passing the traffic, it should be on your left, at 9 o’clock position. Leave a good spacing behind. It is relatively slow moving,*” the air traffic controller probably intended to give the pilot of HB-SRB an overview of the situation. However, this implicit instruction to continue the downwind leg failed to have the desired effect and did not comply with easily understandable standard phraseology.

The air traffic controller later stated that he had observed HB-SRB turning into the left base leg of runway 14 (see figure 1). Despite the crew of HB-ZIE confirming that they did not intend to make a full stop landing on the runway but to continue flying directly to the Swiss Helicopter base, the air traffic controller should have anticipated that the helicopter would be flying at a lower speed near the runway. The averaged GPS data shows that the GS of HB-ZIE during the final approach until leaving the runway level with intersection Alpha was between 50 and 60 kt, i.e. well above the translational speed. On the basis of HB-SRB’s assumed approach speed of 65 kt, the horizontal distance between the two aircraft probably reduced slightly after HB-SRB had turned into the final approach to runway 14. The horizontal distances at 18:06:16 UTC (when the instruction for a go-around was given) and at 18:06:31 UTC (when HB-ZIE had already left the runway and was approximately 50 metres south of it) were estimated based on this assumption and confirm the accuracy of this theory.

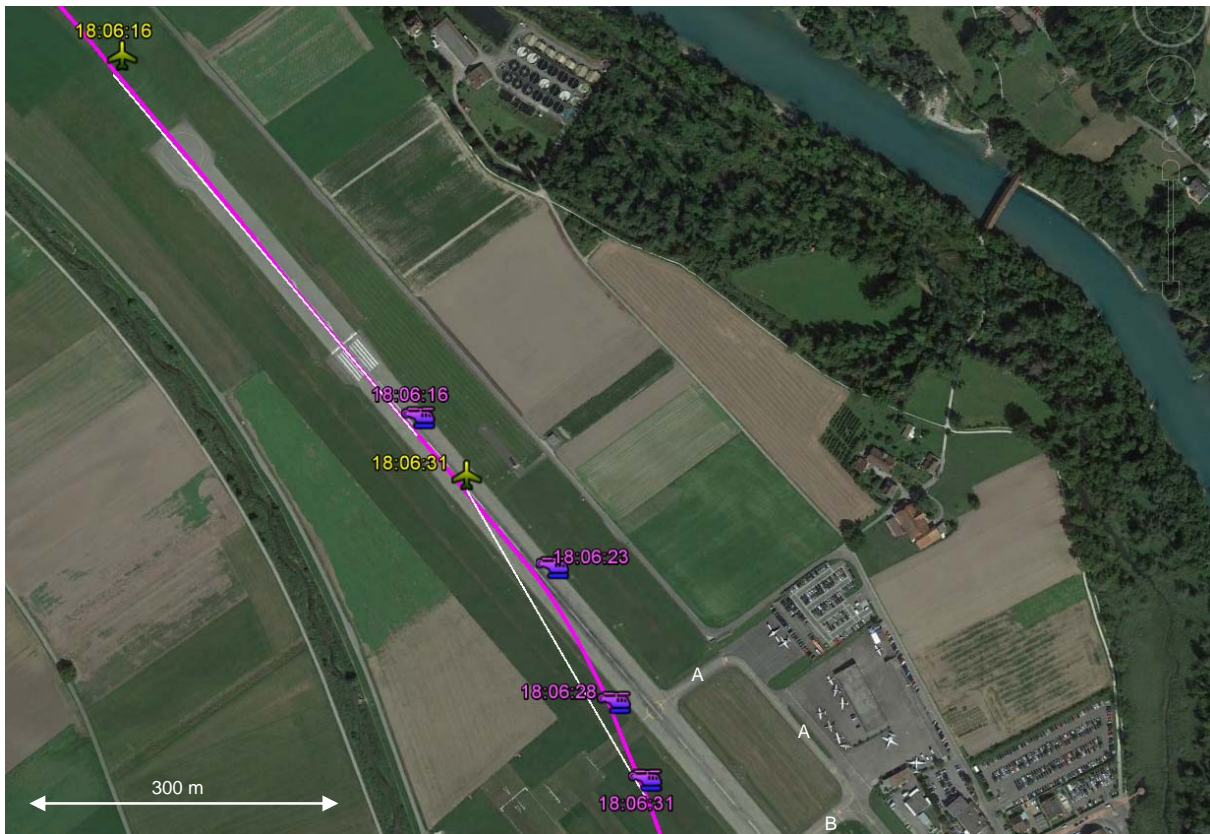
Figure 2: The flight path of HB-ZIE (pink) and extrapolated positions of HB-SRB (yellow points) on the final approach to runway 14 at Bern Belp Airport (LSZB) with horizontal distances (white) at 18:06:16 UTC and 18:06:31 UTC as well as taxiways A and B (white), displayed in Google Earth. All times given in UTC.

Almost one minute later, at 18:06:16 UTC (see figure 2), the flight instructor of HB-SRB, who was in close proximity to the intersection Alpha at this time, instructed the pilot of HB-SRB via a handheld radio on the tower frequency to perform a go-around. At this time, HB-SRB was at a horizontal distance of approximately 400 metres behind HB-ZIE along the direction of the

At 18:06:16 UTC, the flight instructor told the pilot of HB-SRB, which was on the runway axis approximately 400 metres behind HB-ZIE, to perform a go-around. This was a clear decision which led to the situation being defused.
