Serious incident to the CESSNA - 172 - R registered HB-TEA

on 03 September 2020
at Ecuwillens (Switzerland)

Runway veer-off at landing, in solo instruction

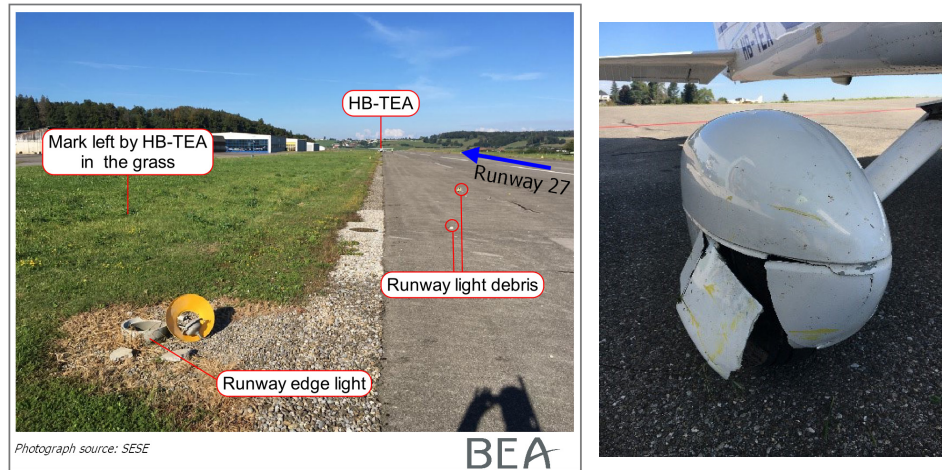
The aeroplane exited the runway to the left. It hit a runway edge light with the RH landing gear. The impact damaged the right landing gear fairing and destroyed the light.

Figure 1: Damage caused to the runway edge light and to the fairing of the right landing gear wheel

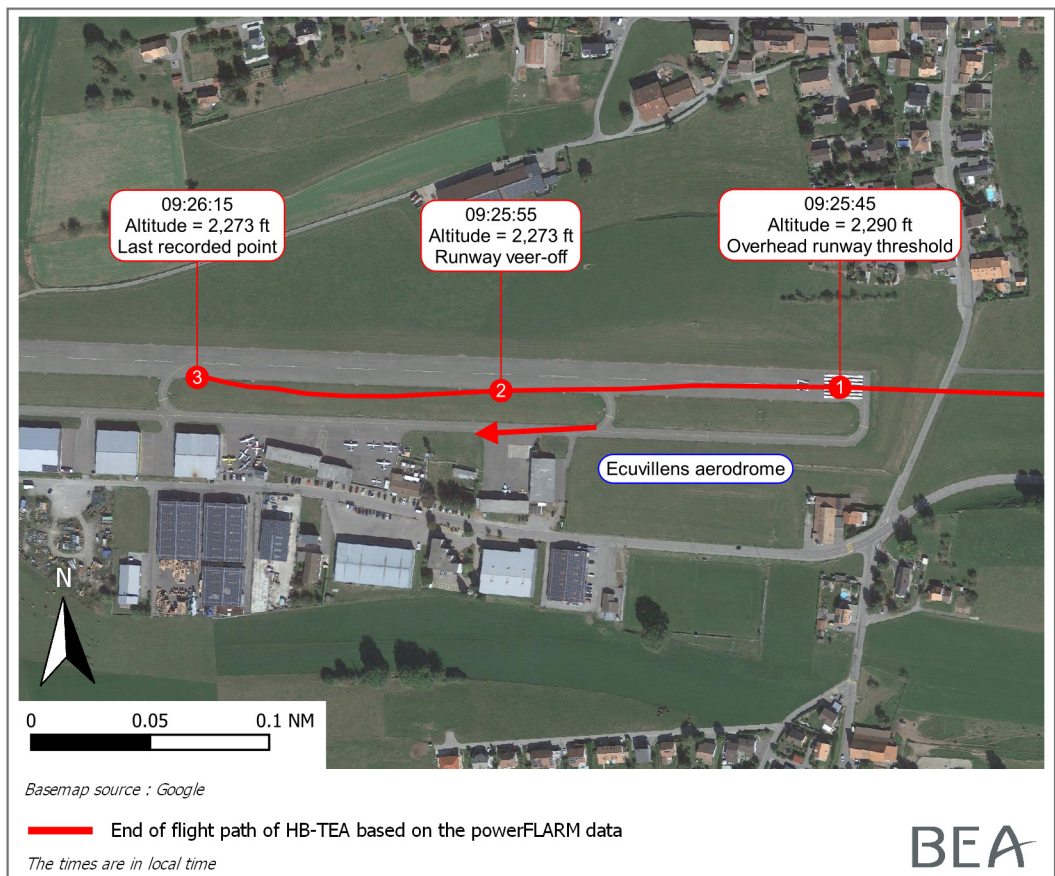
The student-pilot continued to run over the grass steering the aeroplane towards the runway. The aeroplane came to a stop approximately 500 m from the threshold of runway 27⁽³⁾.

Figure 2: Path of HB-TEA during landing run

During the landing, following a bounce due to inadequate flare management, the aeroplane veered to the left. The student-pilot made an insufficient correction using the pedals and the aeroplane exited the runway.
