## Summary report

<b>Aircraft</b>	Schweizer 269C-1	HB-ZLB	
<b>Operator</b>	Heli-Lausanne SA, avenue du Théâtre 7, CH-1005 Lausanne		
<b>Owner</b>	Heli-Lausanne SA, avenue du Théâtre 7, CH-1005 Lausanne		
<b>Pupil</b>	Swiss citizen, born 1987		
<b>Licence</b>	Private pilot licence, aeroplane – PPL(A) according to the European Aviation Safety Agency – EASA, issued by the Federal Office of Civil Aviation (FOCA)		
<b>Flight hours</b>	<b>Total</b> 46:30 h	<b>In the last 90 days</b> 12:20 h	
	<b>On the aircraft type in question</b> 44:15 h	<b>In the last 90 days</b> 11:10 h	
<b>Examiner</b>	Swiss citizen, born 1956		
<b>Licence</b>	<i>Commercial pilot licence helicopter</i> – CPL(H) according to the European Aviation Safety Agency – EASA, issued by the FOCA		
<b>Flight hours</b>	<b>Total</b> 14 795 h	<b>In the last 90 days</b> 62:30 h	
	<b>On the aircraft type in question</b> 1420 h	<b>In the last 90 days</b> 3:40 h	
<b>Place</b>	Botterens / FR

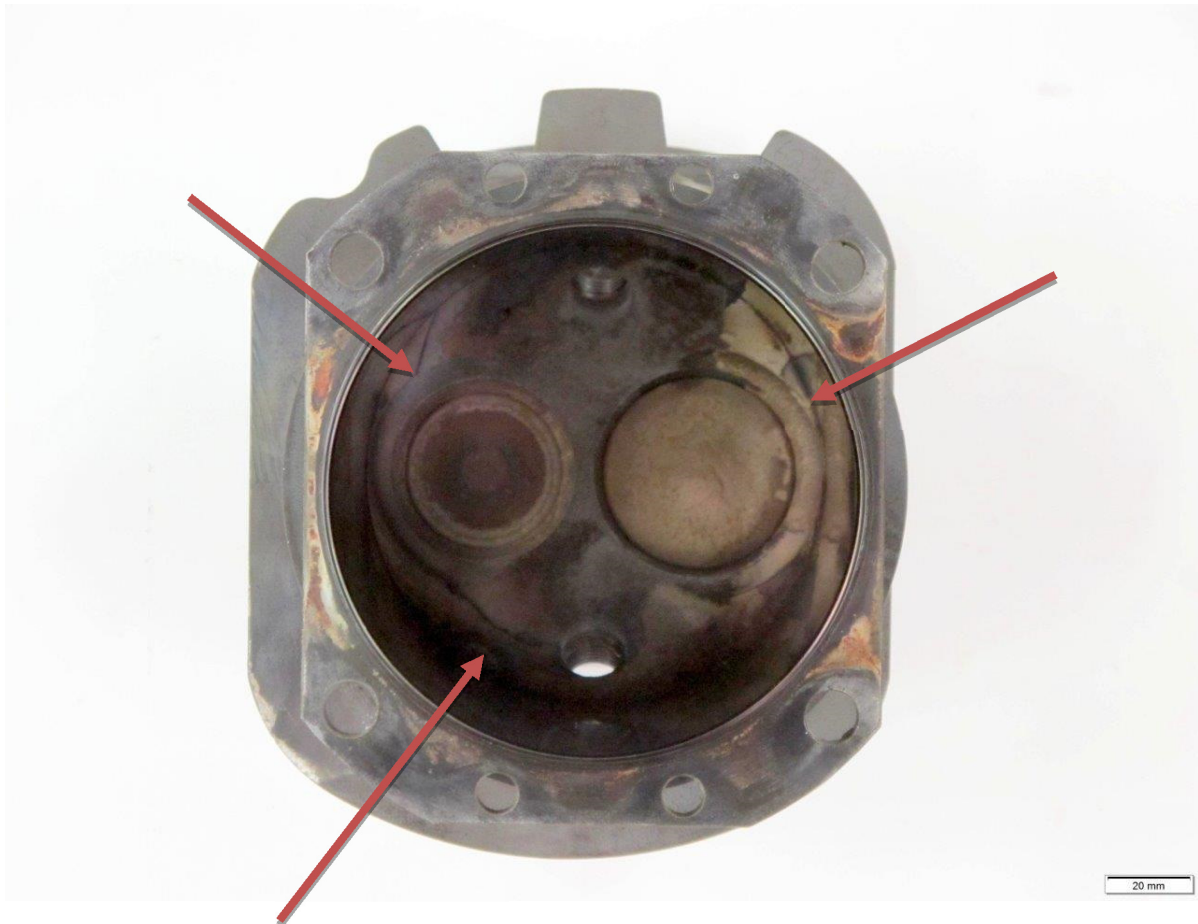
To determine the problem with the engine, the helicopter was transported to a Swiss Transportation Safety Investigation Board site. Qualified staff proceeded to remove the engine, which had accumulated 869 hours since overhaul. A visual inspection revealed a long crack in the head of cylinder 4, starting at the lower spark-plug hole (see figure 1). This crack had caused a loss of compression on cylinder 4, explaining the partial loss of engine power.

**Fig. 1:** The crack in the head of cylinder 4

An examination of the crack showed that its origin was fatigue, and that the surfaces showed signs of overheating.
