# **Interim Report by the Swiss Transportation Safety Investigation Board STSB**

concerning the serious incident involving  
the helicopter Guimbal Cabri G2,  
HB-ZPU,

on 26 June 2021

Bola, Lostallo (canton of Graubünden),  
Switzerland

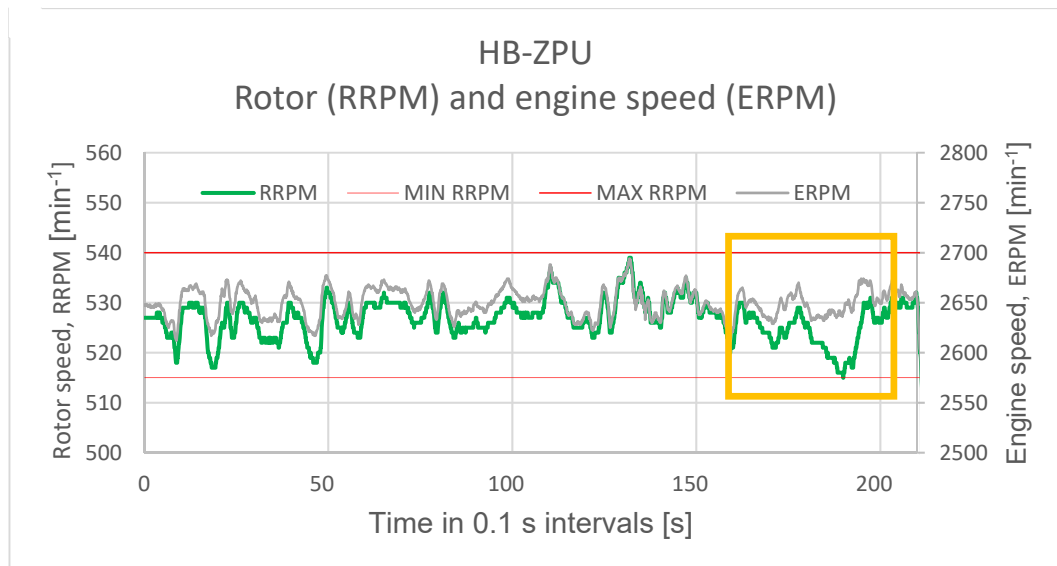
As the helicopter was flying at an altitude of approximately 2,500 ft AMSL, cruising above Lostallo, the clutch light flickered on. After a further approximately 10 seconds, during which the flight instructor also noticed yaw movement by the helicopter and drop in the main rotor speed, a so called needle split,<sup>2</sup> the clutch light remained steady on. In response, the flight instructor commenced an autorotation to a suitable field. When levelling off and performing a flare with power recovery, the flight instructor once again notice a needle split, in which the speed of the main rotor dropped to the bottom of the permitted operating range in relation to engine output (see Figure 1).

**Figure 1:** Illustration of rotor revolutions per minute (RRPM) and engine revolutions per minute (ERPM) prior to and during the serious incident. The needle split is especially visible from 160 s onwards, when it was noticed by the crew (orange square).

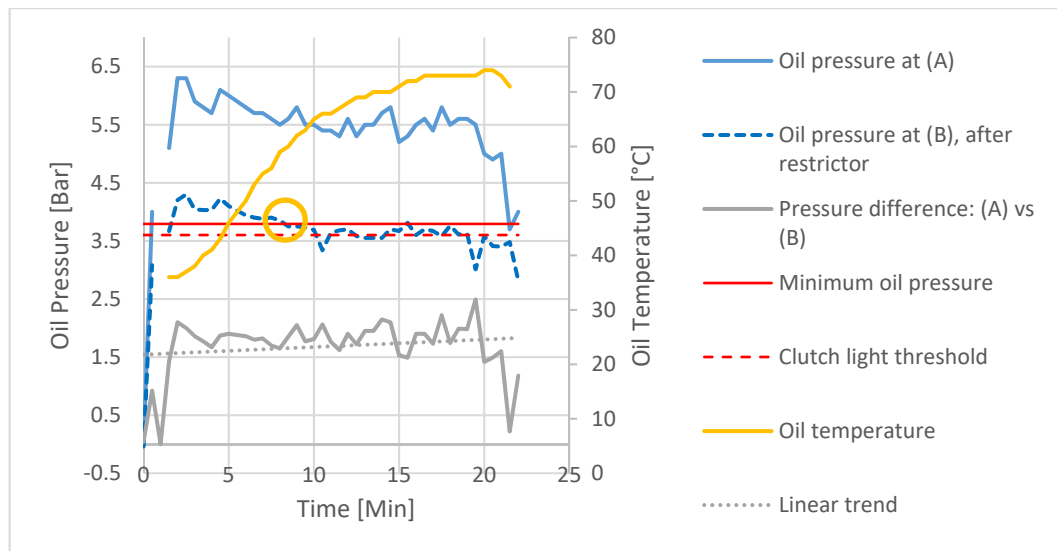
- The settings and values read from the sensor system (oil pressure gauge, oil pressure switch, clutch light oil pressure switch) corresponded to specifications;
- The restrictor was removed and examined. The nominal diameter of 1 mm and the free flow of oil were checked. Both corresponded to specifications;
- There was a difference of around 2 bar (see Figure 4) between the oil pressure displayed on the EPM, measured by STSB with an additional manometer between pick-up point (A) on the accessory housing, and pick-up point (B) downstream of the restrictor (see Figure 3).

**Figure 4:** Oil pressures at the two pick-up points (A) and (B) during a ground run. The graph shows clearly how, from minute 8:30 of the trial onwards, the oil pressure at the pick-up point for the clutch system falls slightly below the minimum permissible operating pressure for continuous operation of 3.8 bar. It is also striking that the difference in pressure tends to widen at a higher oil temperature.

The pick-up point for the feed into the clutch system was located downstream of the narrowed section in the oil duct, close to the point the oil flows into the lubrication system which resulted in a pressure reduced by approximately 2 bar. This lack of pressure going into the clutch system was not measured or shown on the EPM, so the crew could not have been aware of it.

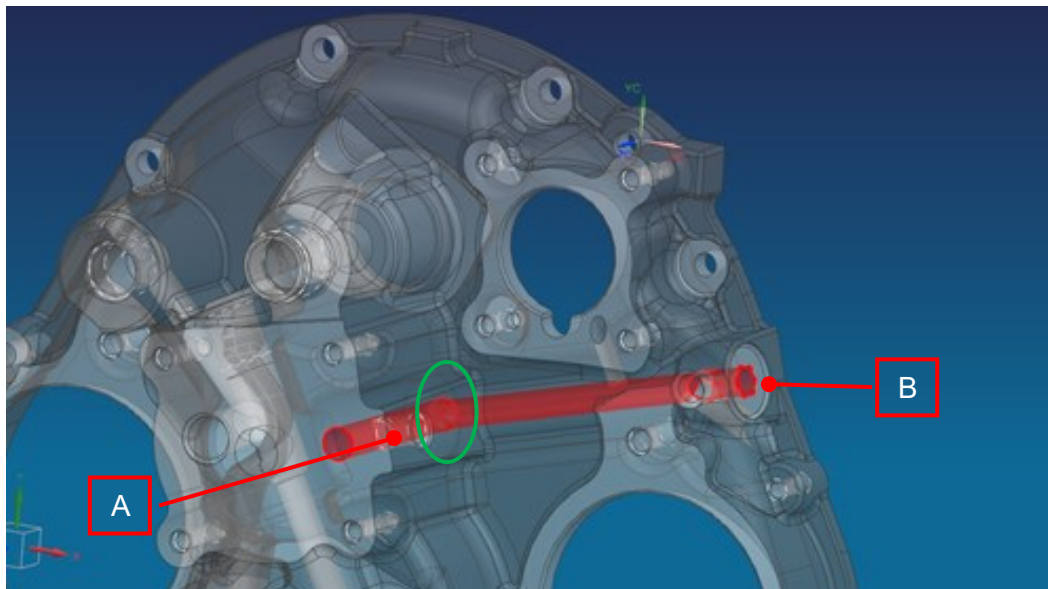
Lycoming Engines notified Hélicoptères Guimbal that free through flow and foreign object damage between the two pick-up points (A) and (B) should be checked, specifically where the oil duct turns at a virtual right angle (see Figure 5).

**Figure 5:** Three-dimensional illustration of the oil duct in the accessory housing. The green circle shows the area to be inspected. (A) and (B) are the two aforementioned pick-up points. The restrictor is installed at (B) (Source: Hélicoptères Guimbal, Lycoming Engines)

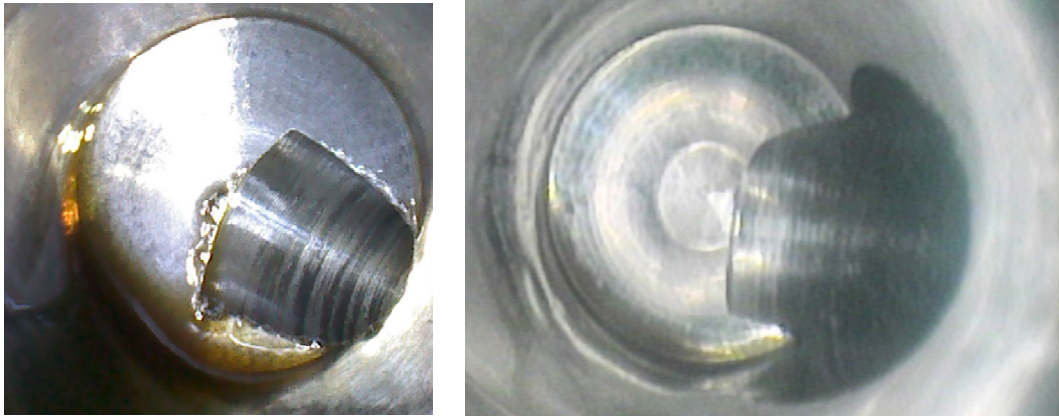
A borescope examination of this area showed that the central axes of the passages in question were not fully centred, meaning that the point of intersection had a reduced pass through section. Machining chips and non-deburred edges could also be seen (see Figure 6, left-hand picture).

Another engine, built in 2017, that had not shown any anomalies in operation also underwent a borescope examination to provide a comparison (see Figure 6, right-hand picture).

**Figure 6:** Passages for engine oil feed (see Figure 5, area circled in green). The left-hand picture was taken during the borescope examination of the HB-ZPU engine. The right-hand picture shows the same area on another Cabri G2 that did not show any anomalies.

The borescope examination of this area found a narrowed section in the duct and also observed chips and non-deburred drill holes. No assessment can be made of whether chips had broken loose and entered the oil system in the course of operation to date. In the present case, STSB estimates the cross-section of this passage was approximately 25–30 % of that of the full cross-sectional area for this channel. In this case, the narrowed section reduced the pressure between the two ends of the duct, as measured after the restrictor, by about 2 bar. This resulted in the pressure going into the engine lubrication system and at the pick-up point for the clutch system falling below the 3.8 bar threshold for normal operations after a certain time. This is due to the reduction in viscosity when temperature rises. At times this pressure even fell below 3.6 bar, which is the threshold at which the tensioning system operates.

The European Union Aviation Flight Safety Agency (EASA) should take appropriate action to ensure that all operators of O-360-series Lycoming Engines identify and remedy narrowed sections of the oil duct in the accessory housing caused by possible manufacturing deficiencies.

The US Federal Aviation Administration (FAA) should take appropriate action to ensure that all operators of O-360-series Lycoming Engines identify and remedy narrowed sections of the oil duct in the accessory housing caused by possible manufacturing deficiencies.

The US Federal Aviation Administration should take appropriate action to ensure that engine manufacturer Lycoming Engines takes the proper steps to remedy the manufacturing deficiencies that have been identified.
