Summary report

Aircraft	Airbus Helicopters MBB-BK117 D-2 (H145)	HB-ZQH
Operator	Schweizerische Luft-Ambulanz AG, PO Box 1414, 8058 Zurich	
Owner	Schweizerische Luft-Ambulanz AG, PO Box 1414, 8058 Zurich	
Pilot	Swiss national born 1979	
Licence	Airline Transport Pilot Licence Helicopter (ATPL(H)) according to the European Union Aviation Safety Agency (EASA), issued by the Federal Office of Civil Aviation (FOCA)	
Flying hours	total 5,615 hrs on aircraft type 54 hrs	during the last 90 days 57 hrs during the last 90 days 54 hrs
Location	1km west of Rüedisbach (BE)	
Coordinates	619 227 / 218 620 (Swiss Grid 1903) N 47° 07' 06" / E 7° 41' 31" (WGS ¹ 84)	Altitude 628 m/M
Date and time	18 January 2021, 13:50 (LT ² = UTC ³ + 1 hr)	
Type of operation	Rescue flight	
Flight rules	Sichtflugregeln (<i>Visual Flight Rules</i> –	
Point of departure	Rüedisbach (BE)	
Destination	Rüedisbach (BE)	
Flight phase	Hovering	
Nature of the serious incident	Serious incident during a rescue operation

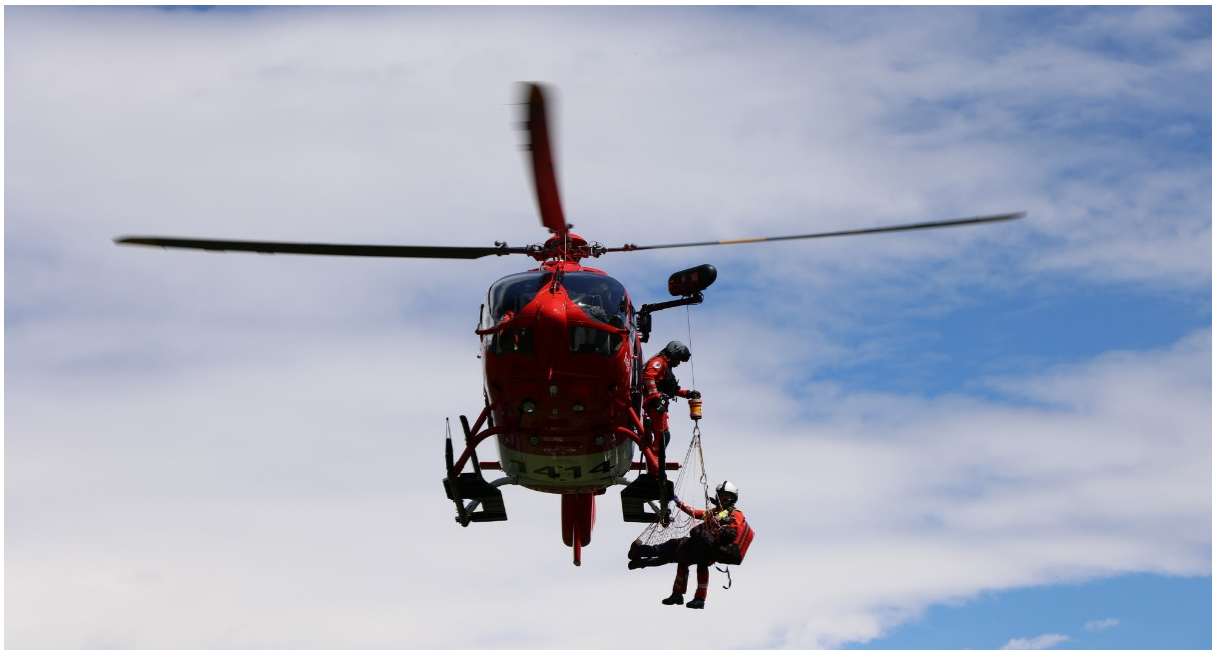
Because of the steeply sloping terrain and the lack of other rescue options, the forestry worker had to be rescued using the rescue winch. Having suffered a blow to the head, the patient was somewhat confused. However, he was responsive and his reactions appeared normal. The MCM prepared the patient for recovery with the horizontal net and positioned him in a lying position as intended (see Figure 1).

Figure 1: Stock image of a patient being rescued by winch in a horizontal net. Source: Rega.
