# **Final report no. 2430 of the Swiss Transportation Safety Investigation Board STSB**

concerning the accident of the helicopter  
Bell 505 Jet Ranger X, HB-ZWC,

on March 12, 2024

Egg, 3 km south of Weinfelden, municipal-  
ity of Bussnang (TG)

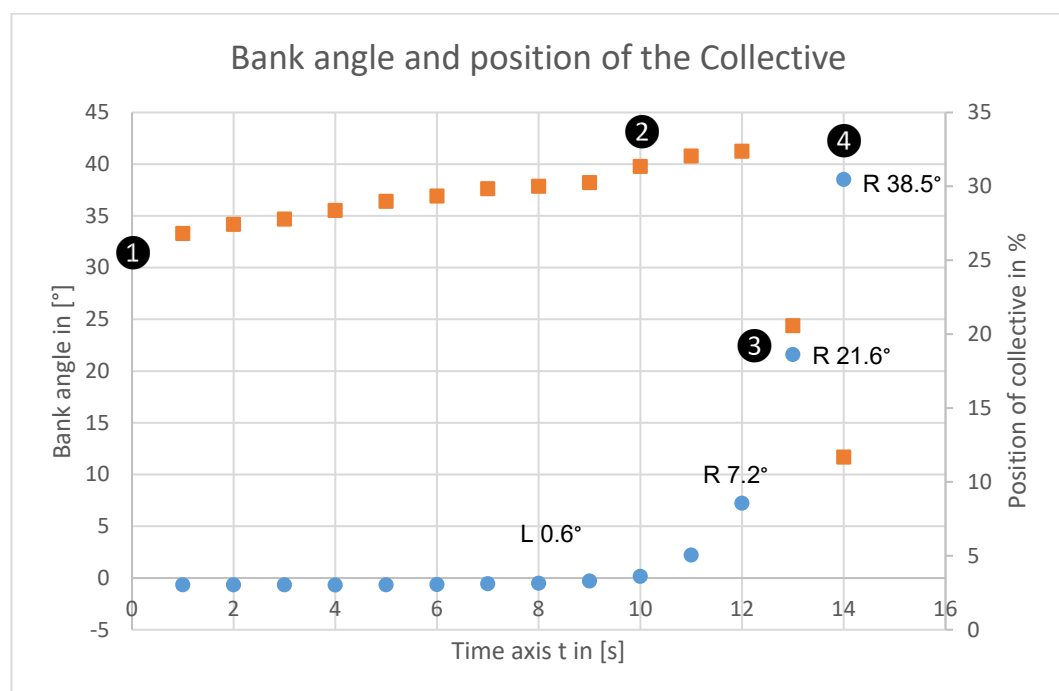
At 11:39:44, the student pilot began to lift off, slowly raising the collective. Around 10 seconds later, the helicopter began a rapid and accelerating rolling movement to the right around the longitudinal axis (dynamic rollover). In the next 4 seconds, the lateral attitude changed from around 0.6° to the left to around 21.6° to the right. At this point, the instructor instinctively tried to stop the rolling movement by quickly lowering the collective (see Figure 2), but was unsuccessful. The last recorded bank angle at 11:39:59 was around 38.5° to the right (see Figure 2 ).

**Figure 2** : Recordings of the on-board navigation instruments for the last 16 seconds before the accident, indicating the bank angle in degrees (blue dots) and the position of the collective in % (orange squares) with the start of the lift-off procedure ① and the increasing bank angle ② as well as a variation of the collective with subsequent rapid reduction ③ up to the last recorded data point of the bank angle ④.

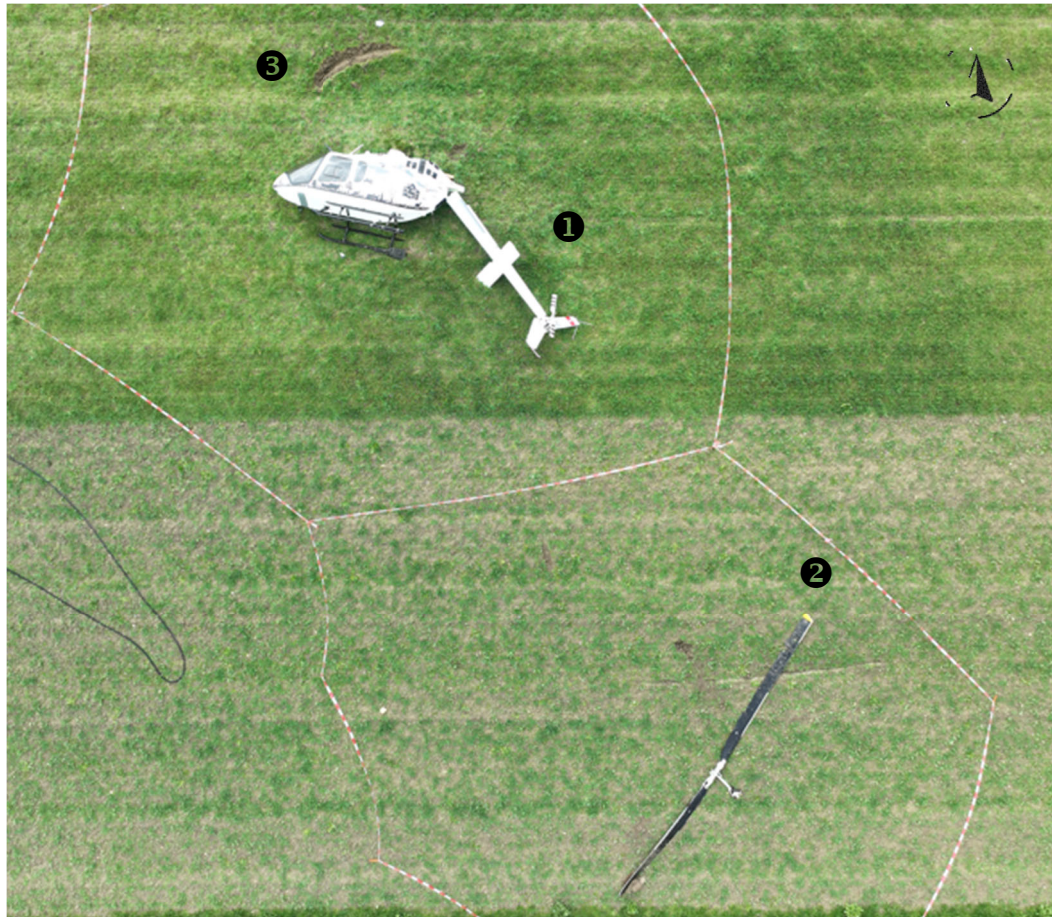
The helicopter was lying on its right side, the airframe and the tail boom were intact except for the fairings in the upper airframe area (see Figure 3 ). The tail boom had broken away and was bent in the area of the attachment points to the airframe. In this area, the tail rotor drive shaft was separated, and the tail rotor control cables were under high tensile stress.

The main rotor mast was broken above the main gearbox; the entire main rotor system was about 20 meters away from the helicopter in the field.

The impact mark of a main rotor blade was visible on the ground to the north of the helicopter cabin. The outer end of one rotor blade was severed by around 40 cm.

**Figure 3 :** Final position of the HB-ZWC with bent tail boom ① and detached main rotor system ②. Above the airframe, the impact mark of a main rotor blade can be seen in the ground ③. Source: Thurgau cantonal police.

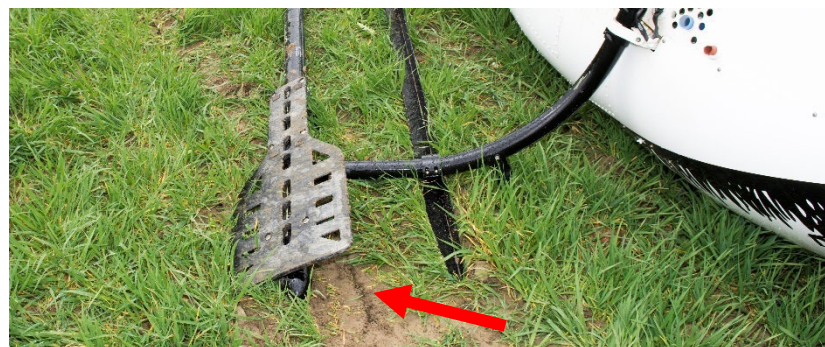
The bear paw of the right skid was turned markedly inwards. A ground scar was visible close to the bear paw of the right skid which had been pressed sideways into the ground (see Figure 4 ).

**Figure 4 :** Right skid with bear paw turned markedly inwards. A ground scar caused by the bear paw pressed laterally into the ground can be seen in the ground (red arrow).

The right bear paw was found markedly rotated inwards, the left bear paw slightly rotated inwards (cf. Figure 4 ).

Based on the findings of the bolted connections on the bear paws, it can be concluded that all self-locking fastening nuts of the bear paws were not tightened to the correct final torque, consisting of the friction drag torque or tare torque and the desired torque or recommended torque of 40 in/lb.

The torque value found on the bolted connections corresponded only to the tare torque for this type of fasteners. Whether this was due to the use of an unsuitable socket wrench insert with an excessively thick wall, contrary to the STC holder's instructions in the installation and maintenance documents, or due to an incomplete installation process, remains open.

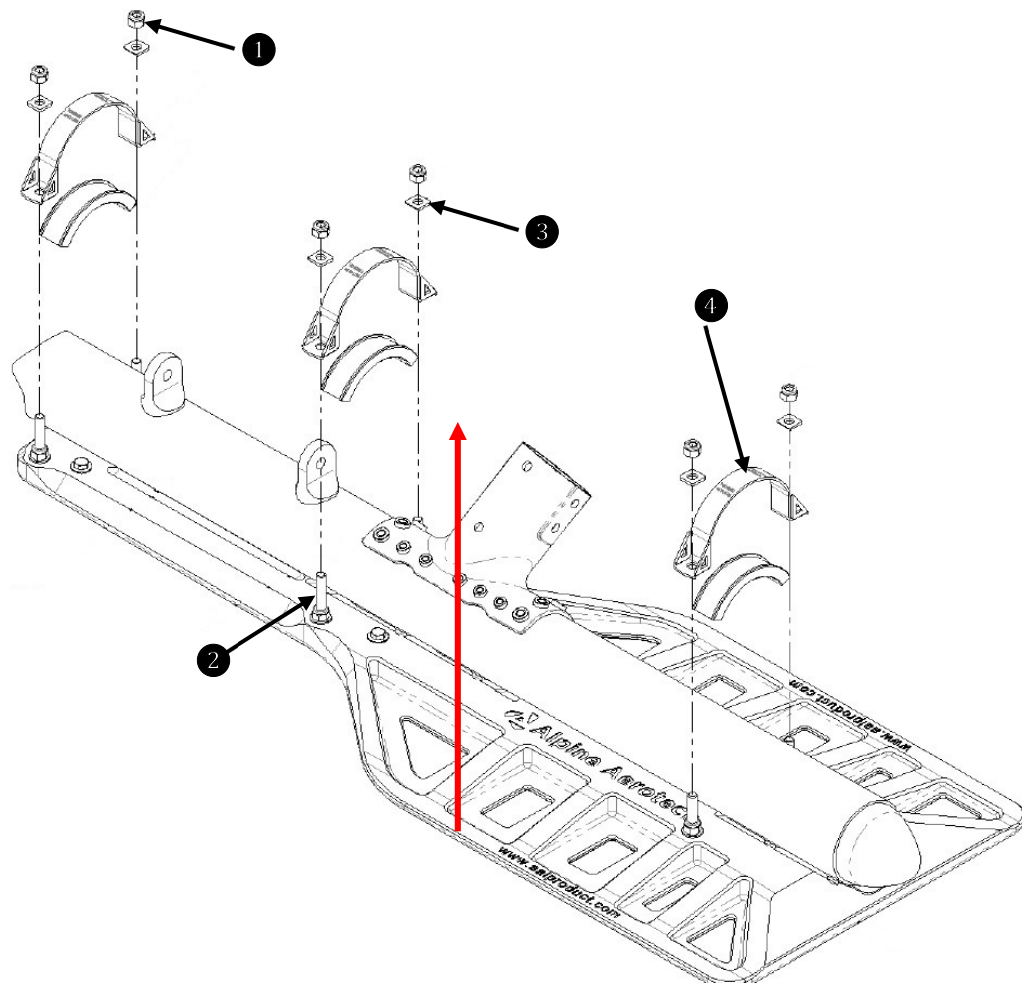
Furthermore, the STC holder specifies that the self-locking fastening nuts (see Figure 5, No. 1) should only be tightened evenly with a torque wrench to 40 in/lb once the helicopter is back on the ground. It is important to note that a thin-walled socket is required to properly tighten the self-locking fastening nuts. The fastening straps (strap assy; see Figure 5, No. 4) are labeled with this tightening torque, although the writing was difficult to read.

**Figure 5 :** Assembly drawing of the bear paw with fastening nut ①, screw ②, washer ③ and fastening bracket ④. The red arrow indicates the point at which the force to turn a bear paw around the longitudinal axis of the runner was measured. Source: ICA of the STC holder.

When the helicopter was raised, the bear paws on the left and right skids could be rotated by hand around the longitudinal axis of the respective skid with little effort. According to the STC holder Alpine Aerotech, the force required to turn a properly tightened bear paw around the longitudinal axis of the skid should be around 220 to 270 N (measured with a spring balance on the outer edge of the bear paw, see

red arrow in Figure 5 ). This value is not noted in the technical documentation (see chapter 1.4.2 and chapter 1.4.4). In this case, the required force was around 20 N.

On the bear paws of the left and right skid, the washers on the 12 bolted connections could be partially moved by hand. The fastening nuts on all bolted connections were turned almost equally onto the bolts or there was the same amount of play between the washers and nuts.

The measured torque for all bolted connections was between 1.5 Nm and 2 Nm (corresponding to 13.3 in/lb and 17.7 in/lb), which corresponds to the tare torque for this type of bolted connection.

According to the STC holder, the force required to turn a bear paw on the skid tube should be between 220 and 270 N. However, this value was not mentioned in the installation and maintenance documents. A corresponding checklist item on the installation instructions and in the flight manual supplement would most likely have made it possible to detect the loosely installed bear paws, which is why the STSB issues a safety advice (see chapter 4.2.1).
