# **Final Report No. 2384**

concerning the serious incident involving  
the aircraft PA-28-181, LX-AVA,

on 19 July 2020

approximately 2 km west of the airport  
St. Gallen-Altenrhein (LSZR)

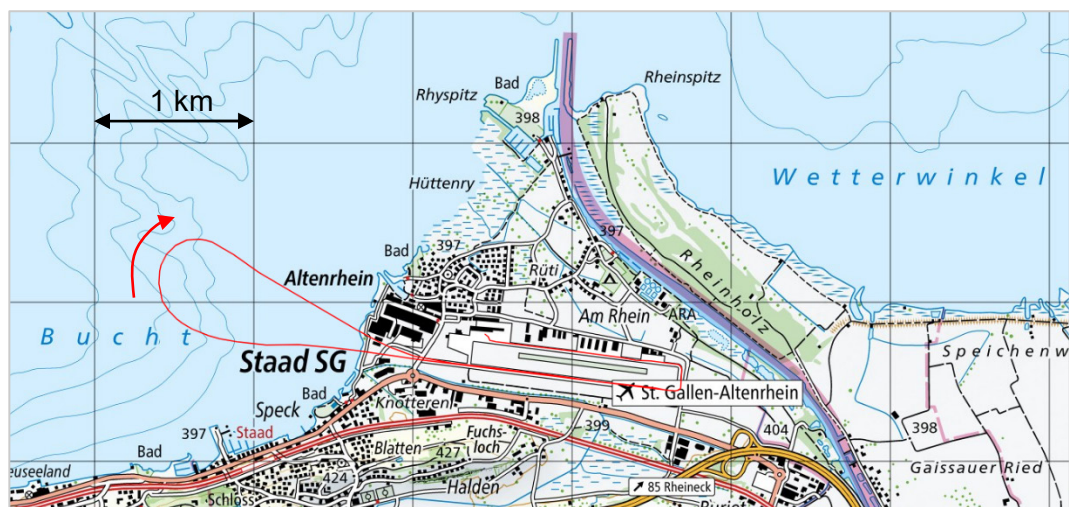
**Figure 1:** Flight path of LX-AVA (red line) after take-off from St. Gallen-Altenrhein (LSZR) on runway 28, followed by a reversal turn and subsequent landing on runway 10. Source of map: Federal Office of Topography.
