Summary Report

Aircraft	SF50 Vision Jet	N474CG		
Operator	I-Fly AG, c/o Aximos Treuhand AG, Baarerstrasse 11, 6300 Zug, Switzerland			
Owner	Southern Aircraft Consultancy Inc Trustee, Office 3, Earsham Hall, Bungay Norfolk, England			
Flight instructor	Swiss national, born 1961			
Licence	Airline Transport Pilot Licence Aeroplane (ATPL(A)), issued by the American Federal Aviation Administration (FAA)			
Flying hours	Total	27,610 h	during the last 90 days	246:30 h
	on the aircraft type	99:31 h	during the last 90 days	32:34 h
Student pilot	German national, born 1978			
Licence	Commercial Pilot Licence Aeroplane (CPL(A)) according to the European Aviation Safety Agency (EASA), issued by the Federal Office of Civil Aviation (FOCA).			
Flying hours	Total	478 h	during the last 90 days	4:29 h
	on the aircraft type	0:59 h	during the last 90 days	0:59 h
Location	Zürich airport (LSZH)			
Co-ordinates	-	Altitude		-
Date and time	22 September 2018, 20:17 (LT = UTC + 2 h)

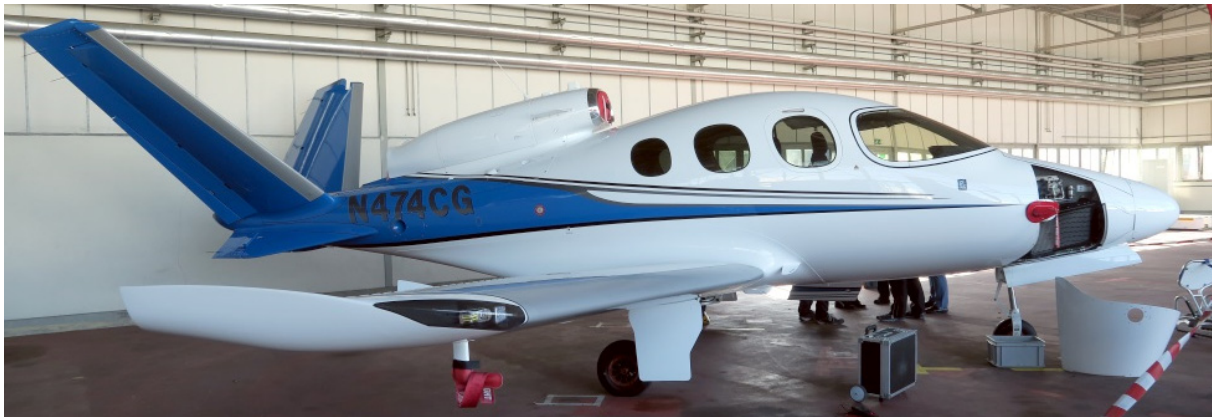
Two days later, the PIC commissioned an avionics company to troubleshoot the aircraft. After the engineer removed the access panel on the right of the nose fuselage, he noticed severe

burn marks at the air-conditioning compressor and substantial soot deposits over the entire fuselage interior (see Figure 1 and Figure 2).

Figure 1: N474CG with the access panel removed from the right of the nose fuselage.

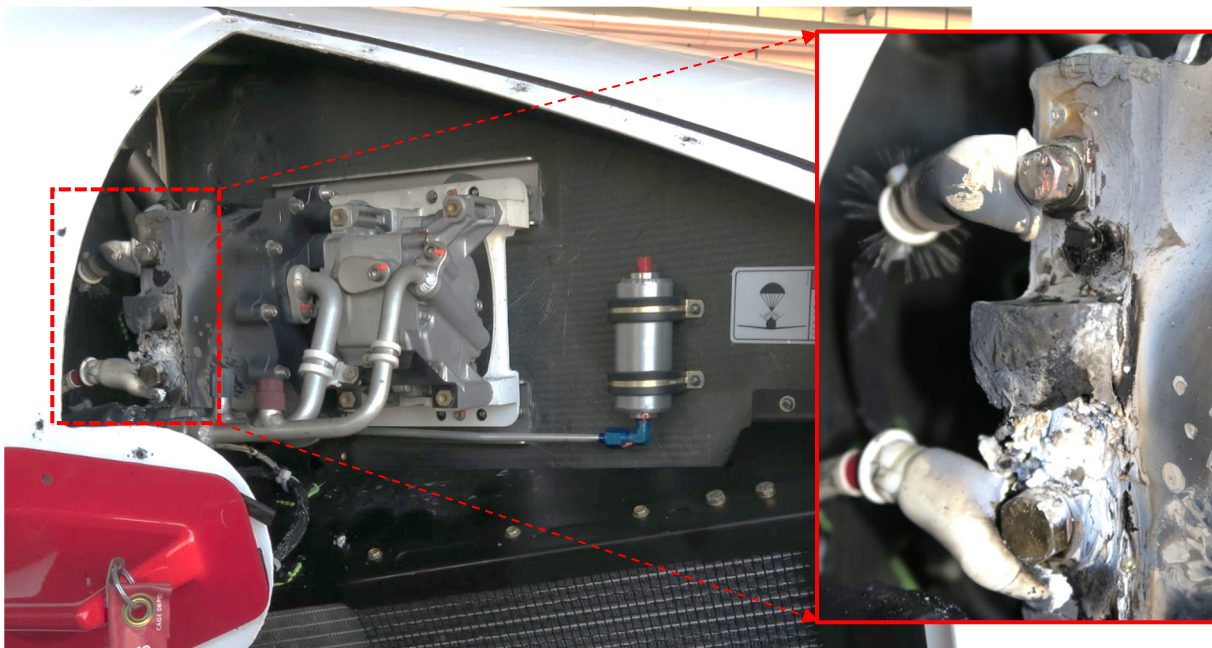
Both the fuselage interior in the vicinity of the air-conditioning compressor and the interior of the access panel were heavily coated with soot. The compressor itself exhibited severe burn marks at the electrical terminals (cf. Figure 2). A white burn mark was found above the terminal screw of the positive pole, and a metallic melting bead was found immediately next to this. The area around the negative pole had only been subjected to minor thermal loads.

Figure 2: Interior of the right of the nose fuselage: Air-conditioning compressor with burn marks on the electrical terminals (top: negative pole, bottom: positive pole) and fire residues throughout the fuselage interior.

A viscous mass with granular inclusions was found below the electrical terminals. Traces of an oily substance could be seen running down the nose wheel strut.

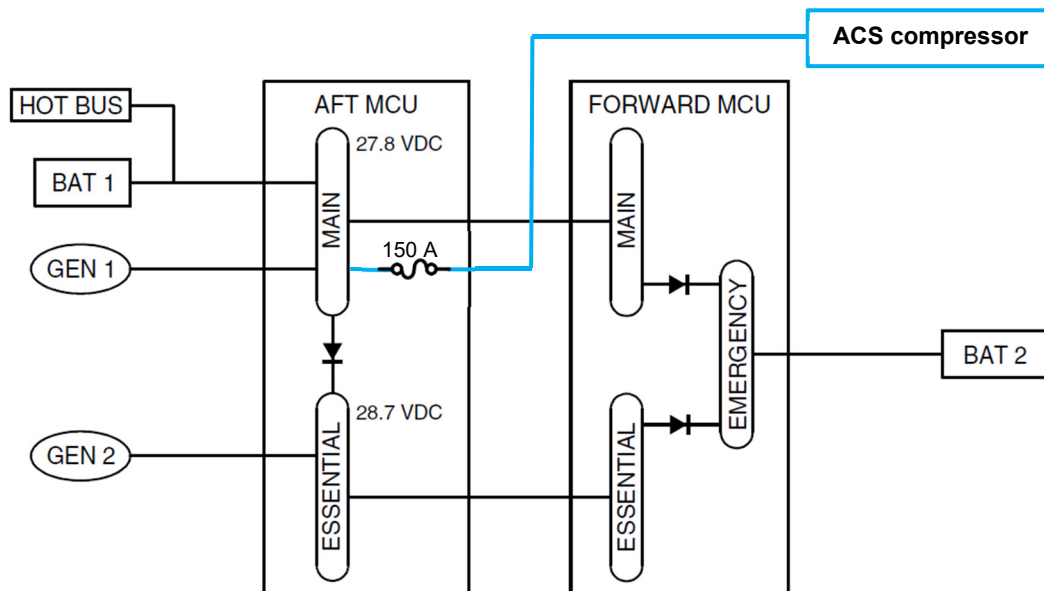
Figure 3: SF50 electrical system block diagram from the Aircraft Flight Manual (AFM), amended by the STSB.

The ACS compressor is supplied from the rear (AFT) MCU. The power cable to the compressor runs through the aft bulkhead under the cabin floor and through the forward bulkhead as far as the nose fuselage. It is protected in the AFT MCU by a 150 A fuse (shown in blue, cf. Figure 3). The compressor is controlled by a controller mounted directly on the compressor.

Working through the smoke removal checklist would have resulted in all the electrical consumers being switched off apart from battery 2, which only feeds the emergency bus (cf. Figure 3) with electrical power. The ECS, ACS and the ACS compressor would also have been deactivated in this case.

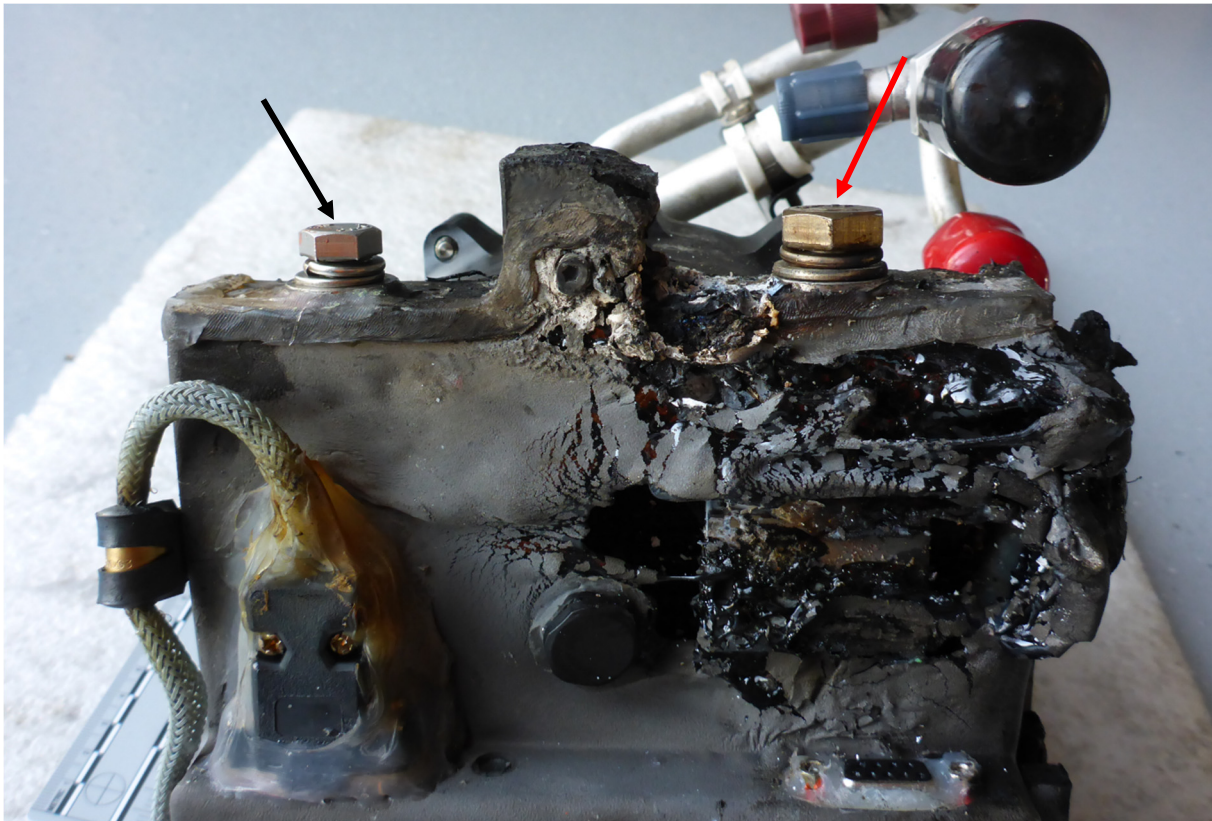
Figure 5 shows the damage to the controller of the compressor in its removed state. Figure 6 shows the controller compared to an undamaged unit, the plastic cover of which has been removed.

Figure 5: Side view of the compressor controller with the positive pole (red arrow) and the negative pole (black arrow).

A more detailed inspection of the damaged controller showed that the Printed Circuit Board (PCB) had become detached from the heat sink at the main current input. This part of the PCB

exhibited severe damage, which indicated both local heat generation of over 900 °C and corrosion damage.

SB5X-21-03 "27 Dec 2018, 21-50 Cooling – Air Conditioning Compressor Electrical Power Input Ports Inspection" states that on aircraft with the applicable serial numbers, the electrical voltage and resistance between the terminals (positive and negative poles, see Figure 5) must be measured at regular intervals to rule out any possible ingress of moisture or water in the compressor controller. If specific limit values are exceeded, the compressor must be replaced.

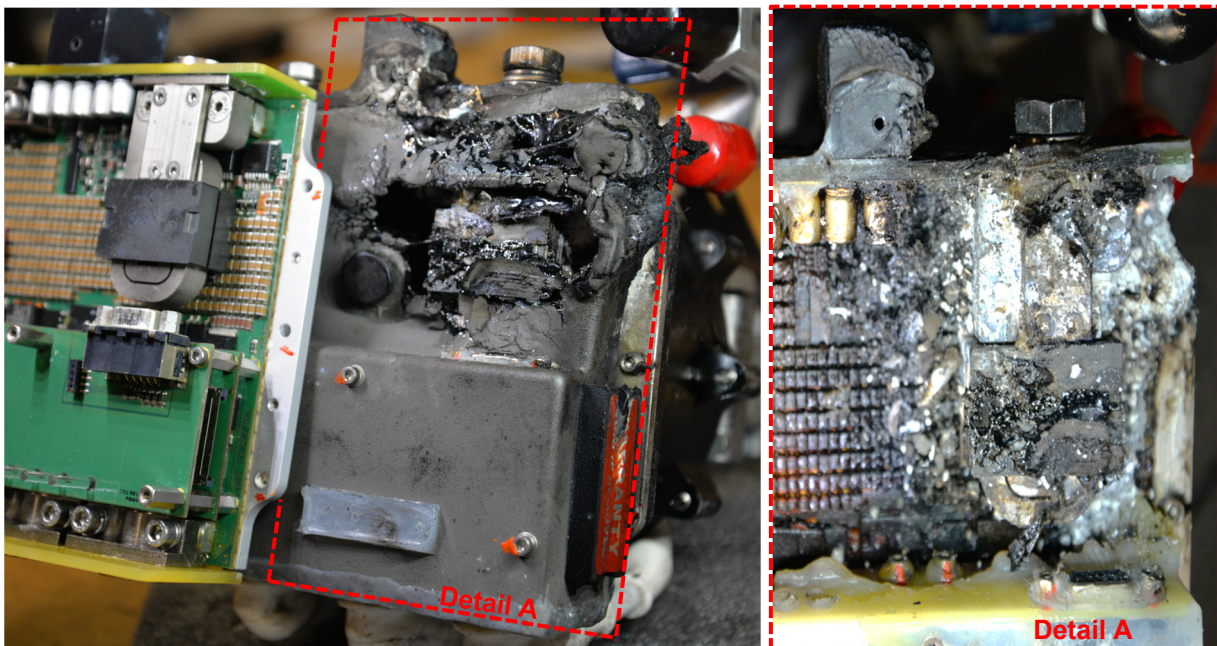
Figure 6: Damaged controller compared to an undamaged controller without the plastic cover (left) The detail on the right shows the damaged controller with the plastic cover removed.
