# **Final report No. 2408**

## **by the Swiss Transportation Safety Investigation Board STSB**

concerning the serious incident involving  
the aircraft Rockwell 112 “Commander”,  
N559SG,

on 18 September 2021

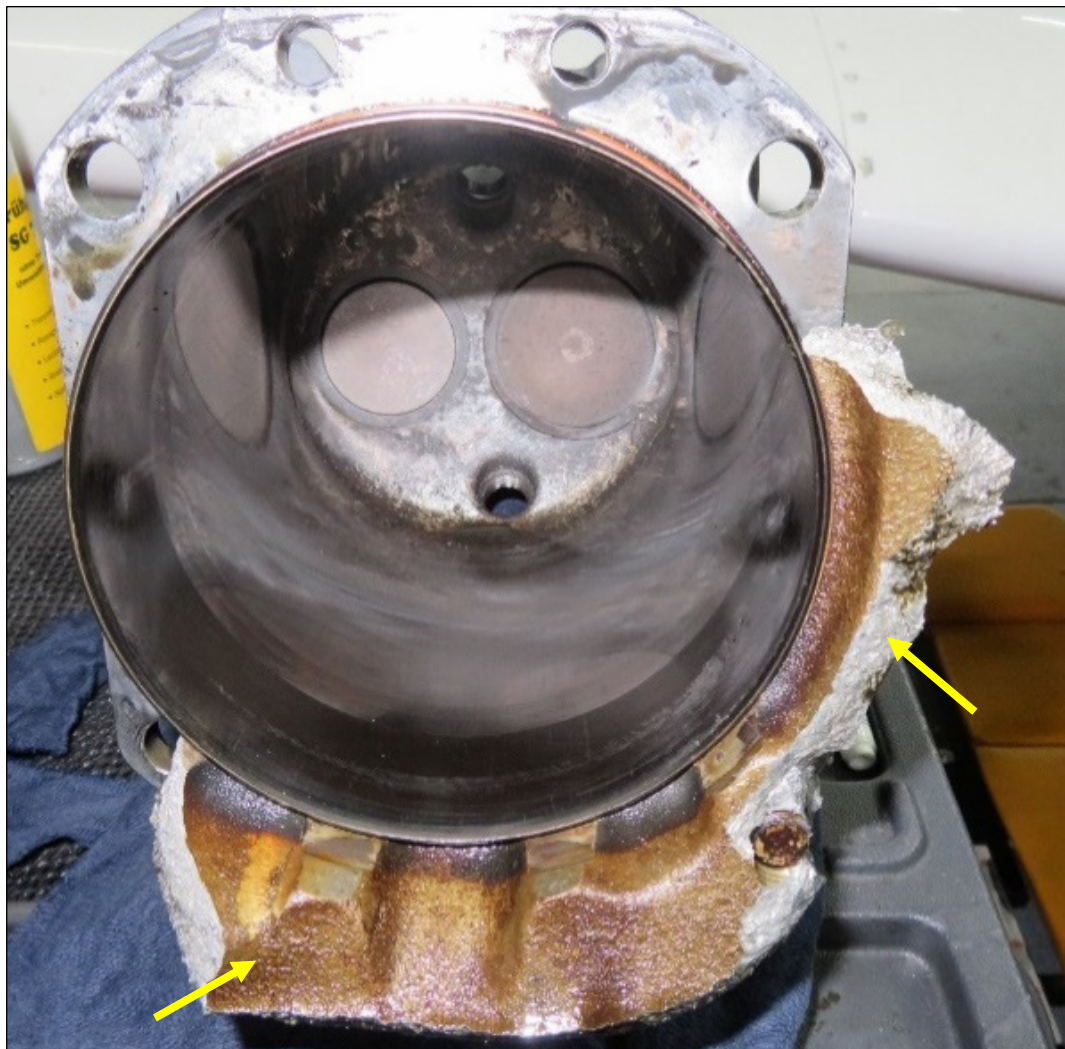
On cylinder #1, the exhaust flange had separated from the exhaust pipe and a large segment of it was cracked; the intake hose was loose and damaged on both sides. The damage had most likely been caused over some time. Furthermore, a stud bolt was broken and the engine case was cracked around the cylinder (cf. figure 2).

**Figure 2:** Cylinder #1 with cracked engine case (yellow arrows).

All things considered, it seems clear that the fracture in the engine case was the result of material fatigue.

The serious incident, in which the pilot performed a precautionary landing off-airfield because the engine was not running smoothly, is due to age-related engine damage.
