# **Final Report No. 2390**

## **by the Swiss Transportation Safety Investigation Board**

concerning the accident involving the  
drone Matternet M2 V9, SUI-9903,

on 9 May 2019

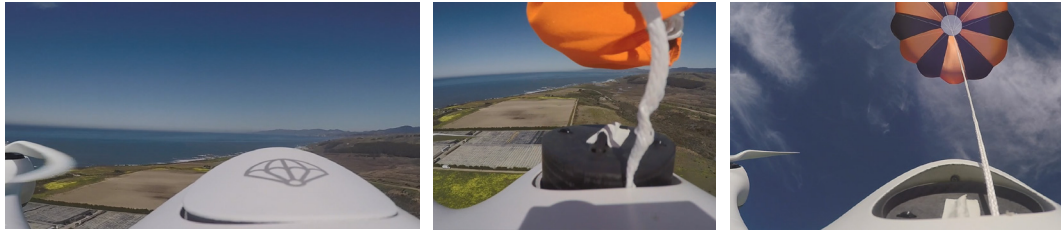
**Figure 2:** Image sequence of the parachute ejection during a test of the autonomous flight termination system (FTS). There are no danger and warning labels for first responders on the drone (source: Matternet).

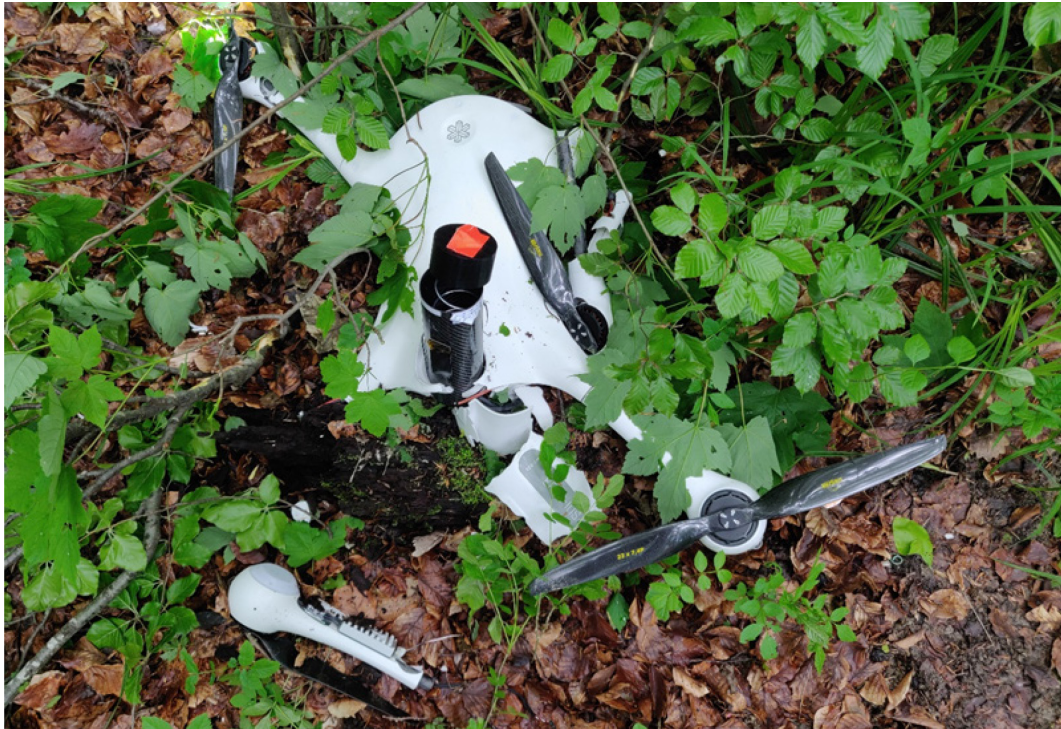
The drone was largely destroyed on impact with the forest floor (cf. figure 3). One propeller blade was not found at the accident site. Furthermore, no remains of the connecting rope to the emergency parachute were found on the structure of the drone. The acoustic warning signal was faintly audible at the crash site.

**Figure 3:** Final position of the destroyed drone SUI-9903 at the crash site

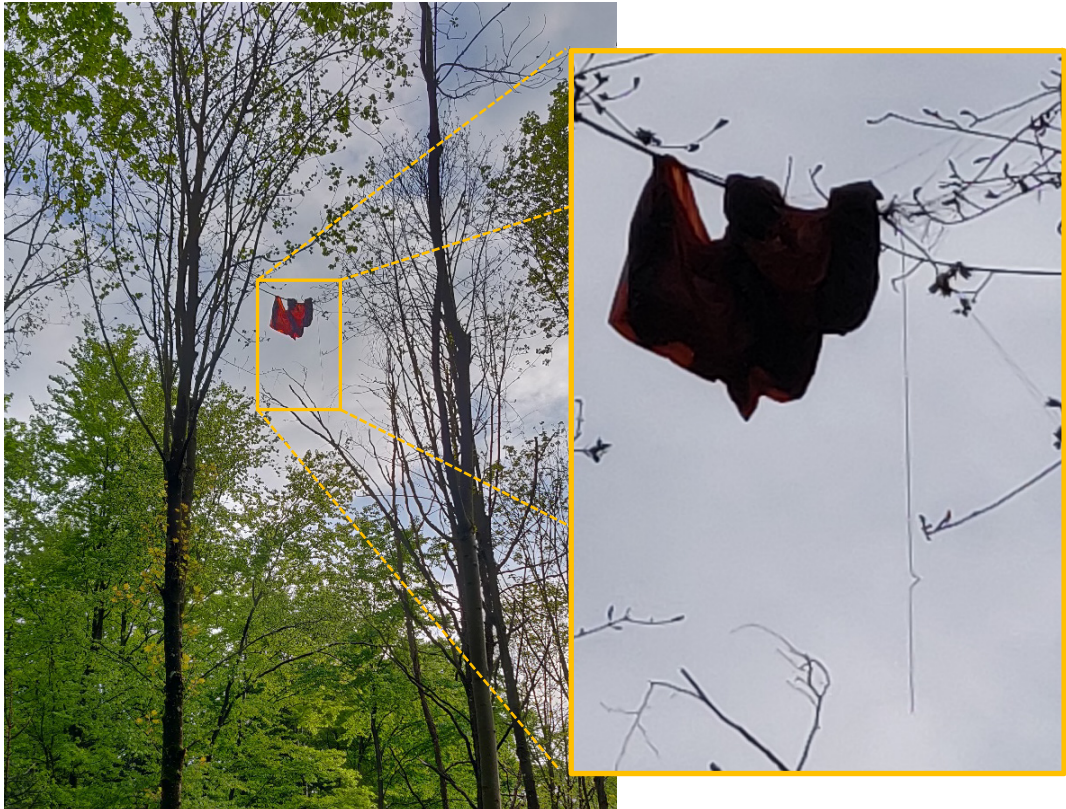
The severed parachute with an intact connection to the bridle became entangled between two trees about 330 m northeast of the crash site (cf. figure 4).

**Figure 4:** Location of the parachute separated from the drone

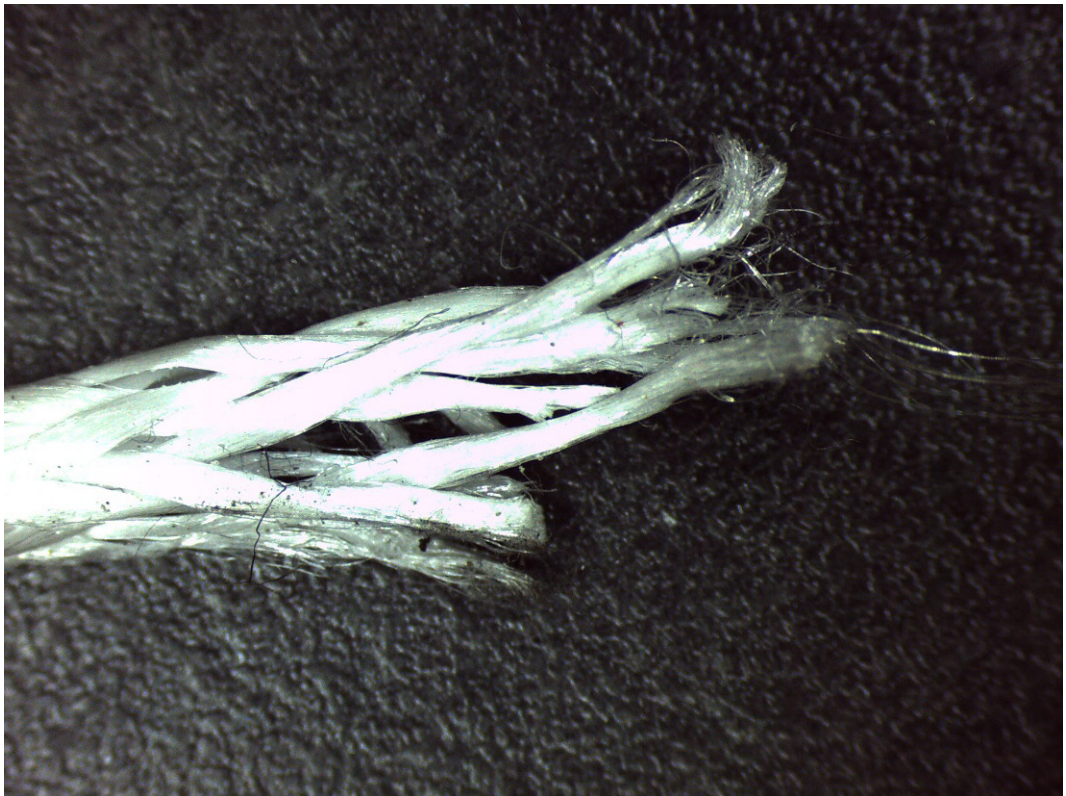
The connecting rope was cut at the drone end and showed signs of cuts and cracks (cf. figure 5).

**Figure 5:** Cut and tear point of the connecting rope

Based on the deformation of the aluminium chassis and the crack fracture on the connecting rope, it can be concluded that it was suddenly decelerated by the forces generated during the ejection of the parachute as a result of the braking effect and was cut at the sharp upper edge of the chassis (cf. figure 5 and figure 6). The connecting rope, which was designed for tractive force, was pre-damaged by the sharp edge at the drone-side attachment point. As a result, it could not withstand the tensile load of the deploying parachute and snapped. This separated the emergency parachute from the transport drone and the aircraft crashed without deceleration.

- *Shock cord mounting on the chassis improved by eliminating sharp edges and adding stainless steel sheathing over areas in contact with the chassis.*
- *Dual shock cords added for redundancy.*
- *Parachute system updated and tested per ASTM F3322-18 including ASTM standardized warning label.*
- *Added a louder 100 dB buzzer that sounds after FTS as the aircraft descends under a parachute.*
- *Modification of the Buzzer to be a continuous siren rather than an on/off beep.*

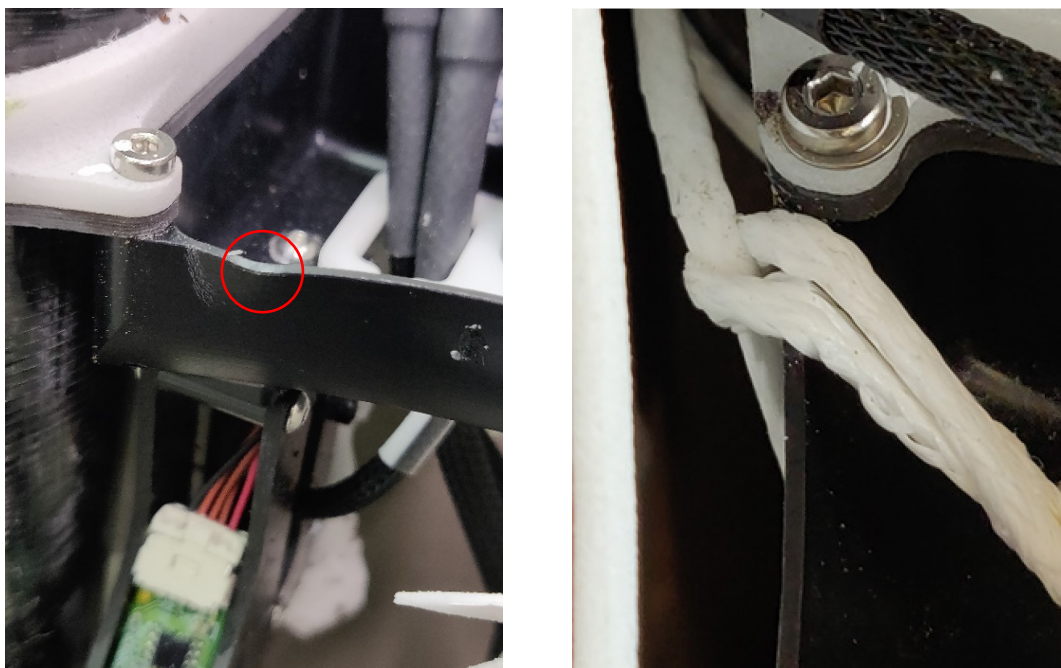
The attachment point on the structure of the drone showed clear deformations (cf. figure 6).

**Figure 6:** Clearly visible deformation of the sharp-edged attachment point (red circle) on the SUI-9903 drone involved in the accident (left) as well as the intact attachment of the connecting rope of an identical drone (right).

- The drone-side attachment point of the parachute, which was a boom of a propulsion unit, had a sharp edge at the deformed point (cf. figure 6).
- A crack fracture could be identified on the connecting rope. Compared to an identical parachute, the last piece of about 4 cm was missing, which corresponded to the circumference of the boom of the drone to which the line was attached. This missing piece of the connecting line could not be found.

- After the parachute was ejected, its connecting rope broke because it had been damaged by the sharp edge at the drone's attachment point.
- As a result, the drone plunged into the forest from about 100 m above ground and was destroyed when it hit the forest floor without deceleration.

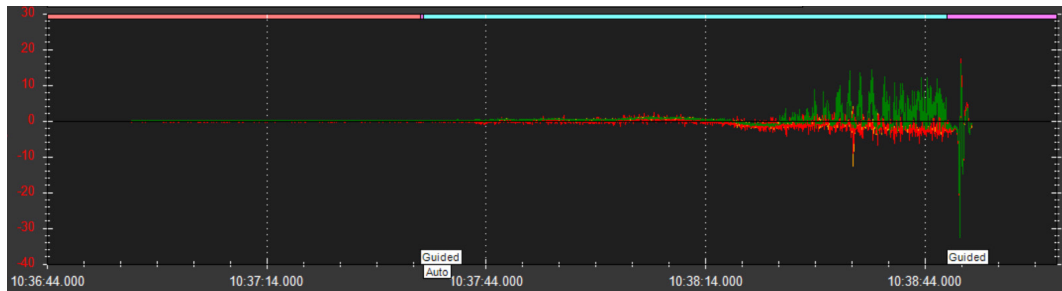
From this point onwards, all three IMUs recorded clearly increasing vibrations, and the associated acceleration values were sometimes well above  $30 \text{ m/s}^2$ . As a result, the drone continuously accelerated and decelerated by varying the pitch angle, which repeatedly exceeded the maximum value of  $-20^\circ$  to  $+20^\circ$  defined for this drone. This led to violent oscillations of the attitude, with the speed of the drone over ground varying between around  $13 \text{ m/s}$  and  $17 \text{ m/s}$  at peaks.

In addition to the vibrations detected by the Inertial Measurement Units (IMU) via the acceleration sensors, there were noticeable deviations between the data of the first two units (IMU1 and IMU2) and IMU3 in all three axes from 10:38:24 onwards; those along the Y-axis are shown as an example (cf. figure 8).

**Figure 8:** Time course of the deviations from the dimensionless values of the accelerometers using IMU1 (orange), IMU2 (red) and IMU3 (green).

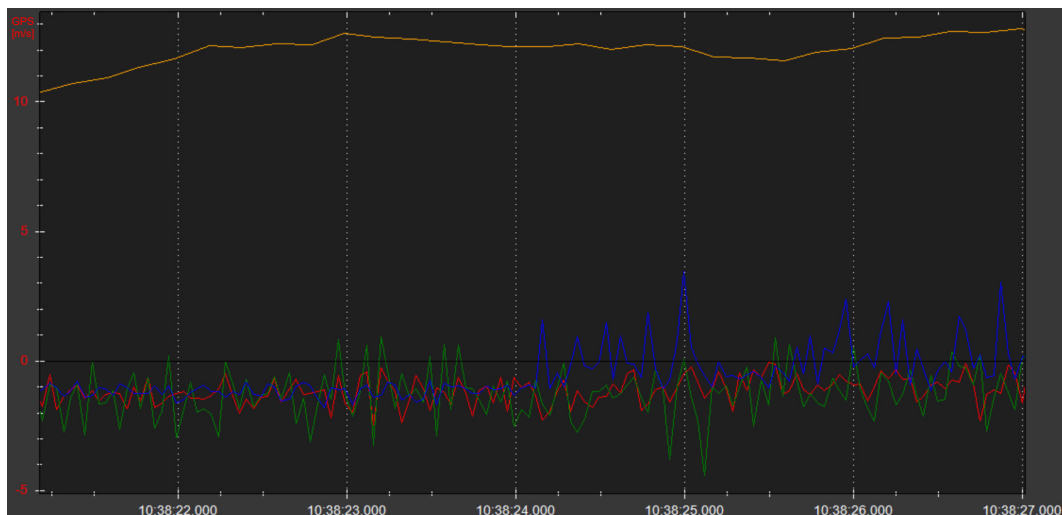
A detailed view of the time ranges from 10:38:21 to 10:38:27 (cf. figure 9) and from 10:38:31 to 10:38:38 (cf. figure 10) clearly shows that strong deviations in the acceleration values of IMU3 occurred abruptly from 10:38:24, while IMU1 and IMU2 continued to deliver similar acceleration values. In the further course of time, these deviations increased in regular cycles.

**Figure 9:** Time section (10:38:21 to 10:38:27) of the course of the deviations from the dimensionless values of the acceleration sensors using IMU1 (red), IMU2 (green) and IMU3 (blue) as well as the GPS speed (orange) in m/s.

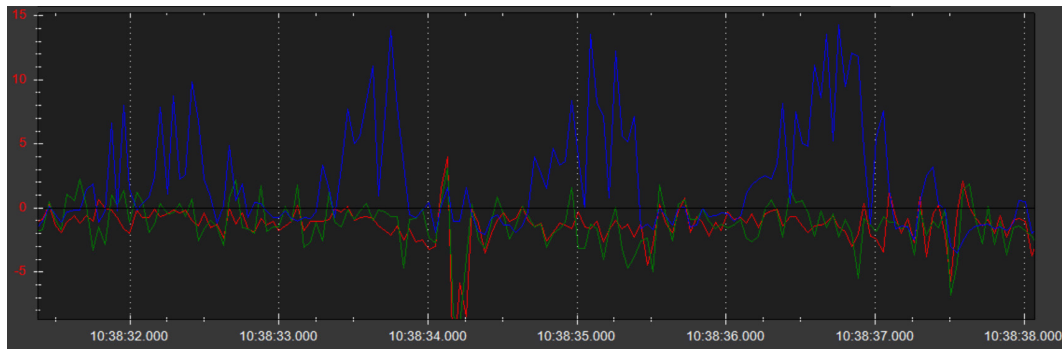
**Figure 10:** Time section (10:38:31 to 10:38:38) of the course of the deviations from the values of the acceleration sensors using IMU1 (red), IMU2 (green) and IMU3 (blue). From about 10:38:32, a clear oscillation (blue line) with a frequency of about 2/3 Hz can be seen.
