## Summary Report

| Aircraft | Cessna C525 | | YU-BST | |
| Location | CTR Sion (LSGS), approx. 2 NM before runway 25 | | | |
| Incident type | Near collision with Remotely Piloted Aircraft System (RPAS <sup>1</sup> ) | | | |

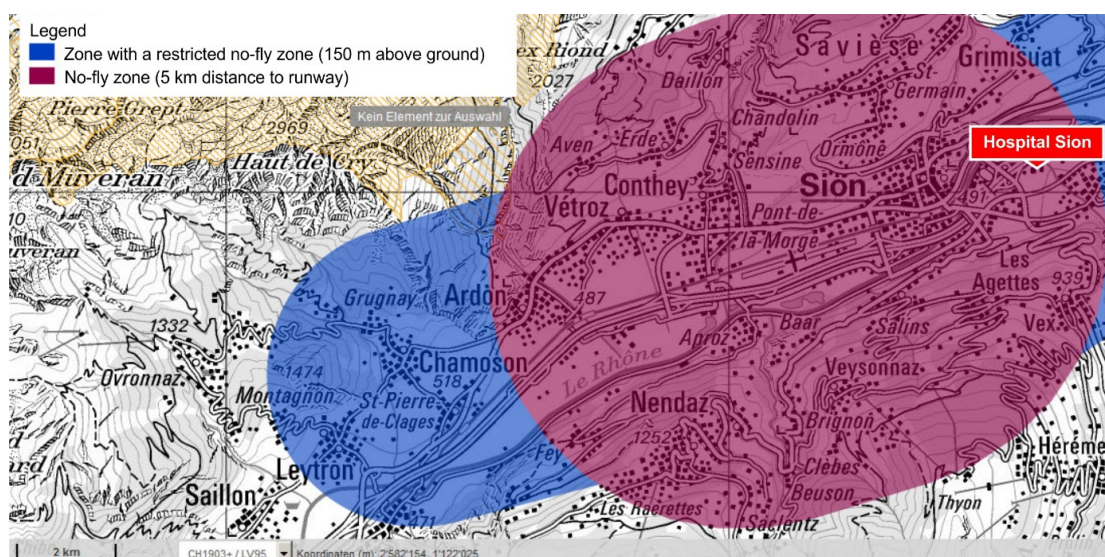
**Figure 1:** Map published by FOCA with the restrictions around LSGS and with the location of the hospital, where the mid-air encounter took place.

As seen in Fig.1 the serious incident took place within the no-fly zone of LSGS. Since the pilot of this Remotely Piloted Aircraft System (RPAS) is unknown, it is not possible to determine the drone-pilot's knowledge concerning the existing legislation.
