Final Report by the Swiss Transportation Safety Investigation Board STSB

on the marine casualty concerning the
Swiss-flagged general cargo ship SABINA

off the island of Bornholm, Denmark,

on 15 October 2015

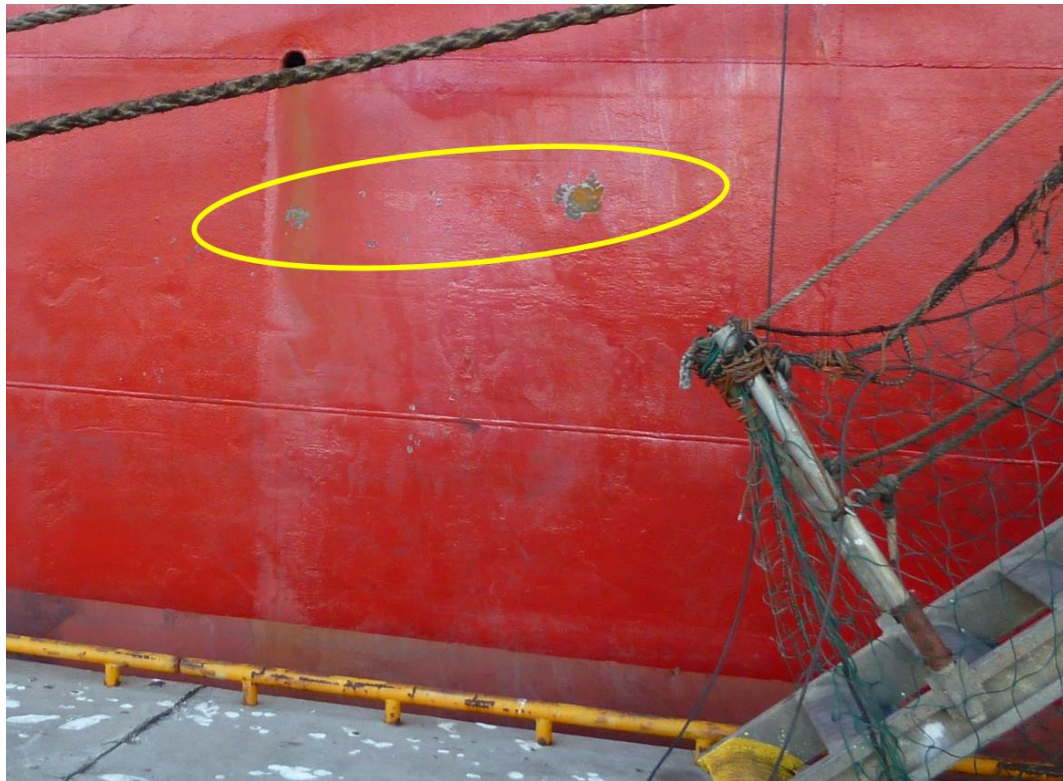
Below the superstructure, superficial damage to the shell plating was found on the port side and above the waterline, apparently from the knocks by the crew of MADS JAKOBSEN (see Figure 10).

Figure 10: Superficial damage to SABINA's port-side shell plating below the superstructure (marked in yellow). The photograph was taken in the port of Kotka.

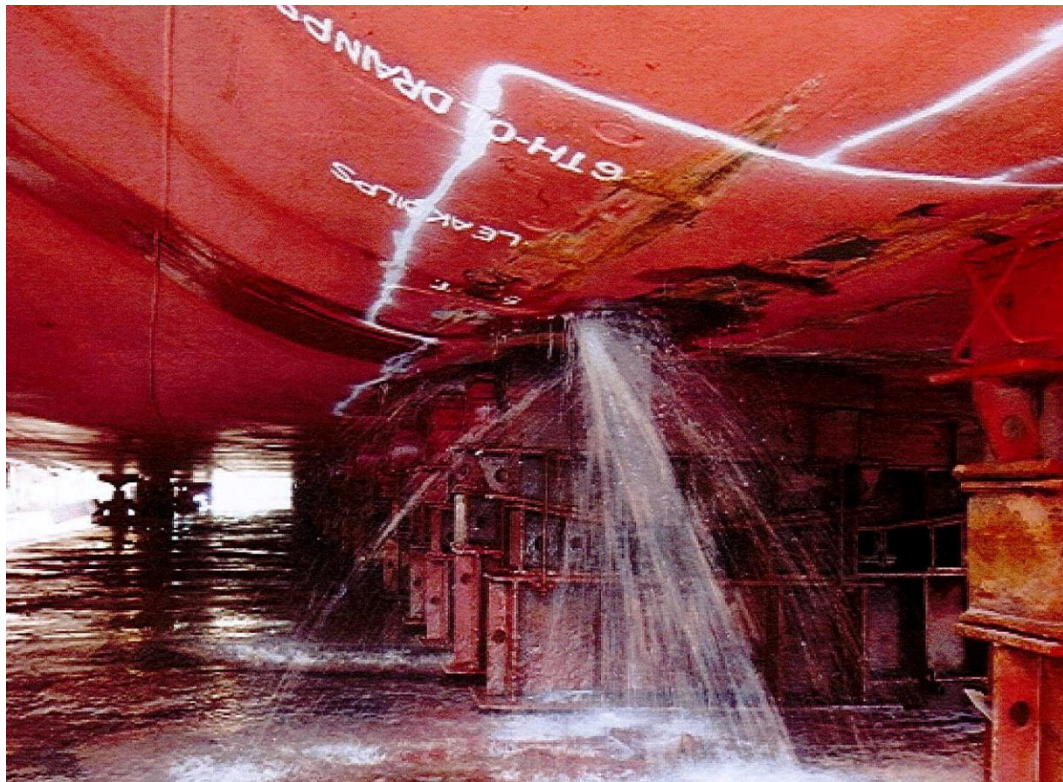
- Outer hull breached between frames²⁸ 32 and 35 in the areas of the port-side double bottom water ballast tank²⁹ and the pipe tunnel (see Figure 11 and Figure 12). The pipe tunnel was flooded.
- Across a length of 7 metres and a width of 1 metre: up to 10-centimetre-deep dents and scratches in the shell plating between frames 28 and 38 in the areas of the port-side double bottom water ballast tank,³⁰ the leak oil tank³¹ and the thermal oil drain tank³² (see Figure 12).

Figure 11: SABINA in dry dock in Tallinn. View from aft towards the bow. Breaches, dents and scratches in the areas of the port-side double bottom water ballast tank and pipe tunnel, as well as dents and scratches in the areas of the port-side double bottom water ballast tank, pipe tunnel, leak oil tank (marked 'LEAK OIL PS') and thermal oil drain tank (marked 'OIL DRAIN PS'). The water that had entered SABINA's double bottom pours out of the breaches in the double bottom and onto the drained dry dock.

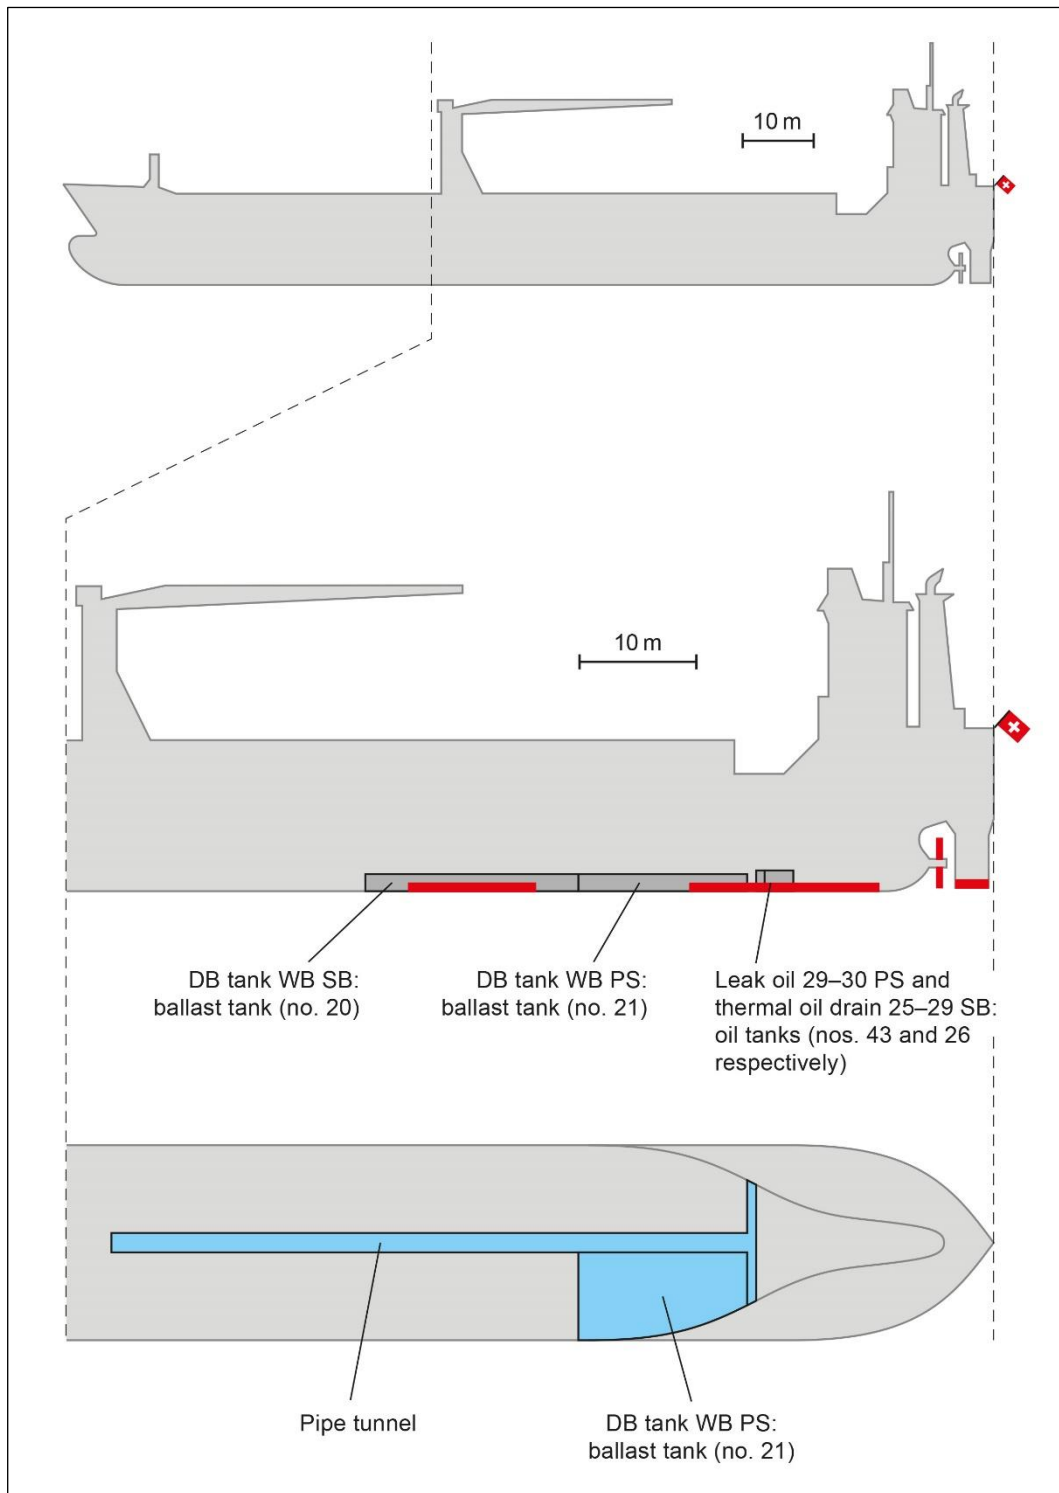
Figure 12: Top illustration: Full profile of SABINA. Middle illustration: Profile including damaged areas (marked in red) on the rudder, propeller and underside of the hull in the areas of the ballast and oil tanks between frames 10 and 38 and between frames 54 and 63. Bottom illustration: Plan view. Volumes into which water could penetrate after grounding (ballast tank and pipe tunnel, marked in blue, see Figure 11). Tank numbers in parentheses relate to the numbering in the ‘Hold and tank capacities’ table. Illustrations and markers are generalised.

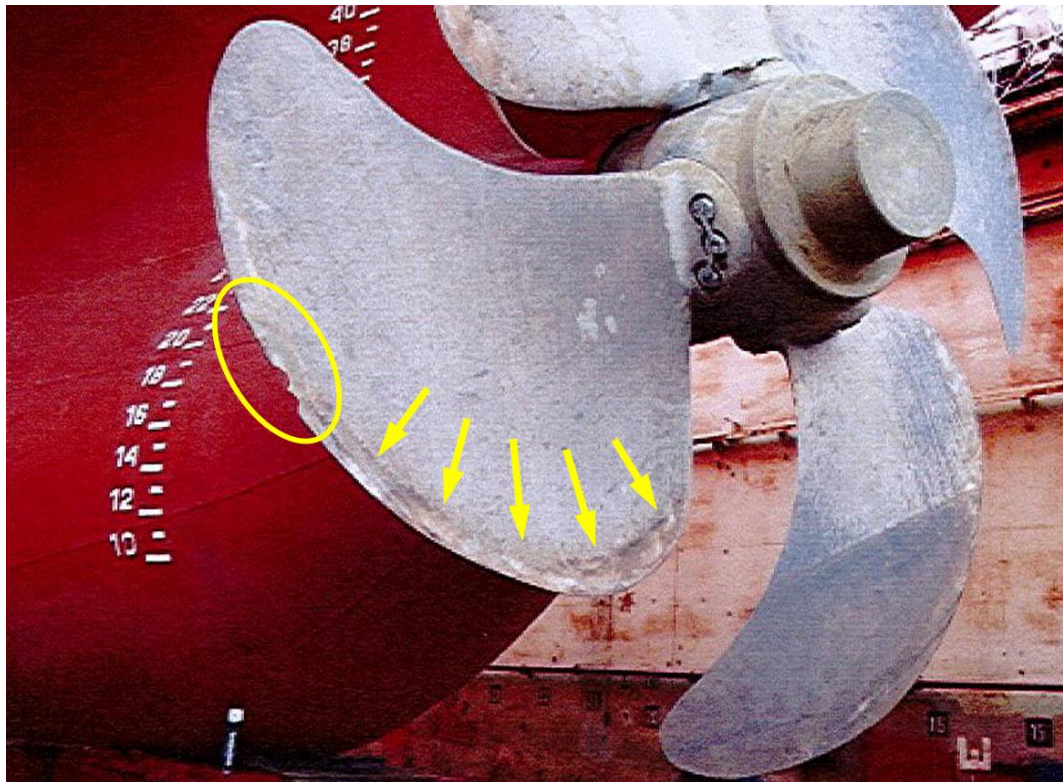
The leading edge of one of the ship's propeller blades exhibited a 35-centimetre-long and up to 5-centimetre-deep serration (see Figure 13).

There were also superficial scratches or grinding marks on the leading edges of all propeller blades. The marks aligned with the propeller's direction of rotation. Along the chord line, the area of the marks was approximately 15 centimetres wide.

Figure 13: SABINA in dry dock in Tallinn. Serration 35 centimetres long and up to 5 centimetres deep is visible in the leading edge of one of the ship's propeller blades (yellow ellipse). Scratches or grinding marks on the leading edges of the propeller blades are also visible (yellow arrows, marked on one blade only).

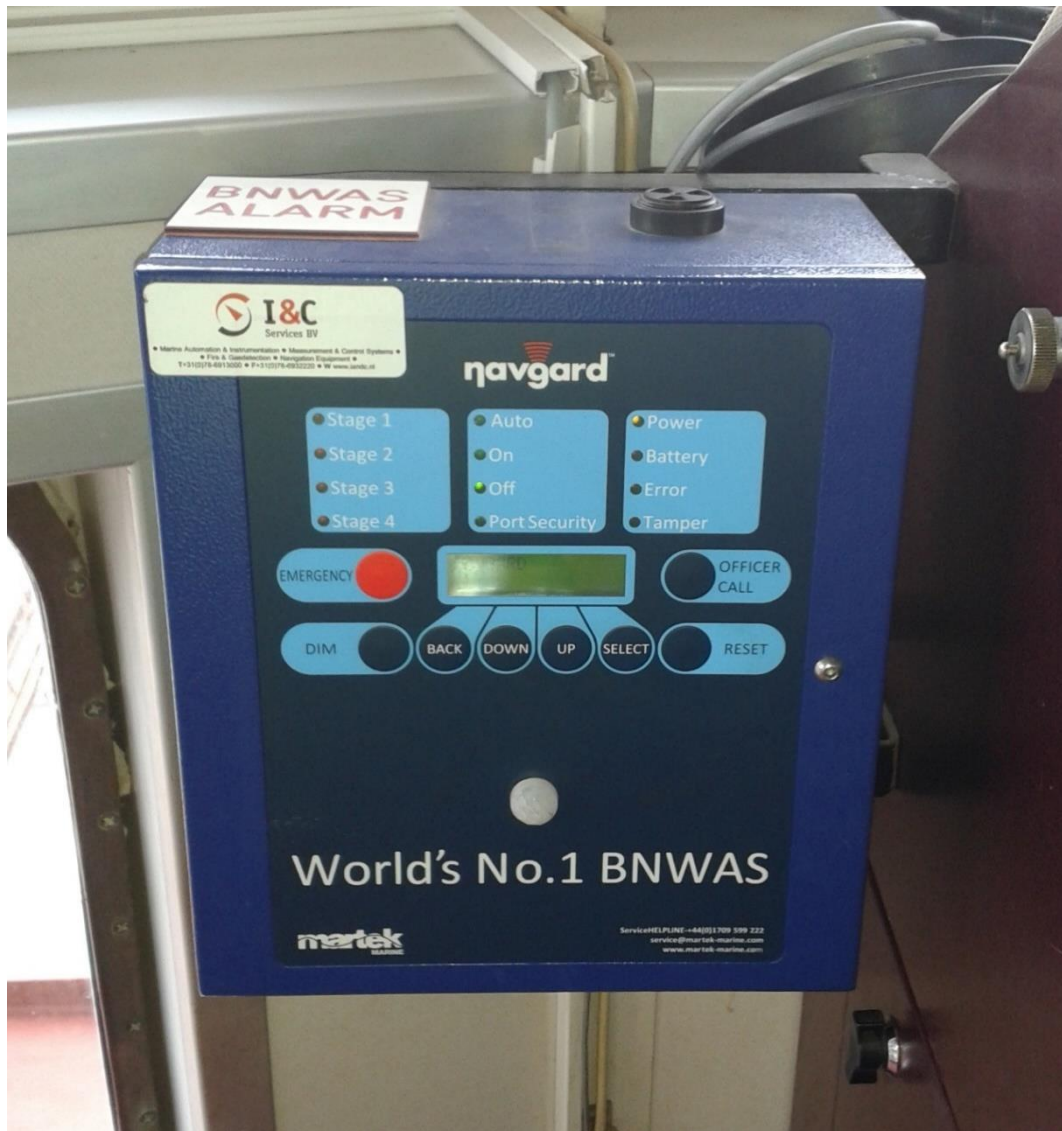
According to the statements made by the second officer, he had never been instructed on how the sensors worked or the functionality and operation of the bridge navigational watch alarm system during the period between his joining SABINA and the incident. The second officer believed that the BNWAS installed on SABINA had three infrared motion sensors.

Figure 16: BNWAS control panel, installed at waist level on the port side directly adjacent to the bridge control console (see Figure 17). The status and operating display is located in the centre, with three groups of four status lights positioned above it. As the device shown is switched off, the green 'Off' status light is illuminated. Below that, there are eight keys to the left and right of the display. The reset key is bottom right, while the red emergency call key is top left. The white 'key' in the centre above the text 'World's No. 1 BNWAS' is the lens of the built-in infrared motion sensor.
