Final Report by the Swiss Transportation Safety Investigation Board STSB

on the marine casualty concerning the
Swiss-flagged general cargo ship SABINA

in a shipyard in Constanța, Romania,

on 26 June 2015

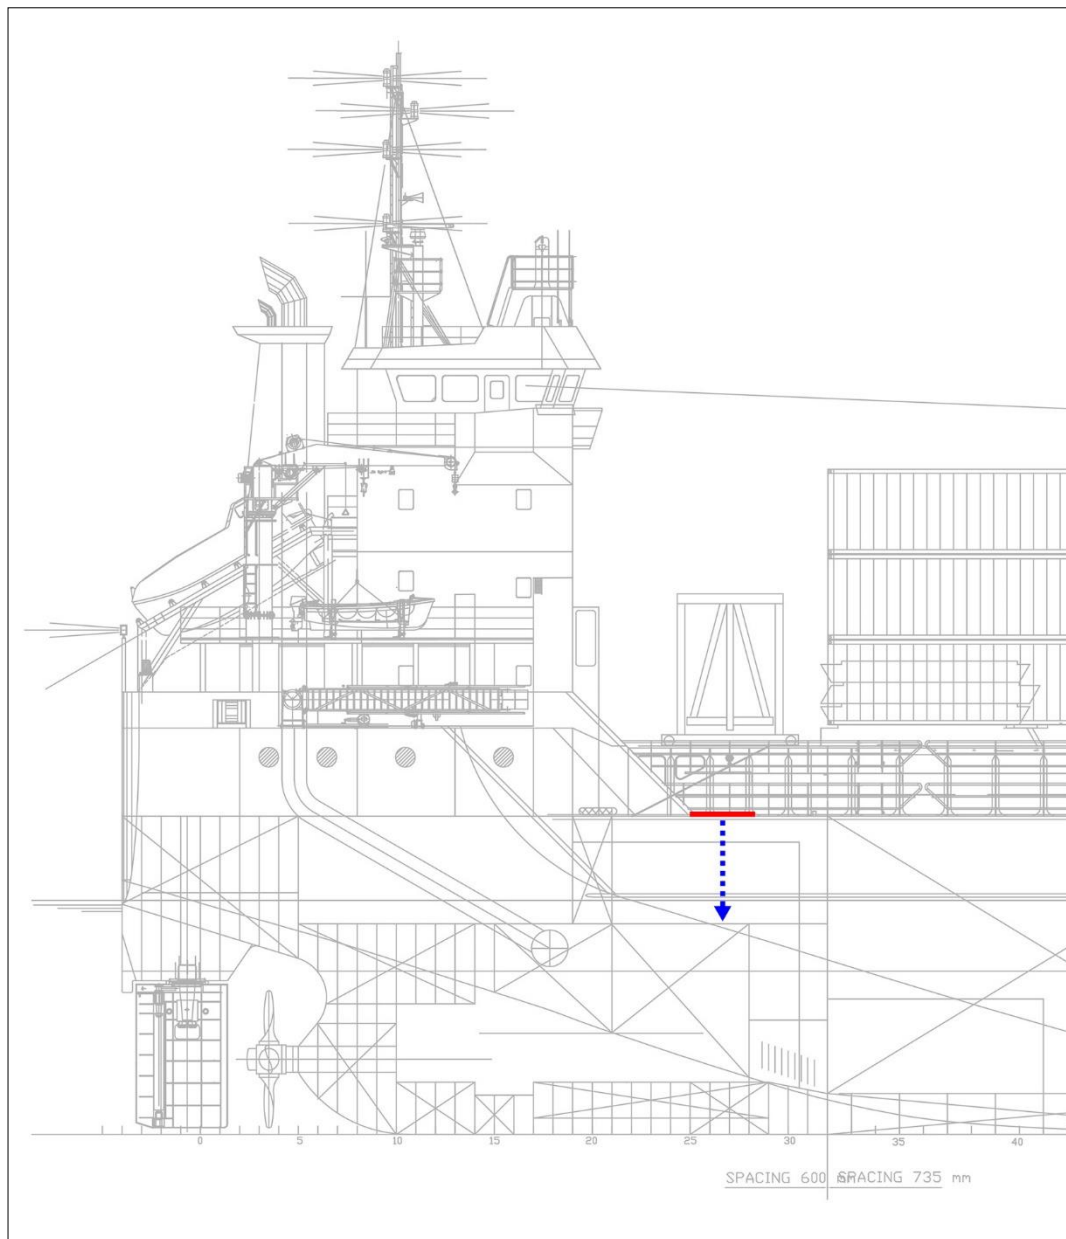
Figure 2: A sketch of the accident scenario based on the general arrangement plan of a sister vessel of SABINA. Red line: the approximate location of the maintenance hatch (sky-light) on the main deck. Blue arrow: the boatswain's fall into the engine room. The length of the arrow corresponds to the approximate fall height of three metres. Source of general arrangement plan: Damen Shipyards Cargo Vessels.

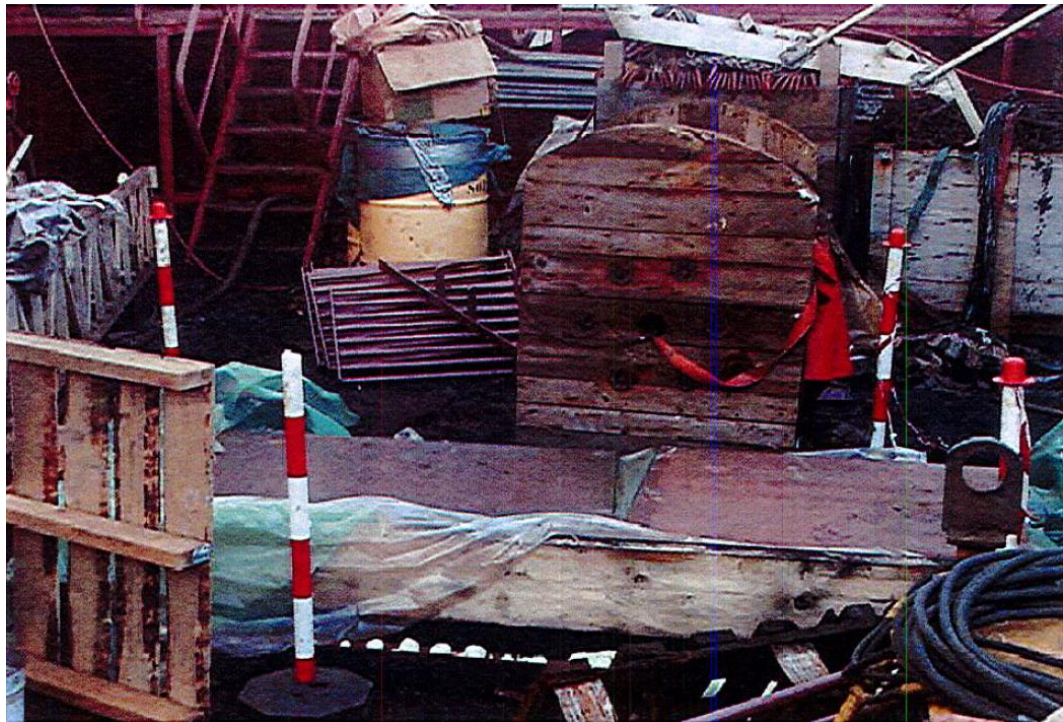
In hindsight, the AB suspected that he and his colleagues had not noticed that the metal sheet was too thin because the deck around the maintenance hatch was obstructed by building materials and tools (see Figure 5). The AB estimated that the sheet was no more than three millimetres thick. He stated that he and his colleagues were wearing the usual safety equipment for shipyard work, notably a hard hat and sturdy footwear. He also stated that he and his colleagues were not wearing safety harnesses because they assumed that the metal sheet was sturdy and therefore there was no risk of falling.

- The incident occurred due to negligence of the shipyard workers. (*"Please state why you think the incident happened – Safety negligence of shipyard workers."*)
- As a corrective measure, the skylight to the engine room was covered with timber and a metal sheet. The hatch was also guarded using railings, which were clearly visible. (*"Corrective action taken: Skylight to ER from main deck protected by timber and steel sheet. Guarded by high visibility railings by ship crew immediately."*)

Figure 5: The state of the main deck after the incident: timber and metal sheets cover the maintenance hatch, and four red and white posts have been put up as a precaution. The area around the maintenance hatch is obstructed by building materials.

The fact that the main deck around the hatch was obstructed by building materials and tools (see section 1.1.2 and Figure 5) may have made it more difficult to notice hazards.
