# Swiss Transportation Safety Investigation Board STSB Annual Report 2020

**Swiss Transportation Safety Investigation Board STSB**

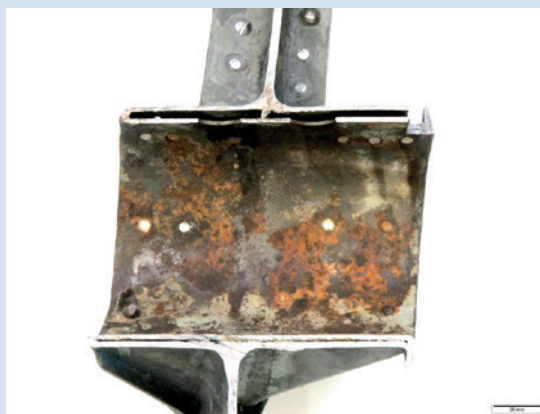
Considerable corrosion damage was found on the wreck of the HB-HOT on the spars, hinges and fittings of the wings and in the area of the cabin floor plate. Two of the three engines were equipped with newly manufactured cam disks which had defects.

Given the same year of construction and similar operating mode and operating hours, it is expected that the sister aircraft, HB-HOP and HB-HOS, have similar defects.

The Federal Office of Civil Aviation (FOCA), in cooperation with the flight operator, should take appropriate measures to ensure that the sister aircraft, HB-HOP and HB-HOS, are inspected for corrosion damage and defects in system components.

Implemented. In a letter dated 28 March 2019, the Federal Office of Civil Aviation (FOCA) announced that it supported the safety recommendation. It has withdrawn the certificate of airworthiness for the two aircraft HB-HOS and HB-HOP until further notice. On the basis of the findings of the accident investigation and the Ageing Aircraft Programme, the FOCA has already placed requirements on Ju-Air regarding engineering support, the establishment of an inspection programme, and the operation and maintenance of the aircraft. The relevant inspections and the resulting findings must be carried out and rectified before a permit to fly is issued.

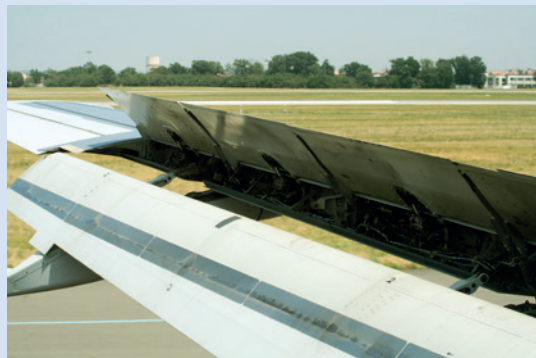
At an indicated airspeed of between 90 and 100kt, the flight crew noticed that the power had been set too low. After advancing the throttles past the critical TLA of 23°, the spoilers retracted by design. During this time, the CONFIG SPOILER warning was displayed for four seconds.

Together with the manufacturer, National Aircraft Certification at Transport Canada (TC) should ensure that the spoilers are not automatically deployed when taking off with insufficient take-off power.

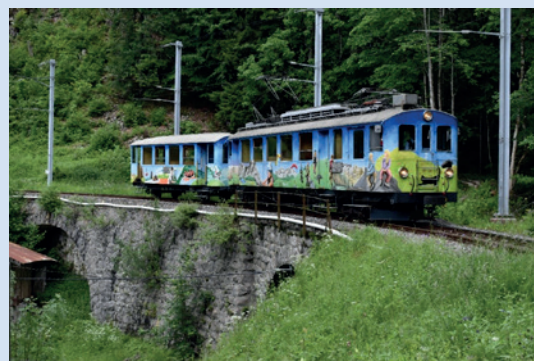
During the stop on the bend of the Folles Bridge, the victim had moved over to the left side of the bridge. The reason why the victim fell from the bridge could not be determined by the STSB.

The way the train stopped in the bend of the bridge led to a dangerous situation. This situation was exacerbated by the various vehicle movements, without regard to the presence of the passengers, and by the lack of regulatory controls to ensure that all passengers were on board the train before it resumed its journey to Aigle.

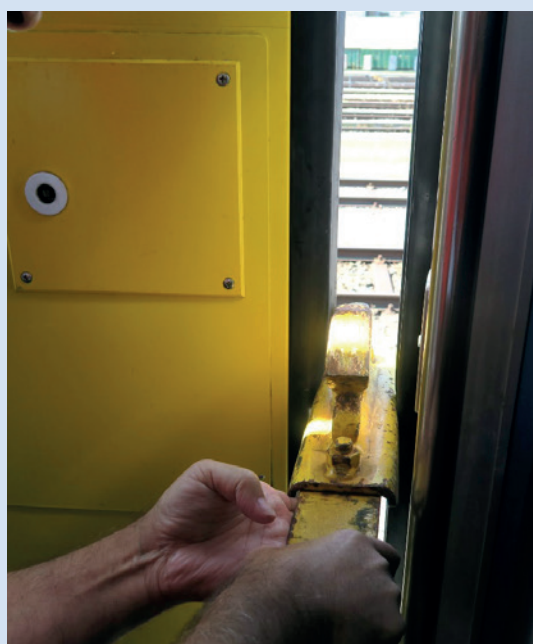
separate button. The train manager was trapped in No 4 door set during the closing action.

The pneumatic anti-trap system must be switched off for technical reasons shortly before the closing action.

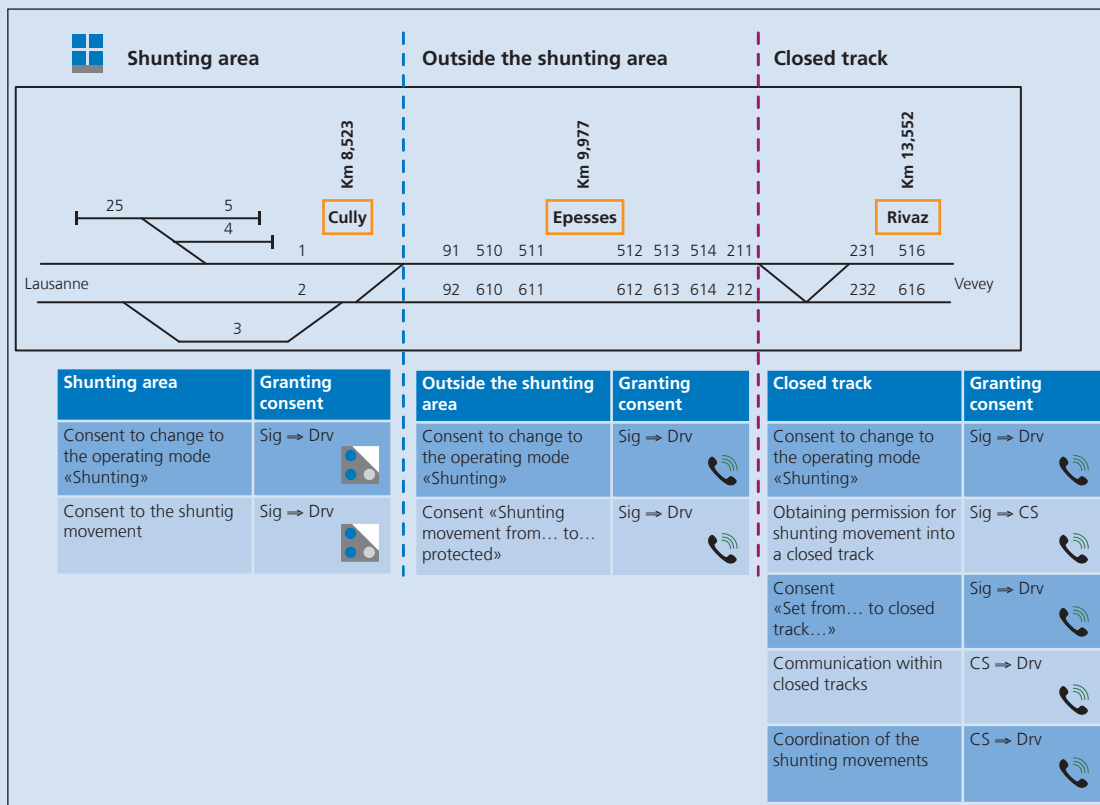
Operations were endangered because a vehicle from the engineering worksite made a return journey at the end of the works without authorisation to move on the five kilometres of the ETCS Level 2 line between Rivaz and Cully, while the tracks were in service.

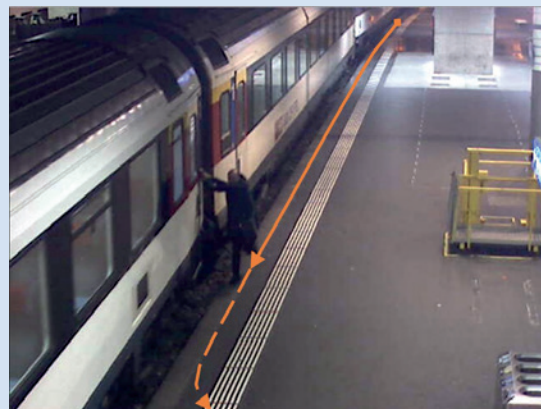
At 01:09 on Sunday, 1 March 2020, a passenger's hand became caught in the closing boarding door of a Eurocity passenger coach of the Intercity (IC) Bern-Interlaken Ost at Bern station. The train left a short time later. The passenger ran alongside the carriage and tried to free his hand. After running alongside the carriage for about 45 metres, he finally managed to pull his hand out of the rubber door seals. He sustained minor injuries in his efforts.

The rubber profile used (second-generation) is so hard that persons or objects coming into contact with the front edge of the door when it is closing are not reliably detected. This

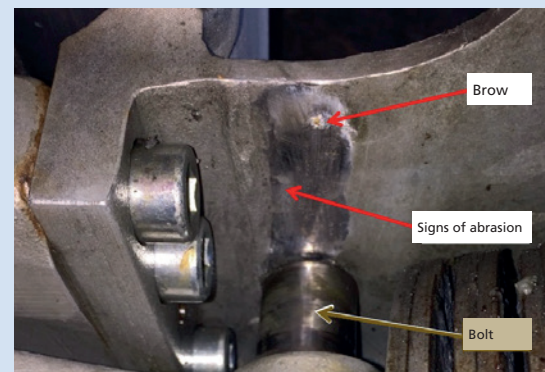
On 11 February 2016 at around 15:20, an empty four-seater chair on the Obersäss-Stelli circulating chairlift in Flumserberg crashed to the ground during the descent. The crash occurred in the vicinity of the third pylon from the top, No 16. No one was injured. The chair that crashed, No 36, was damaged in the event.

The chair crashed owing to a clamp failure. During the last clamp revision, the operator installed a non-compliant heavy-duty dowel pin. The mechanical loads and weathering in combination with the properties of the heavy-duty dowel pin resulted first in longitudinal cracks followed by transverse fractures. As a result, the bolt in the pin joint moved against the clamp housing wall and prevented the clamp from closing completely. The clamp thus no longer gripped the cable forcefully and tightly. At pylon No 16, the clamp was forced open and detached itself from the cable.

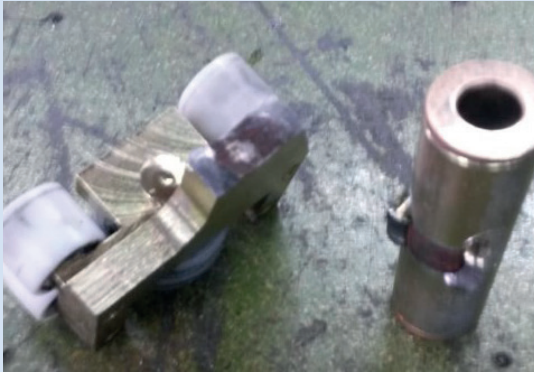
In Crans-Montana, on Monday, 20 January 2020 at around 13:45, on the funitel that links the Violettes hut to the Plaine Morte glacier, the door of a cableway cabin carrying around 15 passengers opened just outside the lower station. The facility was immediately stopped by staff. A reverse manoeuvre was performed to return the cabin to the station. The passengers disembarked and the cabin was taken out of service. There were no injuries.

The unexpected opening of the door of cabin No 15, at the exit of the lower station, occurred because the guide rail carriage on the door leaf was faulty.
