# Swiss Transportation Safety Investigation Board STSB Annual Report 2022

**Swiss Transportation Safety Investigation Board STSB**

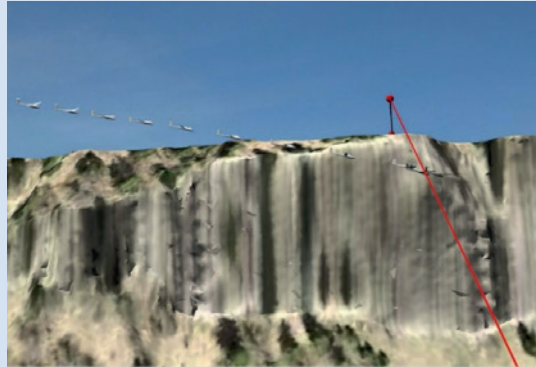
### Collision of a glider with an obstacle near Bettlach-berg, 03.05.2020

On 3 May 2020, a DG-1000S glider equipped with a Flarm collision warning system collided with a power line while descending along a terrain edge.

Air navigation obstacles such as power lines, cableways and radio masts are integrated in obstacle databases in the Flarm collision warning system for different regions, such as the Alps, Germany, Switzerland, Austria and northern Italy. Databases that cover a large geographical area, such as the database for the Alps region, usually do not include antennas, towers and power lines.

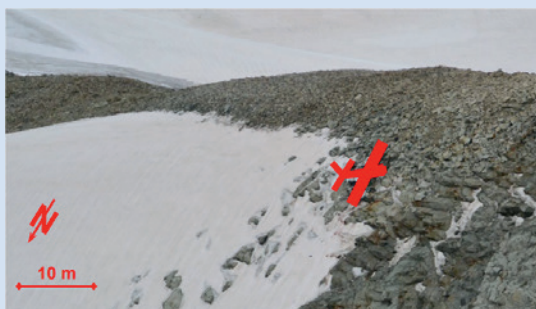
### Collision with the terrain in the mountains, Col Durand (VS), 27.07.2018

On 27 July 2018, a motorised aircraft on a mountain tour collided with terrain while flying over the Mont Durand pass; all four occupants died immediately on impact.

The pilot had decided to make sightseeing flights from Sion airport in a four-seater low-wing aircraft to show his passengers the Matterhorn region. For the second flight, the pilot refuelled the aircraft and allowed three passengers to climb on board. The aircraft was close to the maximum allowable take-off mass, the temperature was ISA +15 °C and the pilot had had minimal flight training.

Flying clubs should have more stringent requirements for private pilots who wish to conduct sightseeing flights with passengers in the mountains. Particular attention should be paid to the degradation in aircraft climb performance in hot weather and high mass. A flight in these conditions should take place with an instructor on board to review tactics for mountain flying before taking passengers.

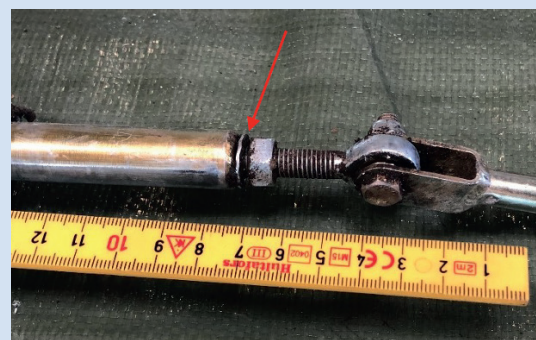
#### Glider accident in the mountains, 28.05.2022

On the afternoon of 28 May 2022, several pilots saw a glider in a spin (vrille) and, after a few rotations around its longitudinal axis, it hit the steep mountain slope at about 2500 m/M.

On a self-launching glider of the type DG 800 B that had been involved in an accident, various lock nuts on the rod ends of the control rods were loose, which could not be explained by the consequences of the accident. From this it can be concluded that the connections had already loosened before the accident and that this condition may have existed for some time. Untightened or incorrectly secured lock nuts on the control rods can affect the operational safety of the control elements.

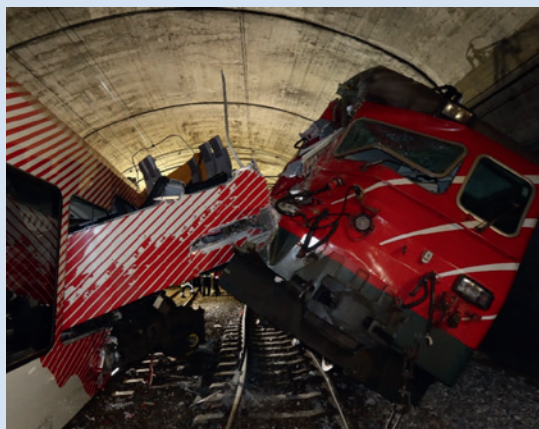
### Collision of a car train with a regional train in Oberwald (VS), 03.07.2020

On 3 July 2020 at 10:09, in the tunnel bypassing Oberwald (the Stephan Holzer Tunnel), a car train travelling towards Realp collided with a regional train coming from Realp at Switch no 15.

The collision of a car train with a regional train coming from Realp in Oberwald at Switch no 15 was due to the fact that the car train drove past the H81 main signal, which was showing a stop, into the path of the regional train.

- Oberwald station was equipped with an intermittent transmission system. The speeds and the braking curve of the car train were not continuously monitored as it ran on track 81. For this reason, the transmission system did not intervene early enough despite the train's excessive speed and failure to brake in time. Only when the train passed the H81 main signal showing stop did it trigger an emergency brake.
- The overlap of 3.5 m was too short to ensure that the train stopped before the danger point at Switch no 15.

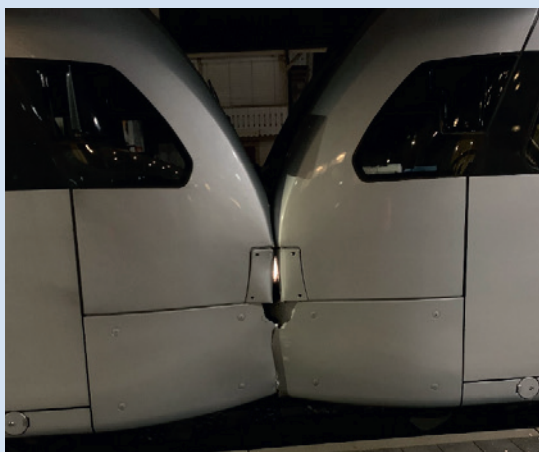
### Collision of a train composition with a stationary composition in Belp, 31.12.2020

On 31 December 2020 at 16:43, a train composition was to be coupled with an identical composition waiting on the entry track at Belp station. The incoming train applied insufficient braking power and collided with the stationary composition. No one was injured.

The collision was due to the combination of several circumstances that affected the train's braking capacity in such a way that the available braking distance was insufficient for the train to be able to stop in time.

- The combination of a slippery rail due to salt run-off and grease on the wheel treads caused increased slippage between the wheel and the rail.
- As friction was poor under these conditions, the braking system control mechanism did not ensure that the multiple unit could maintain the intended braking distance.
- The brake pads did not have the full friction value from the start.

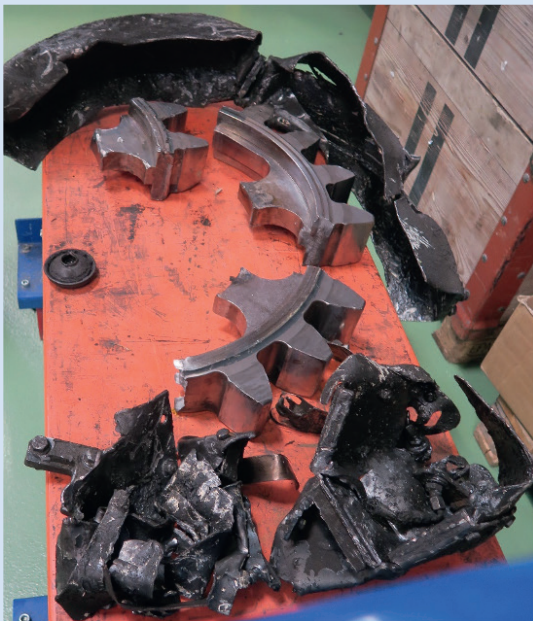
#### Broken driving pinion on the Brünig-Giswil line, 06.03.2021

At around 09:50 on 6 March 2021, a driving pinion on a seven-car Adler rack-and-adhesion multiple unit of the Zentralbahn railway company broke on the line between Brünig-Hasliberg and Giswil.

The driving pinion broke while the Adler multiple unit was descending the Brünig pass. The break was due to crack initiation in the spring chamber, which was caused by over-stressing the tangential spring system, for which the driving pinion was not designed. This led to mechanical damage to the spring chamber wall.

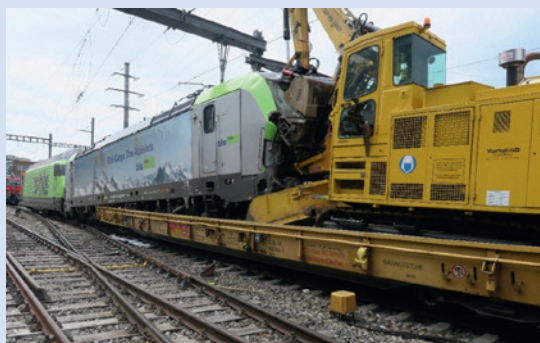
#### **Collision of a locomotive train with a goods train in Zollikofen, 02.06.2022**

On 2 June 2022 at 11:36, in Zollikofen station, a light engine collided with the rear of a goods train comprising special vehicles for track construction work. This goods train was about to depart. The front locomotive of the light engine came to a stop on the low-floor wagon located at the rear of the goods train. The driver of the light engine sustained minor injuries.

The light engine collided with a stationary goods train about to depart Zollikofen station on 2 June 2022 because the light engine had passed a stop signal. The driver expected the next signal to be the exit stop signal. He did not notice the signal layout between the entry and exit signals.
