# Swiss Transportation Safety Investigation Board STSB Annual Report 2023

**Swiss Transportation Safety Investigation Board STSB**

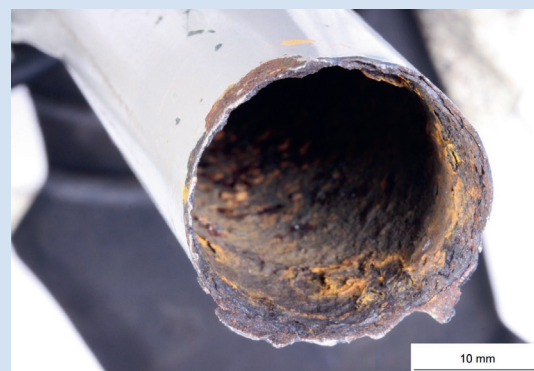
On an SF 25C motor glider the right control stick broke directly above the weld seam at the transmission joint so that it could no longer be used to control the aileron and elevator. The design was such that the aileron, but not the elevator, could still be controlled with the left stick. The crew, who were unaware that the control stick was broken, therefore lost control of the motor glider during the take-off run. The aircraft hit the ground hard, collided with a tree and came to a halt heavily damaged.

The motor glider was manufactured in 1977. The investigation revealed that the broken steel rod was heavily corroded on the inside and therefore weakened.

Other glider models of comparable design and manufactured during the same time period also experienced structural failure due to material fatigue or other signs of ageing. In older aircraft of similar design, the maintenance manuals usually do not contain any maintenance specifications

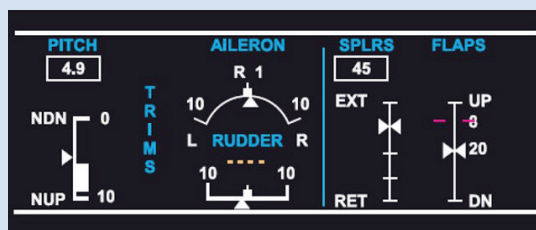
The investigation revealed that the reversal of the spoileron function caused by a maintenance error had not been recognised by any of the flight crews flying the aircraft before the serious incident occurred. In the synoptic display on the flight control page, the position indices of the left and right spoilerons are grouped around a single vertical axis and can easily be confused. When checking the spoilerons before take-off, pilots are therefore likely to 'fall victim' to a confirmation bias, confusing the indices and confirming the deployment sequence that they believe to be true.

The US Federal Aviation Administration (FAA) should ensure that the manufacturer modifies the flight control display to minimise the possibility of confusion between the left and right spoilerons; this recommendation should apply to all aircraft equipped with similar displays.

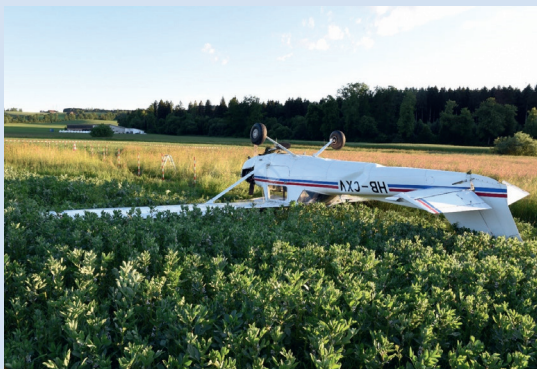
**Take-off accident involving a powered aircraft at Beromünster aerodrome (LU), 12.06.2020**

The aircraft took off at too low a speed, whereupon the available take-off power was insufficient to accelerate it or bring it into a climb. An emergency landing was unavoidable; the aircraft overturned in a field of tall grass.

Incidents may occur during take-off particularly on aerodromes with challenging conditions and relatively short runways on which the available take-off distance is insufficient to ensure a safe take-off. Similarly, landings on short

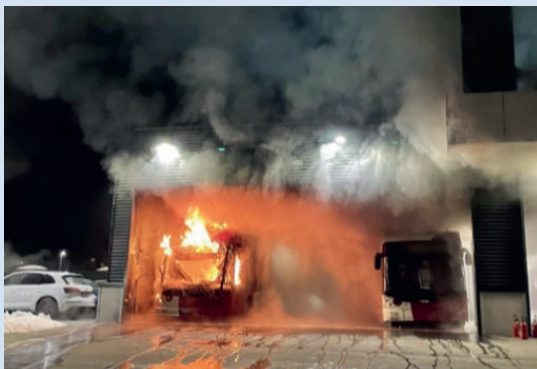
- The lack of insulation between the negative terminal of the 24V battery system and the chassis.
- The lack of protection for the power cables, which run over various metal parts with sharp edges.
- The fact that some cables in the secondary circuits were not suitable for containing the flames.

The chassis and bodywork of trolleybuses consist of various interconnected metal parts. Some of these have sharp edges which, over time, due to the vibrations caused by the movement of the vehicle, damage the electrical wiring and lead to a faulty electrical connection, which may result in a fire.
