Final Report No. 1887

by the Federal Aircraft Accident Board

concerning the total failure of the radar air picture presentation

on all workstations of the Area Control Centre (ACC)
and the approach and departure control centre (APP)
in Zurich Air Traffic Control (ATC ZRH)
on 11 November 2003

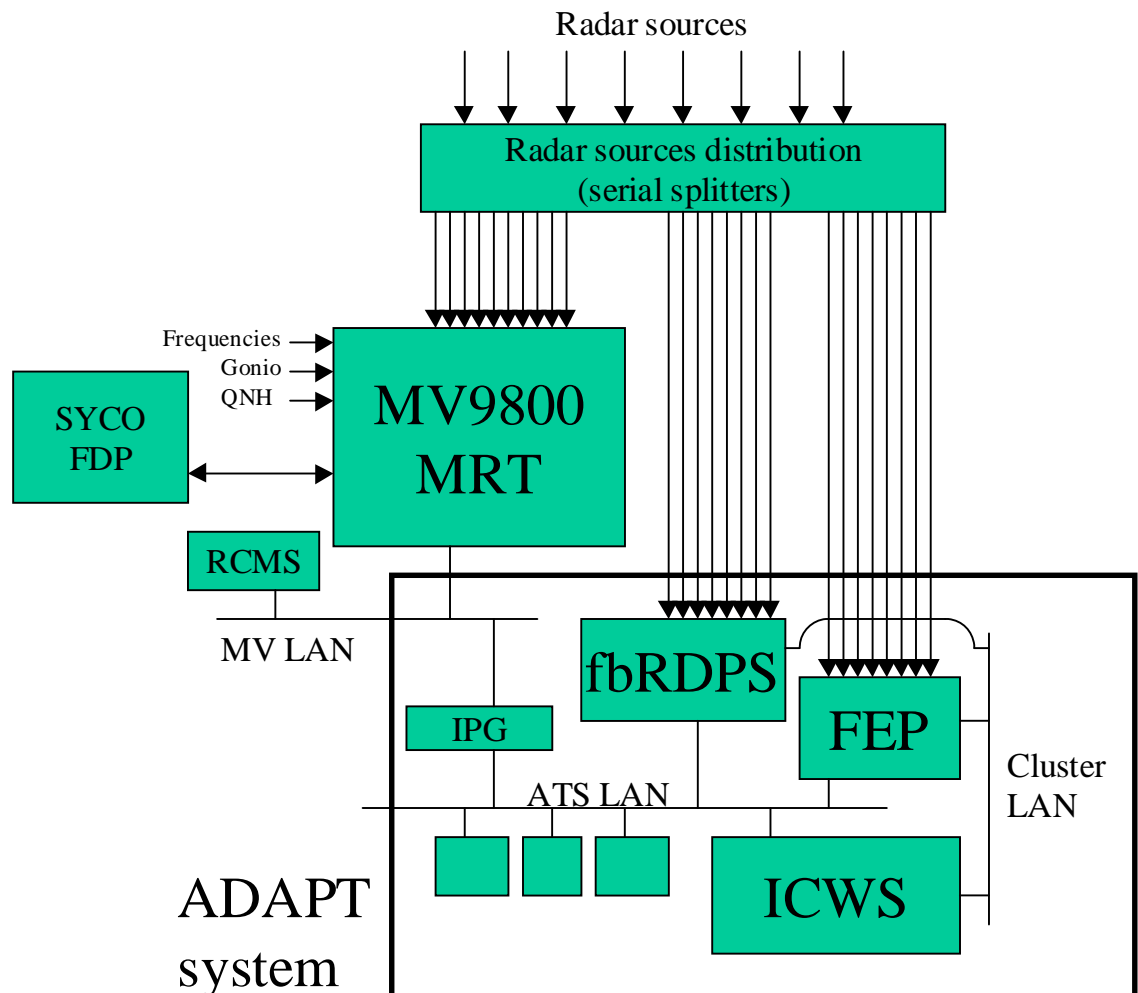
Figure 1: Block diagram with the main components of the skyguide radar system. Radar data can be processed and displayed in three different ways.

The block diagram in figure 1 shows the main components of the skyguide radar system. The components of the implemented ADAPT system are included in the frame.

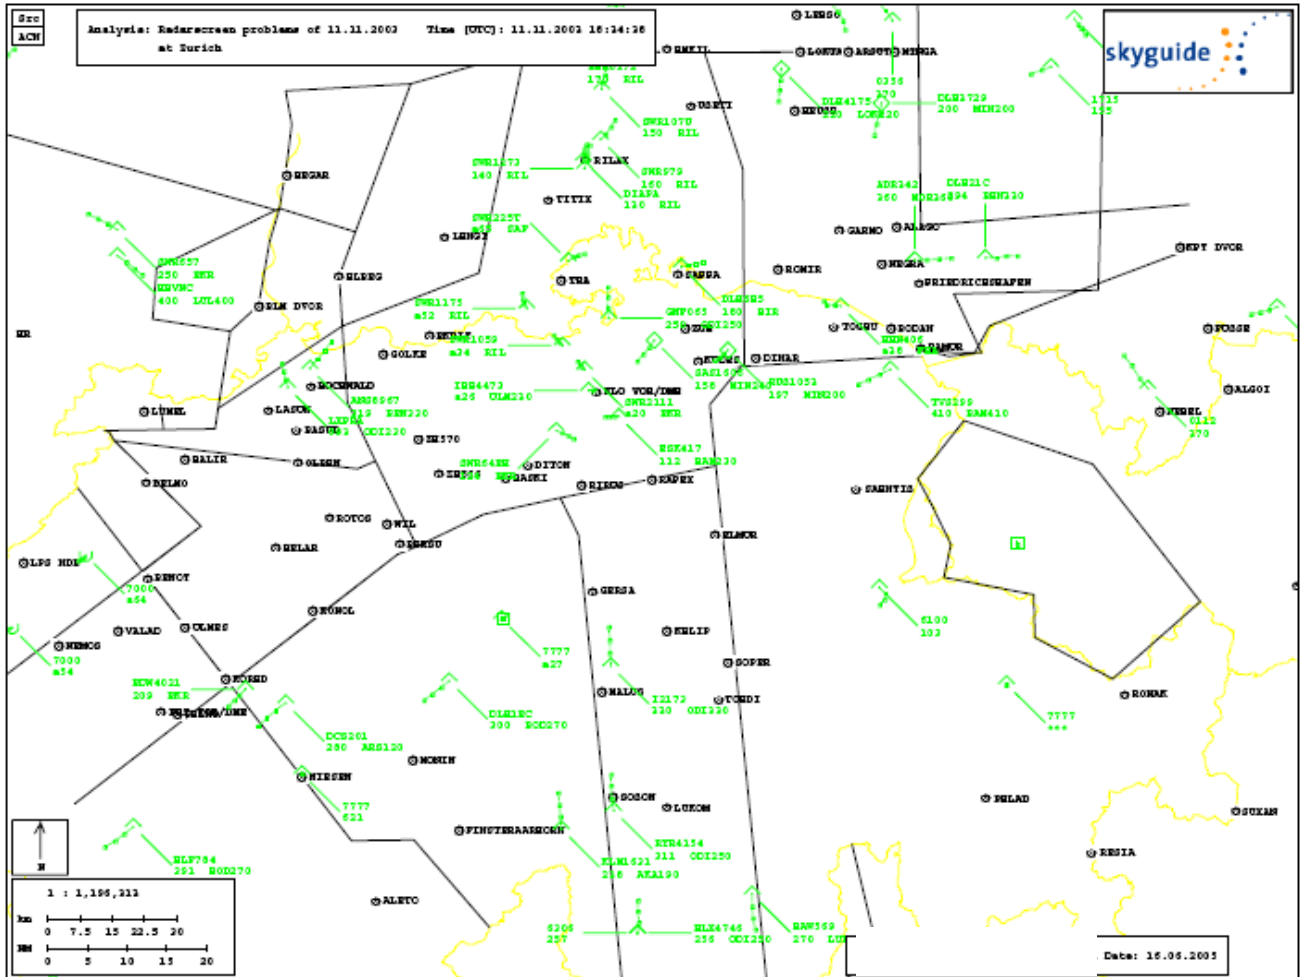
Annex 3: Radar air picture at the beginning of the serious incident

At the time of the radar display failure, 28 aircraft in the airspace under the control of Zurich ATC were on the air traffic controllers' screens (see annex 5.3).
